TECHNICAL REPORT 1761
January 1998

VLF Cutler: September 1997 Four-Panel Tests; RADHAZ and Field Strength Measurement

P. Hansen
J. Chavez
SSC San Diego

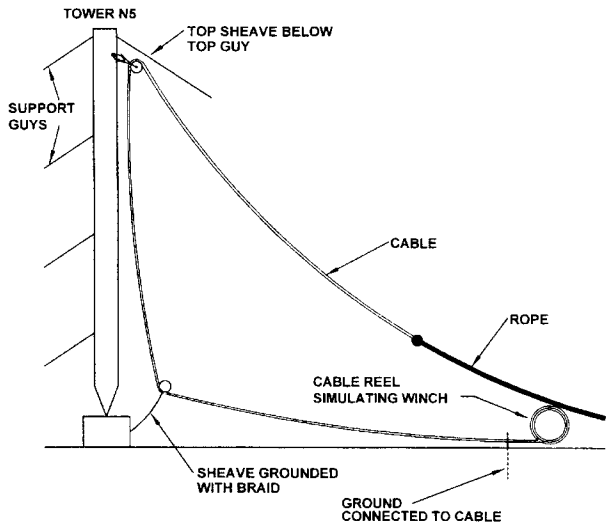
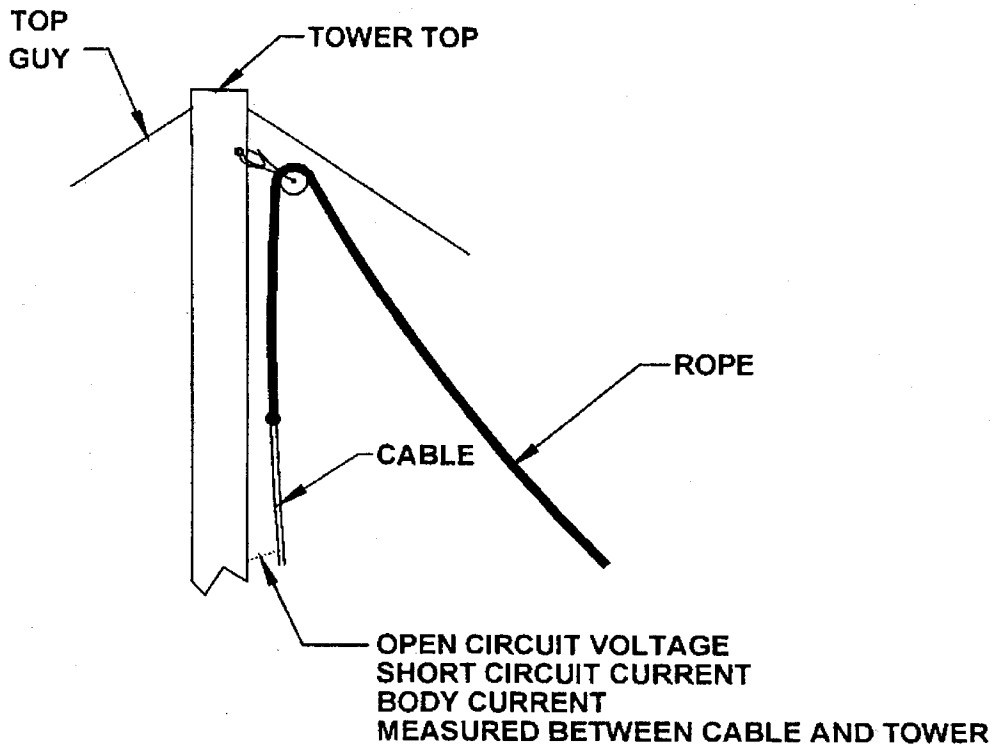
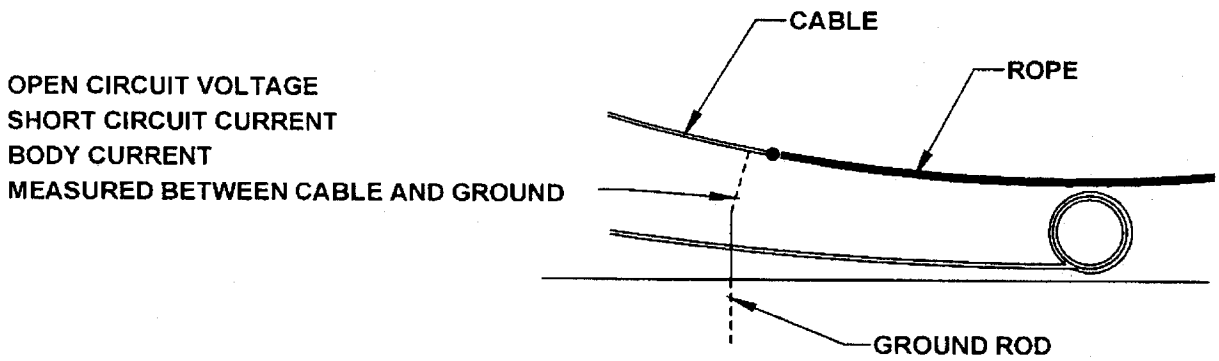
Figure 14. Simulated winch configuration.

In six-panel mode, when the loop was completed by touching the end of the cable to ground or to the part of the winch cable going to the tower base, sparking was barely visible (figure 16). We completed the circuit briefly by holding the ground rod with one hand and brushing contact to the cable end with the other hand and experienced significant shocking, but no burning. The body current was excessive and not measured. The same test was done in four-panel mode and sparking could not be observed. The body current for this condition was 12.5 mA, which is less than the ANSI safety limit.

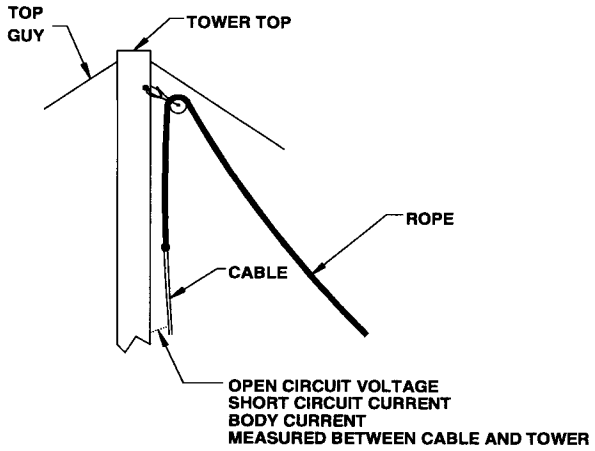
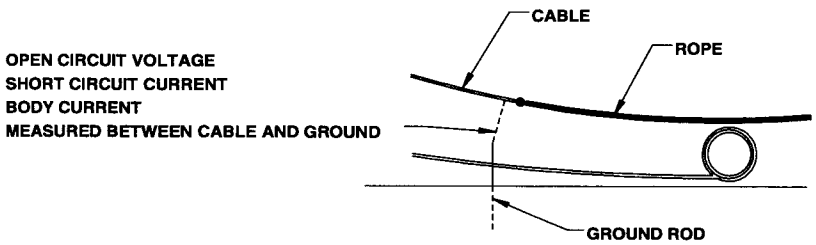
Figure A-1. Simulated winch RADHAZ measurement at tower top.

A simulated winch was rigged on tower N5 while in six-panel mode. There are many ways that a winch can be rigged to hoist materials and equipment up the tower for use by personnel painting or performing maintenance. We used a configuration that was familiar with our experience at the Navy's site at H. E. Holt in western Australia. Winches rigged by a contractor could well be in a different configuration. The rigging for the winch is shown in figure 14. Note that the winch rigging is all in one plane, which was approximately perpendicular to a radial to center tower of the active array.

The top of the winch line was rigged through a snatch block rigged just beneath the top guy level. The conductive winch line was hauled up the outside face of the tower using a nonconductive line. At the top of the tower, the voltage between the end of the conductive line and the tower and the short circuit current between the conductive line and the tower were both measured (figure A-1). Similar measurements were made when the winch cable was completely in place, running all the way back down to the ground, forming a large loop (figure A-2). The currents flowing in the sheave ground cable at the tower base were also measured. All the voltage and current measurements for both four- panel and six-panel modes are included in table A13.
