Structural Performance of Cylindrical Pressure Housings of Different Ceramic Compositions Under External Pressure Loading

Part IV, Silicon Carbide Particulate Reinforced Alumina Ceramic

Technical Report 1594
December 1993

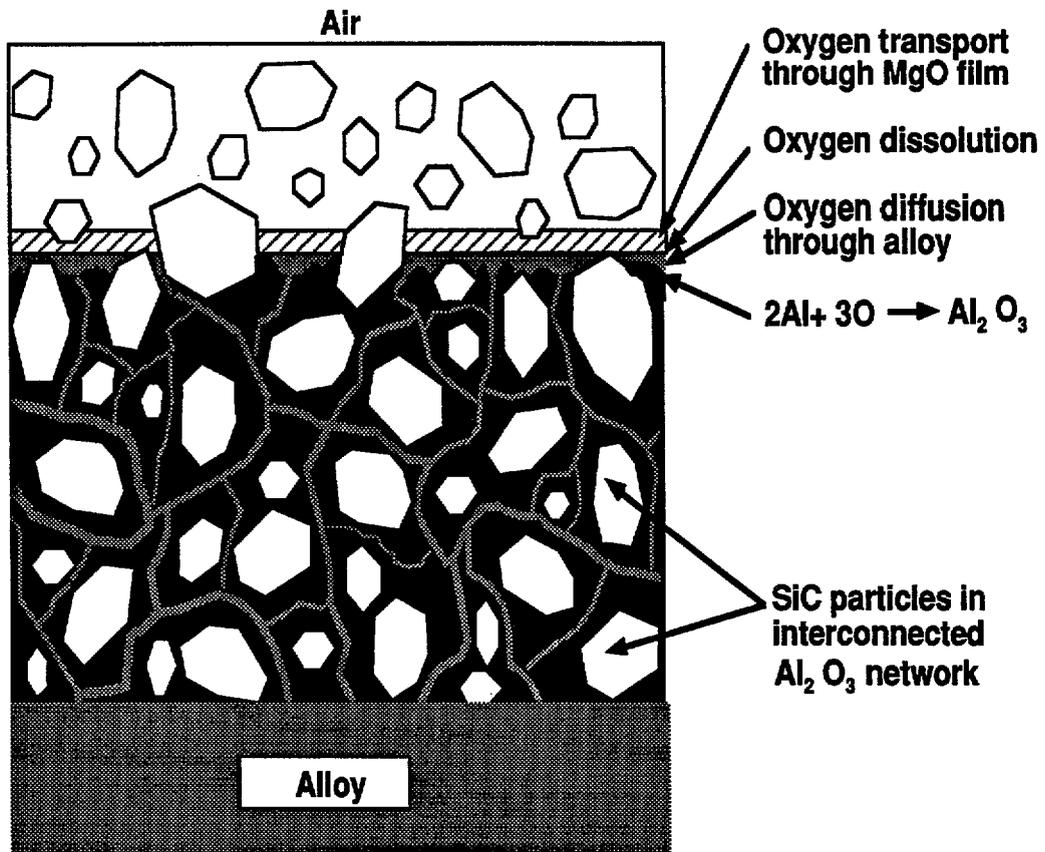
Figure 1. Illustration of the growth mechanism for the formation of alumina-ceramic composites via the DIMOX™ process.

To achieve this special microstructure, preforms of SiC particles are placed into contact with specially alloyed aluminum at 900 degrees C. The aluminum alloy simultaneously oxidizes around the SiC particles as it wicks into the preform. The SiC particles are locked into place without the traditional ceramic processing shrinkage associated with

Barrier coatings on the "air side" of the preform stop the directed metal oxidation process at the preform surface when infiltration is complete, yielding a smooth net-shape finish. Upon completion of growth, the alloy and composite are separated. The resultant ceramic composite net shape is strong (because of the SiC-reinforced matrix of pure alumina) and tough (because of the metal-filled microchannels).

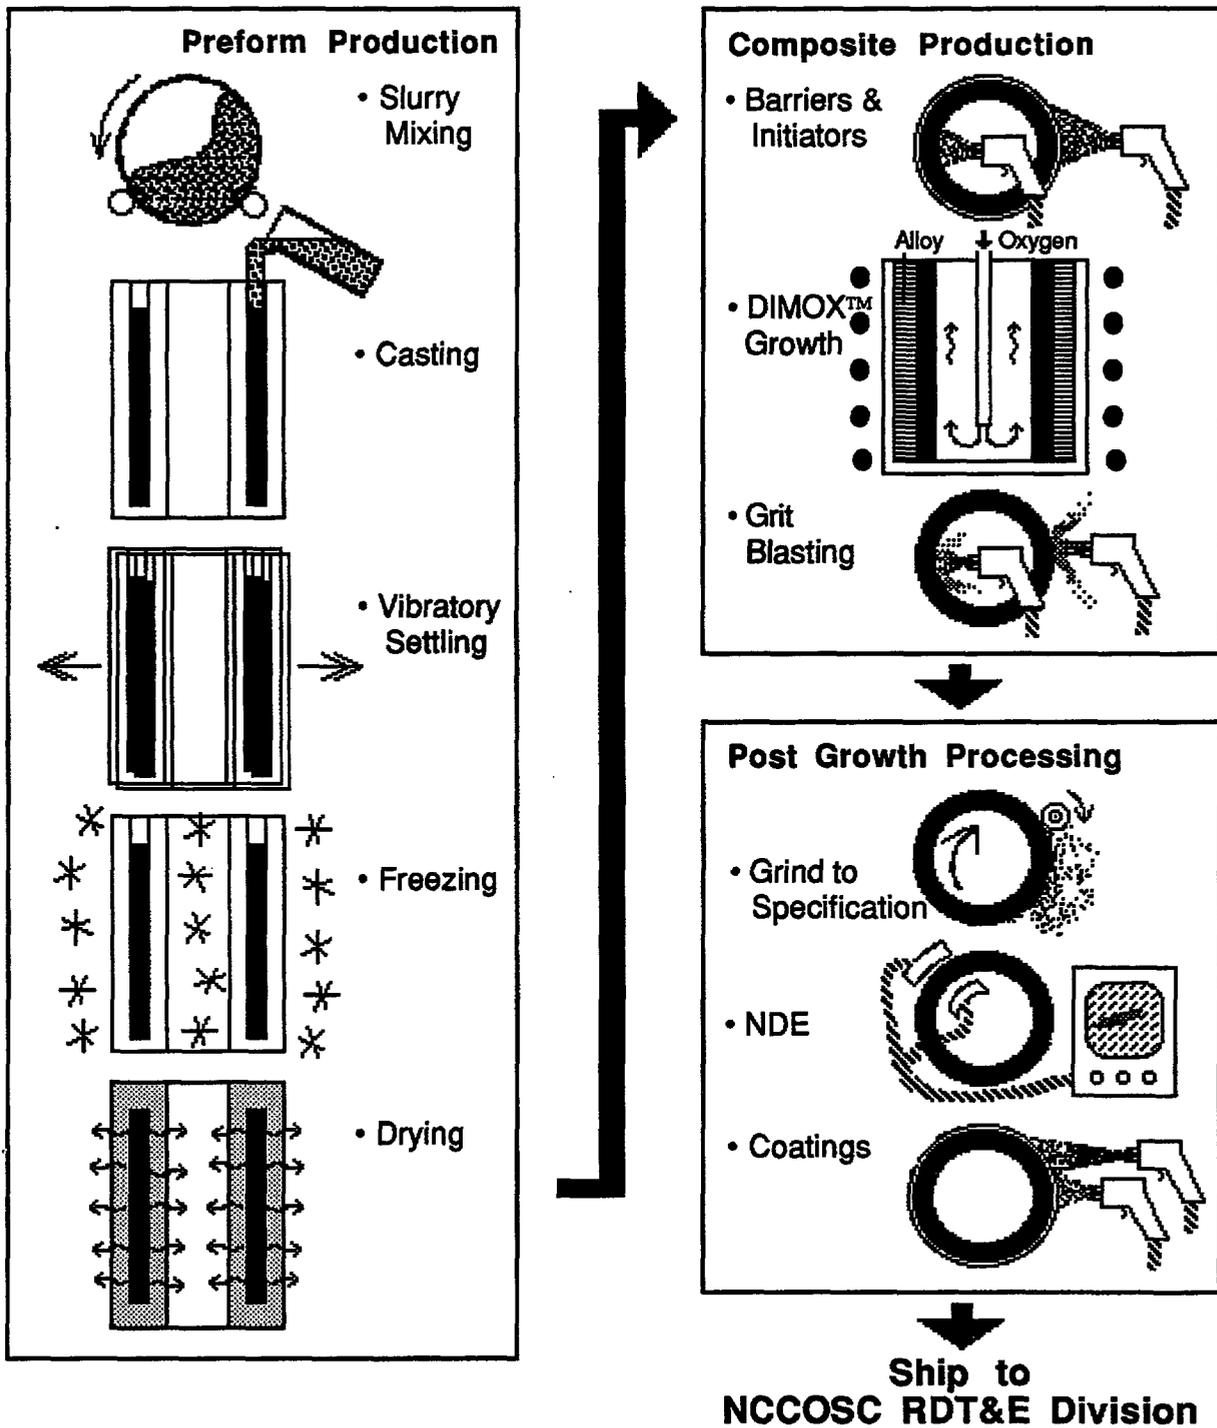
Figure 2. Processing steps to produce a ceramic composite cylinder.

1. Preform Production
2. Composite Production (Growth or Matrix Infiltration)
3. Post Growth Processing

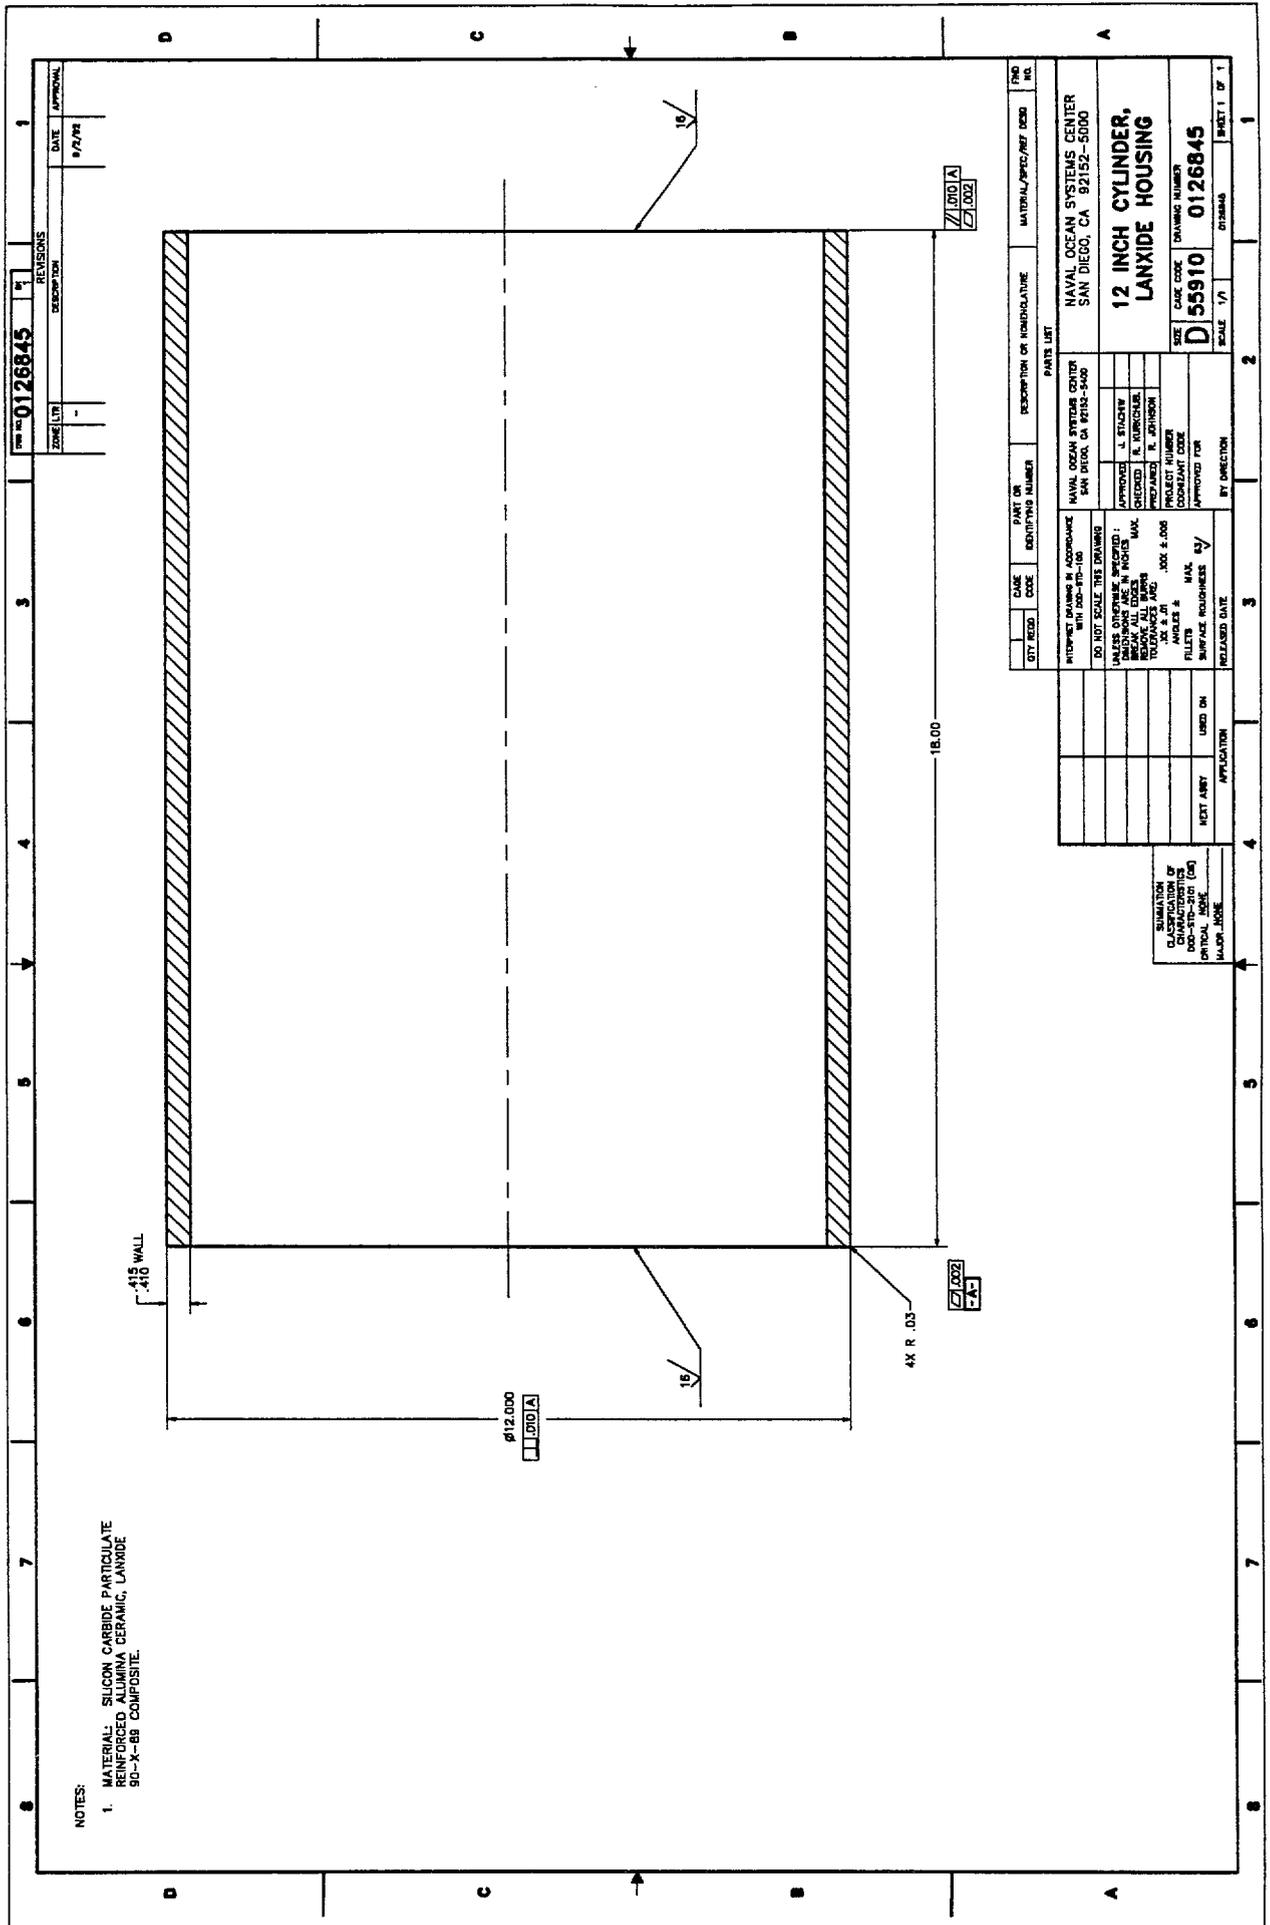
Figure 3. Engineering drawing for fully-ground 12-inch-OD by 18-inch-OD $\text{SiC/Al}_2\text{O}_3/\text{Al}$ composite cylinder.

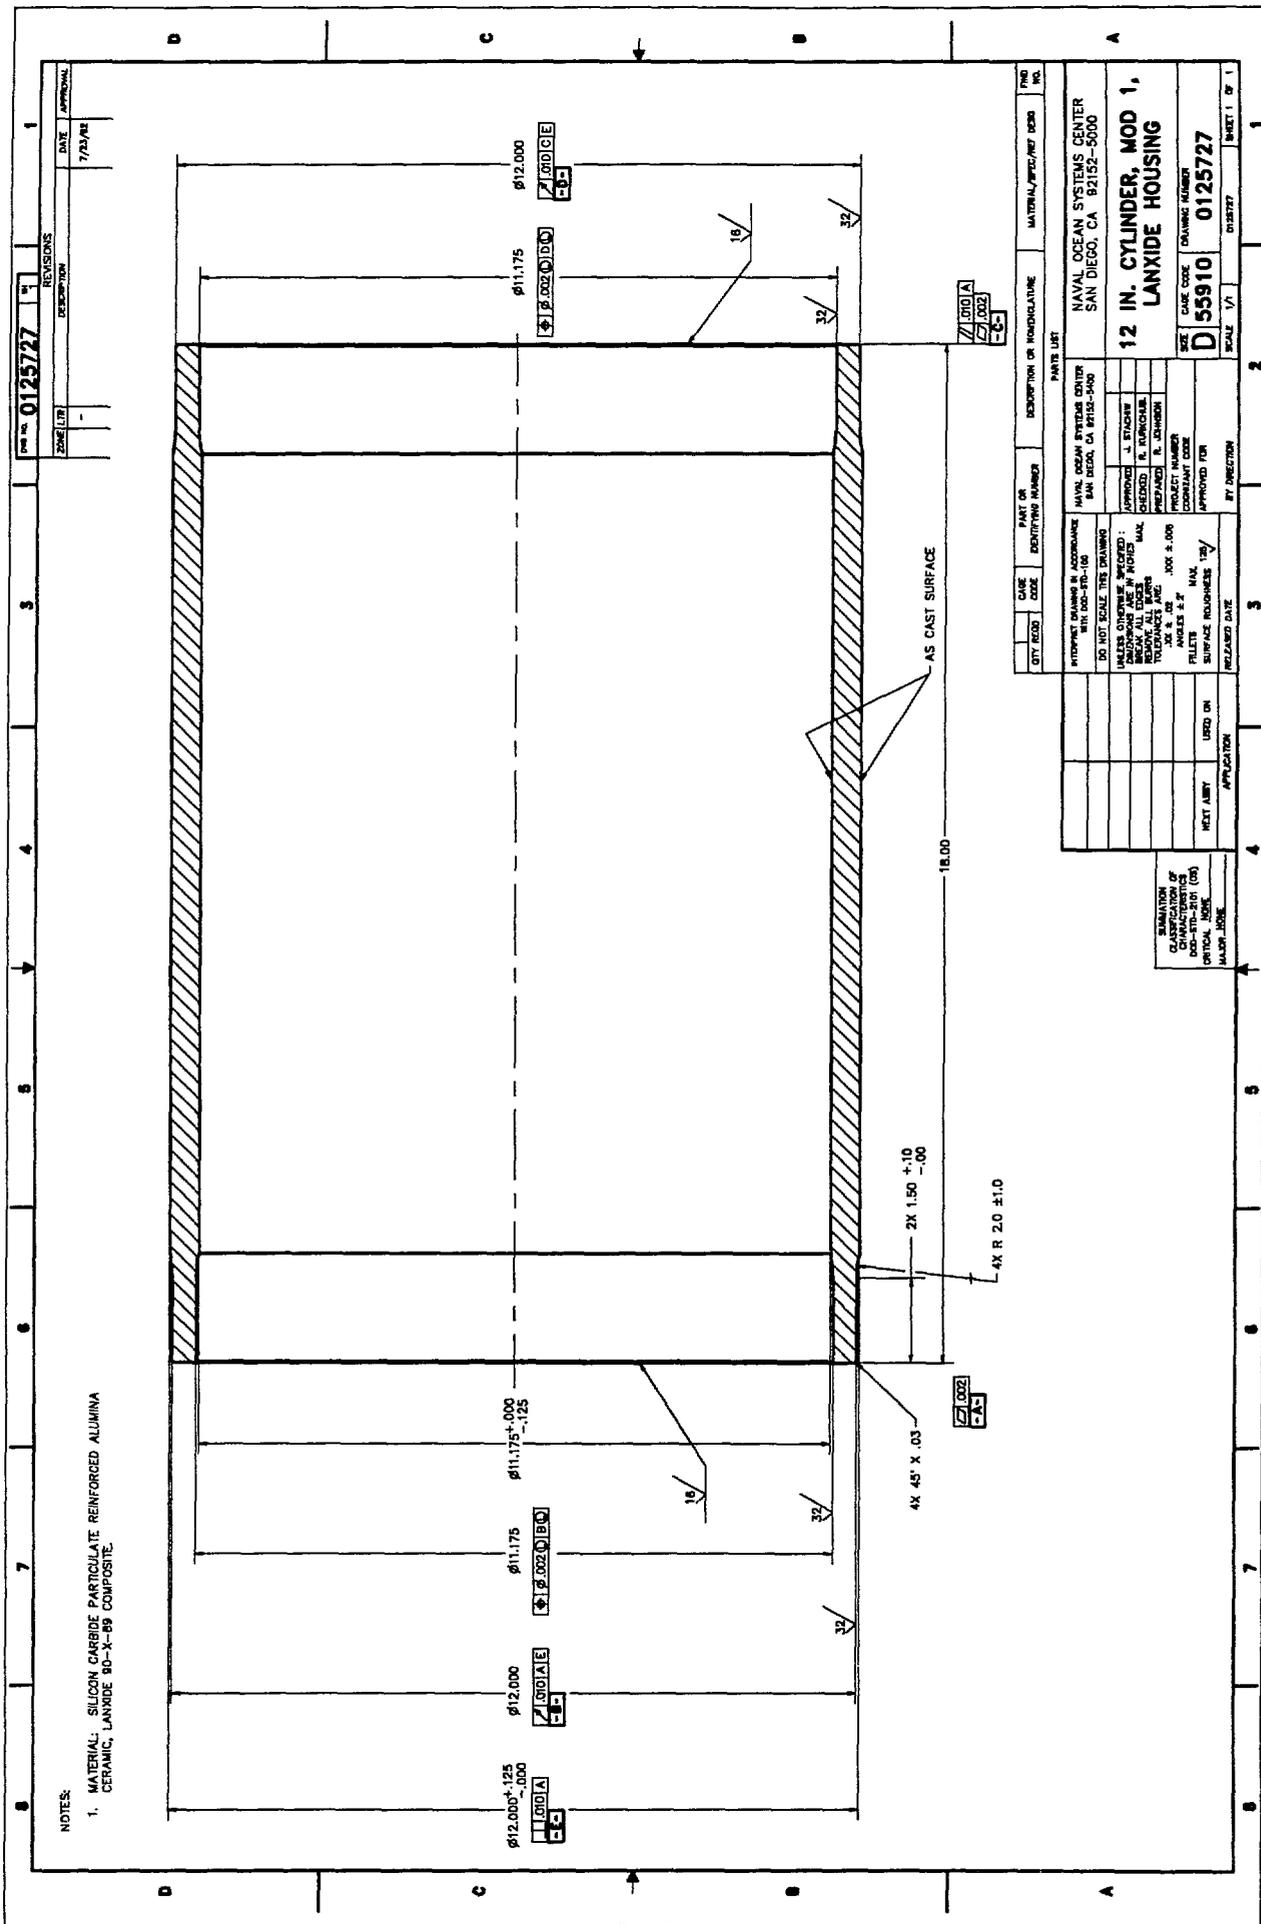
Figure 4. Engineering drawing for "as-cast" 12-inch-OD by 18-inch-OD SiC/Al₂O₃/Al composite cylinder.

for the two housings machined only on each end, leaving the center region of both the inside and outside surfaces in the "as-cast" or net-shape condition.

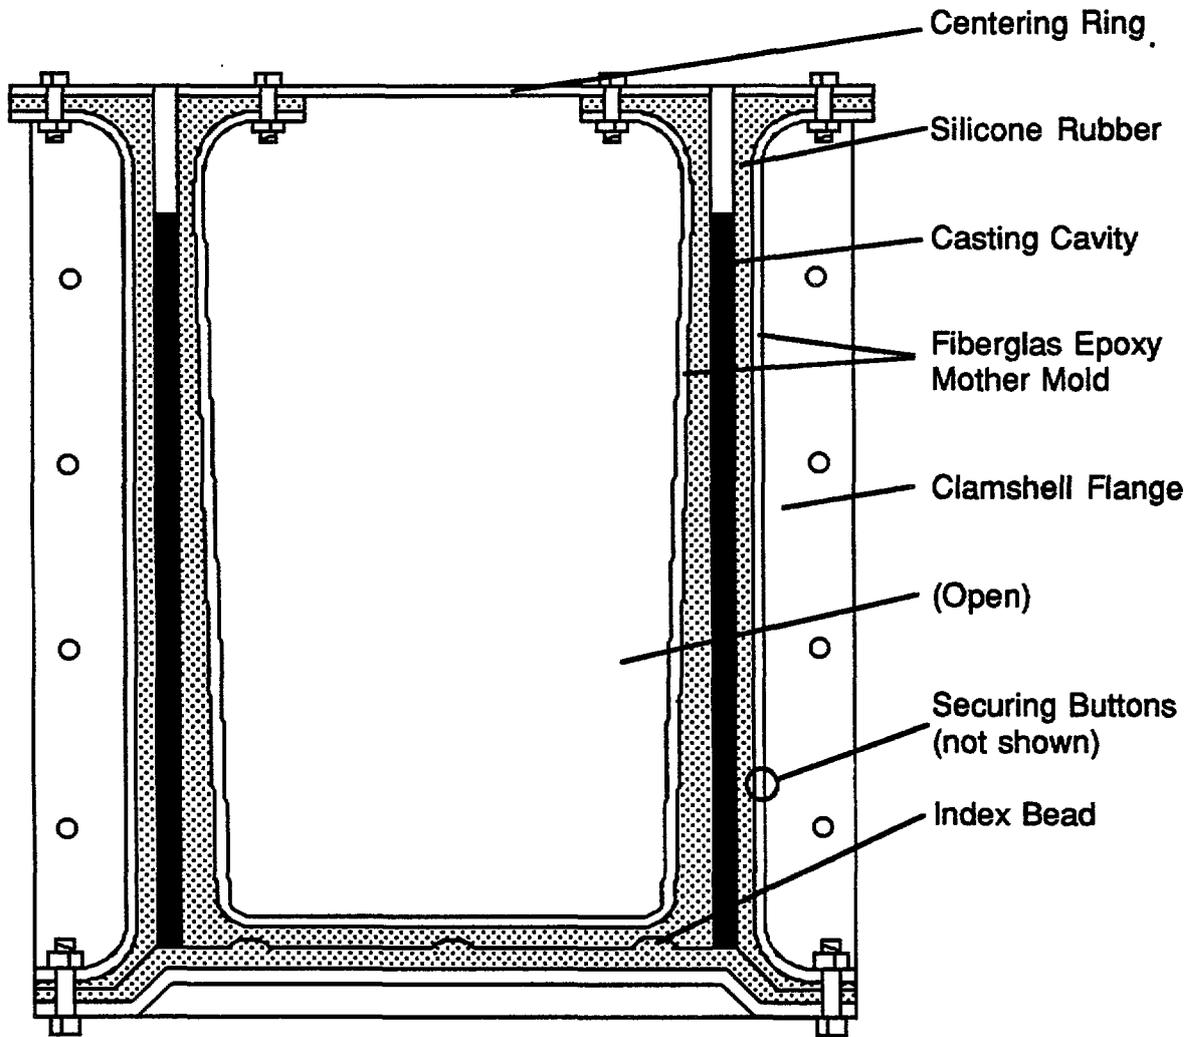
Figure 5. Schematic of mold design to sediment cast cylinder preforms.

The rubber elements of the mold were cast against an aluminum cylinder model, machined to specification. During the program, it became necessary to cast a cylinder with a thicker wall to provide sufficient material for overcoming a slight out-of-round condition of the preforms cast in the original mold configuration. This condition originated from the poor dimensional stability of the tapered, two-piece, fiberglass/epoxy center-core element.

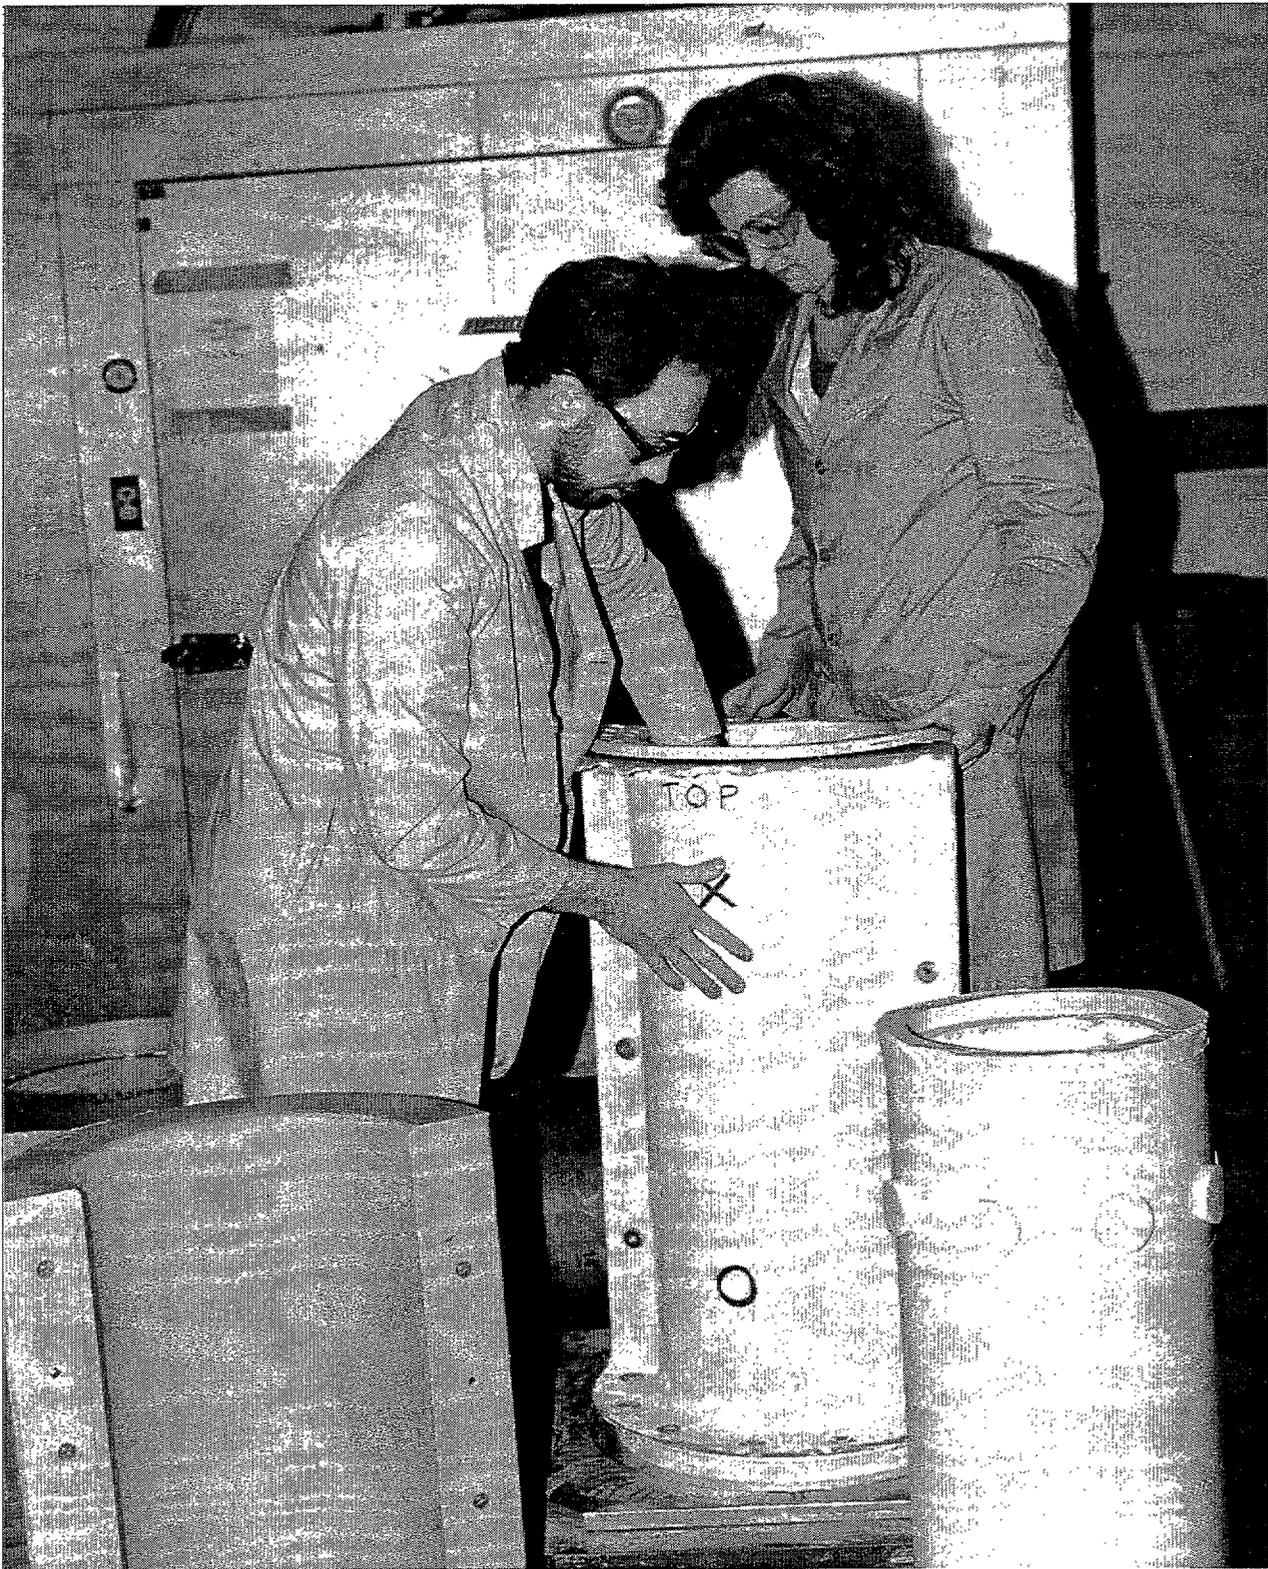
Figure 6. Rubber/fiberglass cylinder casting mold.

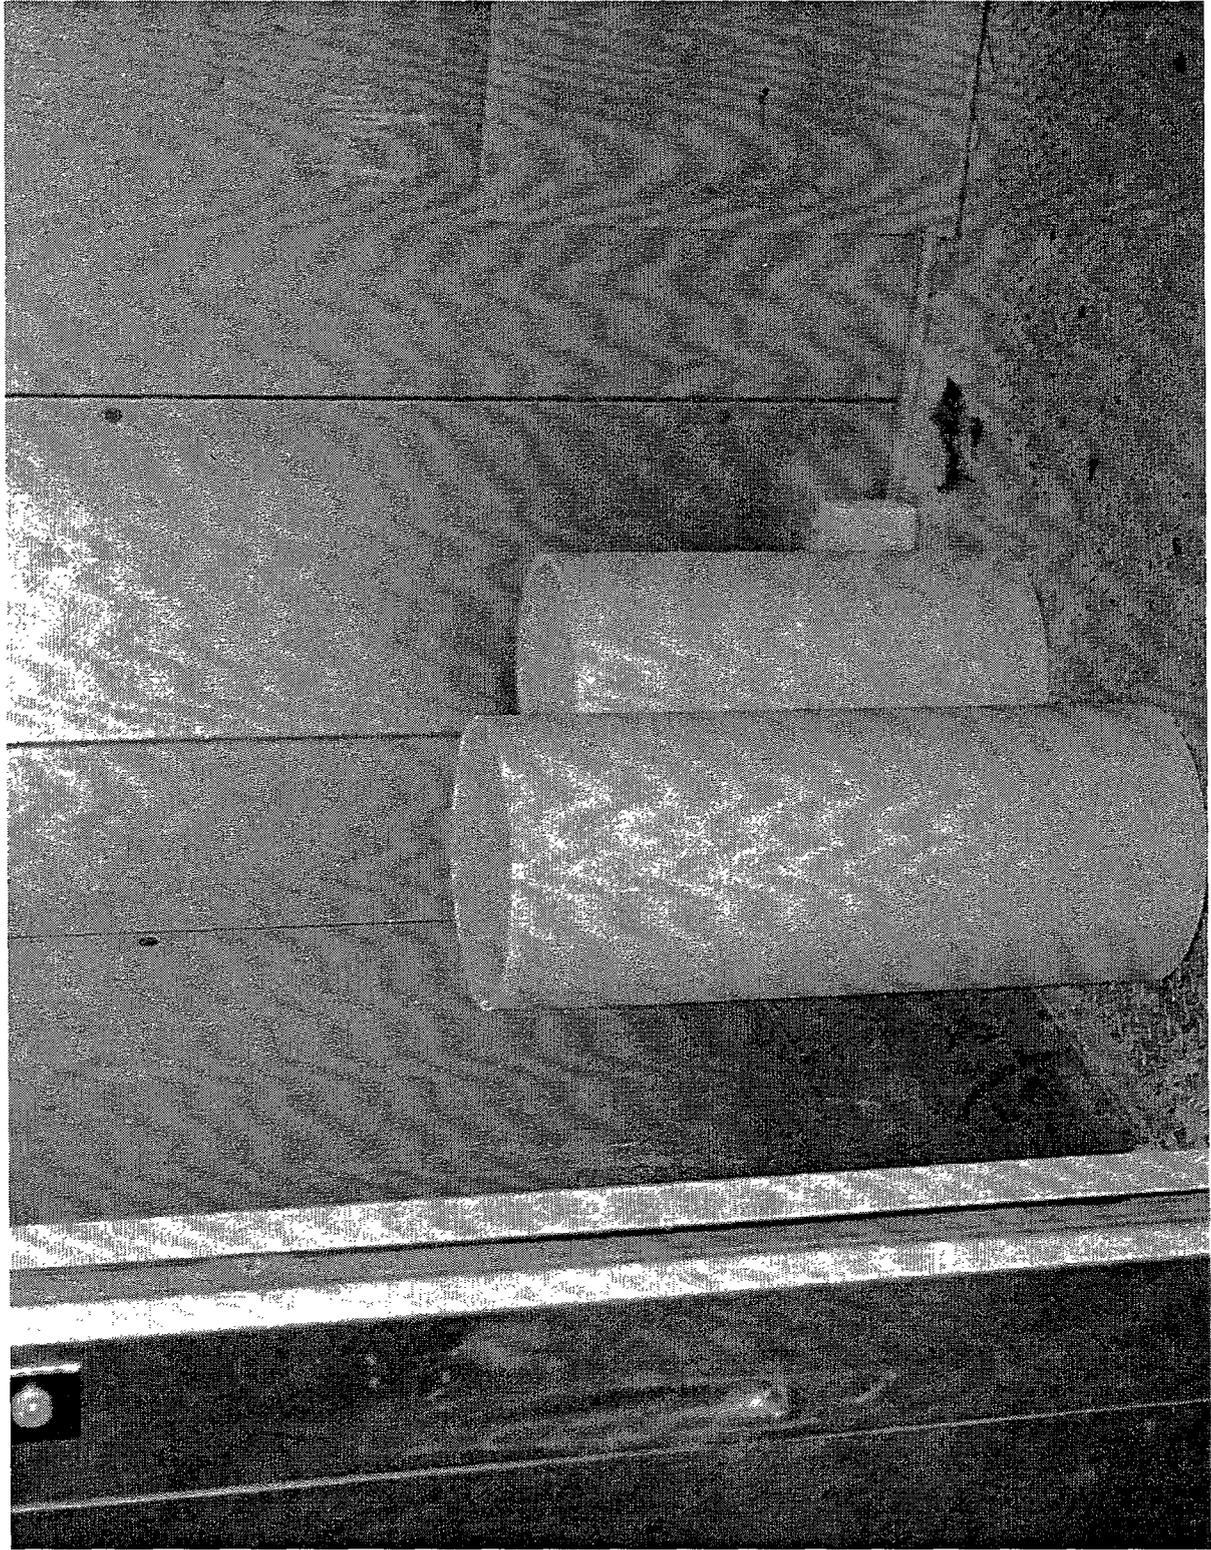
Figure 7. Frozen cylinder preforms after demolding.

An SiC slurry was prepared from SiC powder mixed with binders and dispersion aids in a proprietary composition. This slurry was cast into the mold and allowed to settle under vibratory conditions. After a predetermined time, the mold assembly was placed into a freezer to avoid thawing, which could result in distortion or fracture. Figure 7 shows two demolded, frozen preforms inside a freezer.

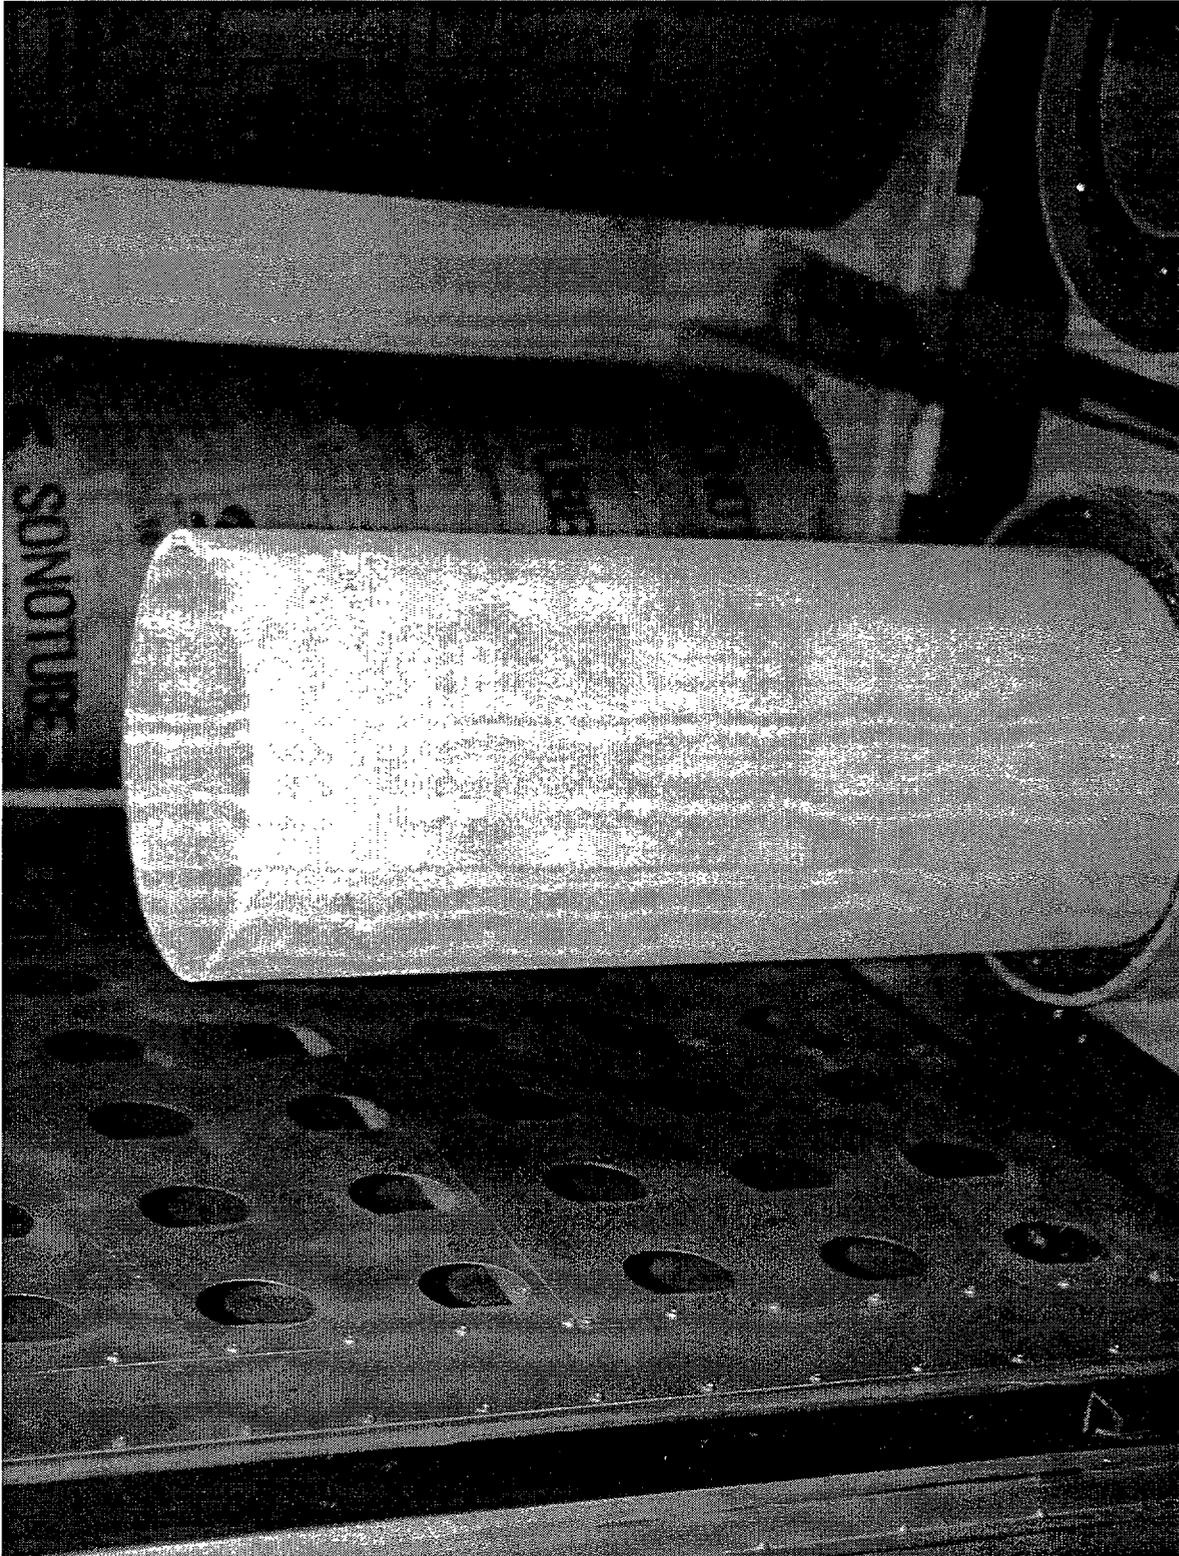
Figure 8. Dried cylinder preform inside dryer.

Special procedures were developed to dry the frozen preforms carefully, avoiding stresses that distort or fracture the preforms during the critical period between the frozen state and the dry state. Controlled moisture removal from all surfaces at a uniform rate is critical. Maintaining constant preform support to avoid stress concentrations was also important. A proprietary drying system was developed to perform this function.

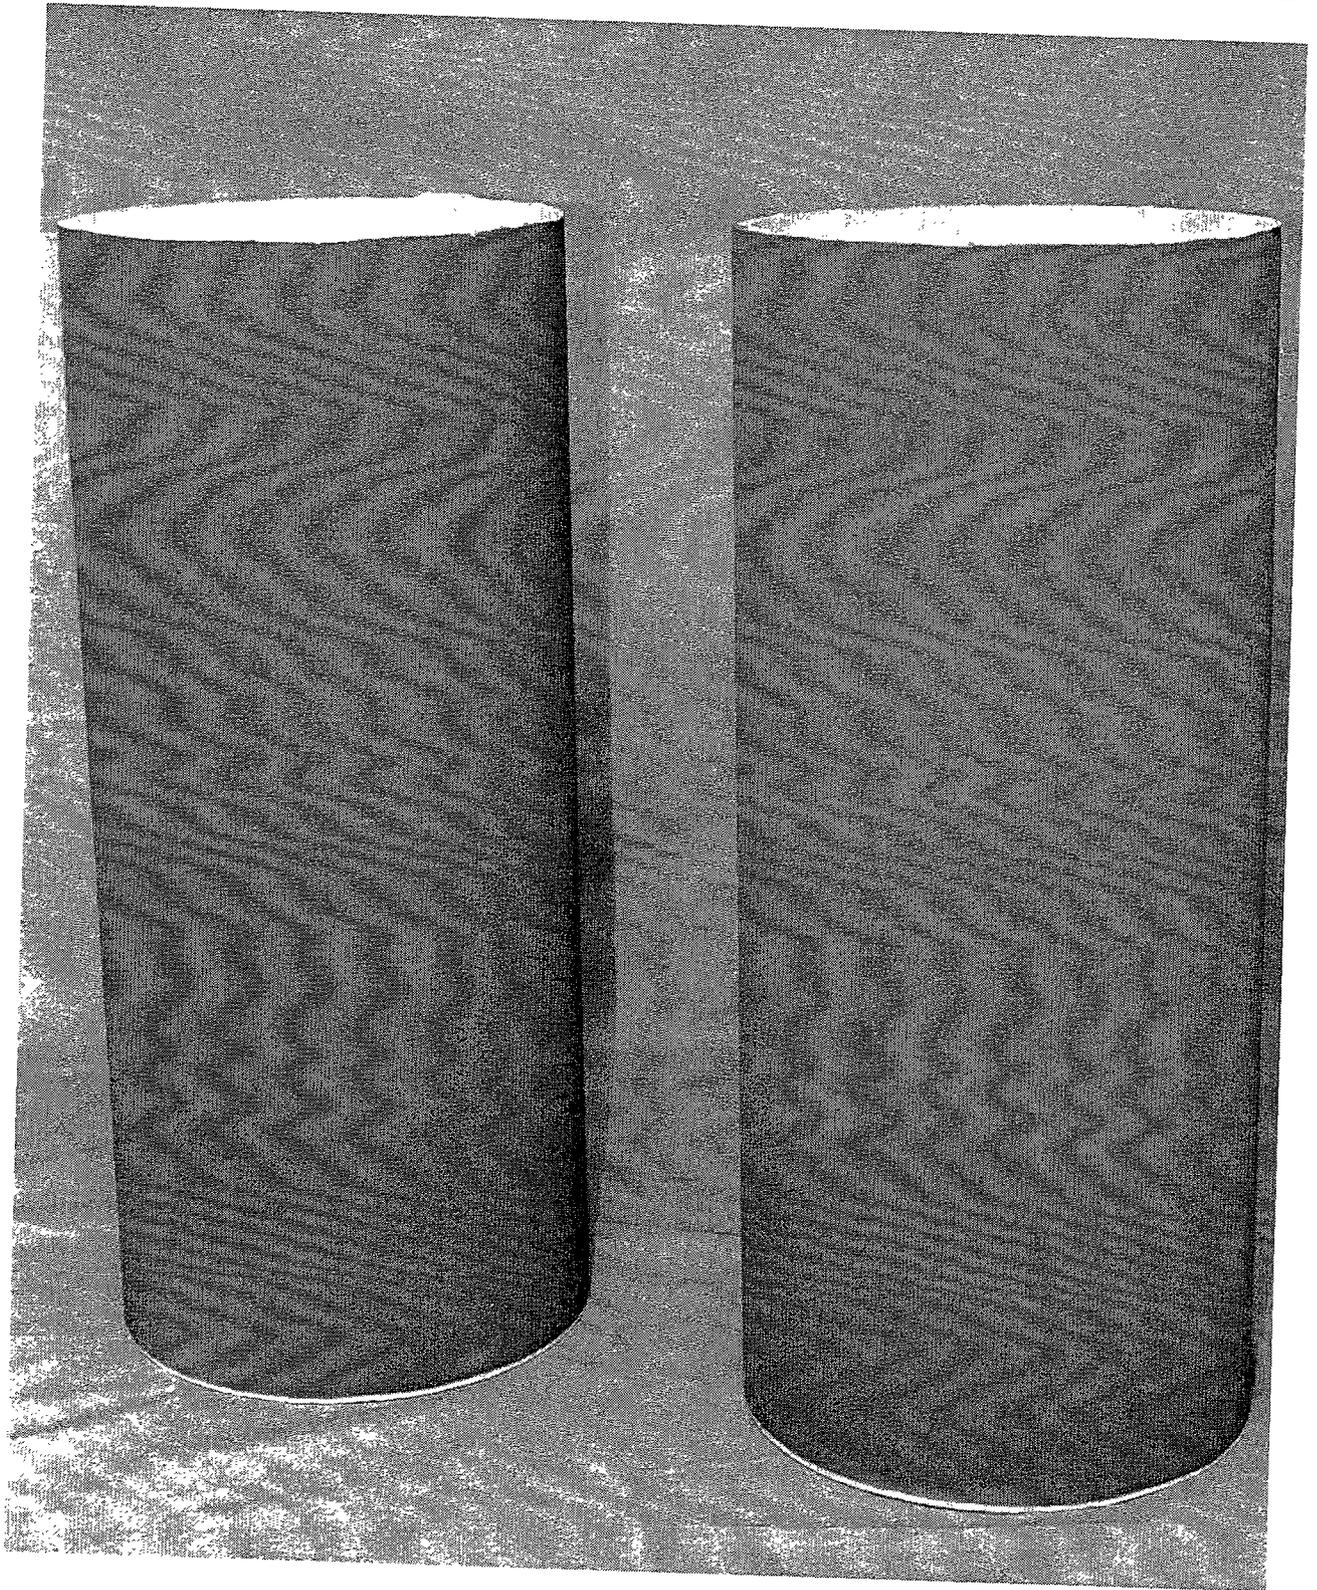
Figure 9. Preforms with barrier and initiation coatings prior to matrix infiltration.

Prior to the infiltration using the DIMOX™ process, two preparation steps must be made to the cylinder preforms. First, a proprietary coating is applied to the inside of the cylinder by spraying. This coating is a barrier to the infiltration process, preventing the oxide from building up beyond the surface of the preform when infiltration has been completed. While the bulk of the infiltration is controlled by time, some regions in the preform will complete infiltration before other regions. Without the barrier, regions of aluminum oxide scale will build up as the oxidation proceeds beyond the preform surface. This scale bonds with the composite wall and is difficult to remove without damaging the surface of the composite. Another proprietary coating is applied to the outside surface of the cylinder preform. This coating makes the initiation of the oxidation process uniform over the surface of the cylinder in contact with the molten alloy. Figure 9 shows two preforms with barrier and initiation coatings, ready for matrix infiltration. Figure 10 shows a growth shell with a preform inside it.

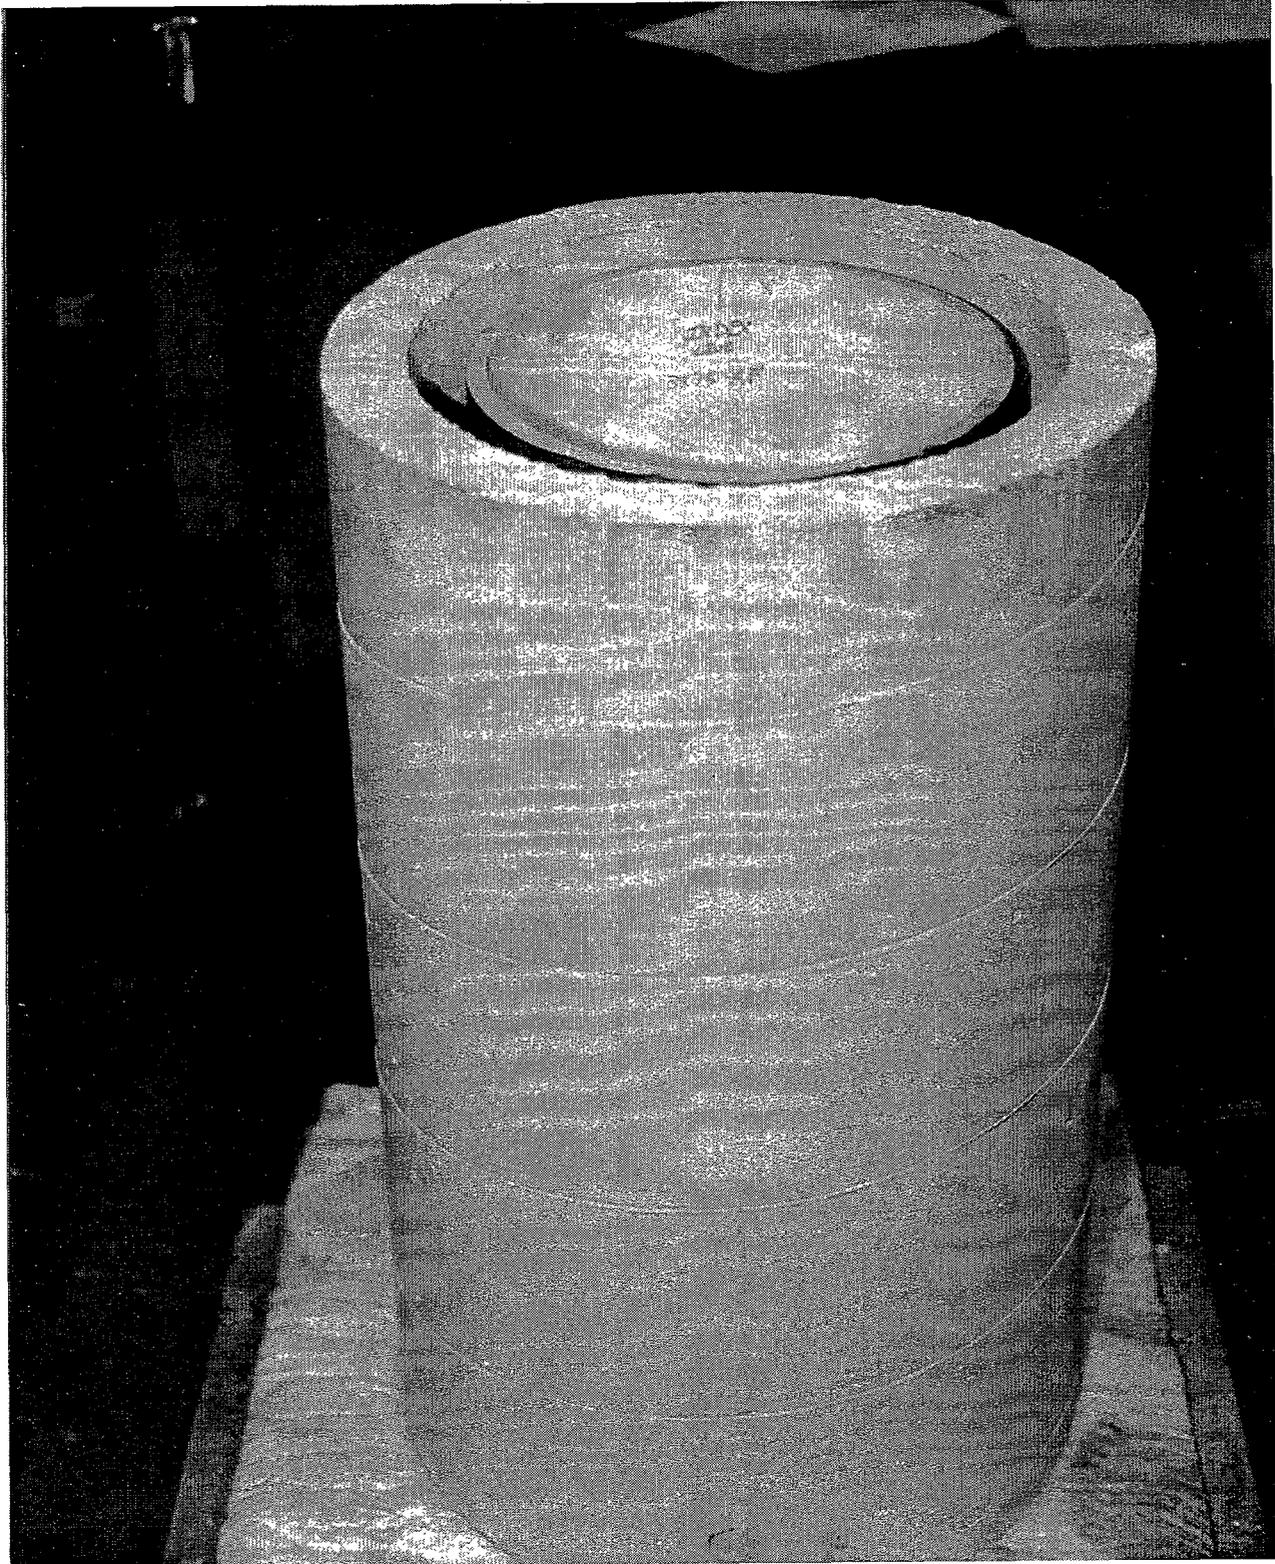
Figure 10. Refractory growth shell with preform inside.

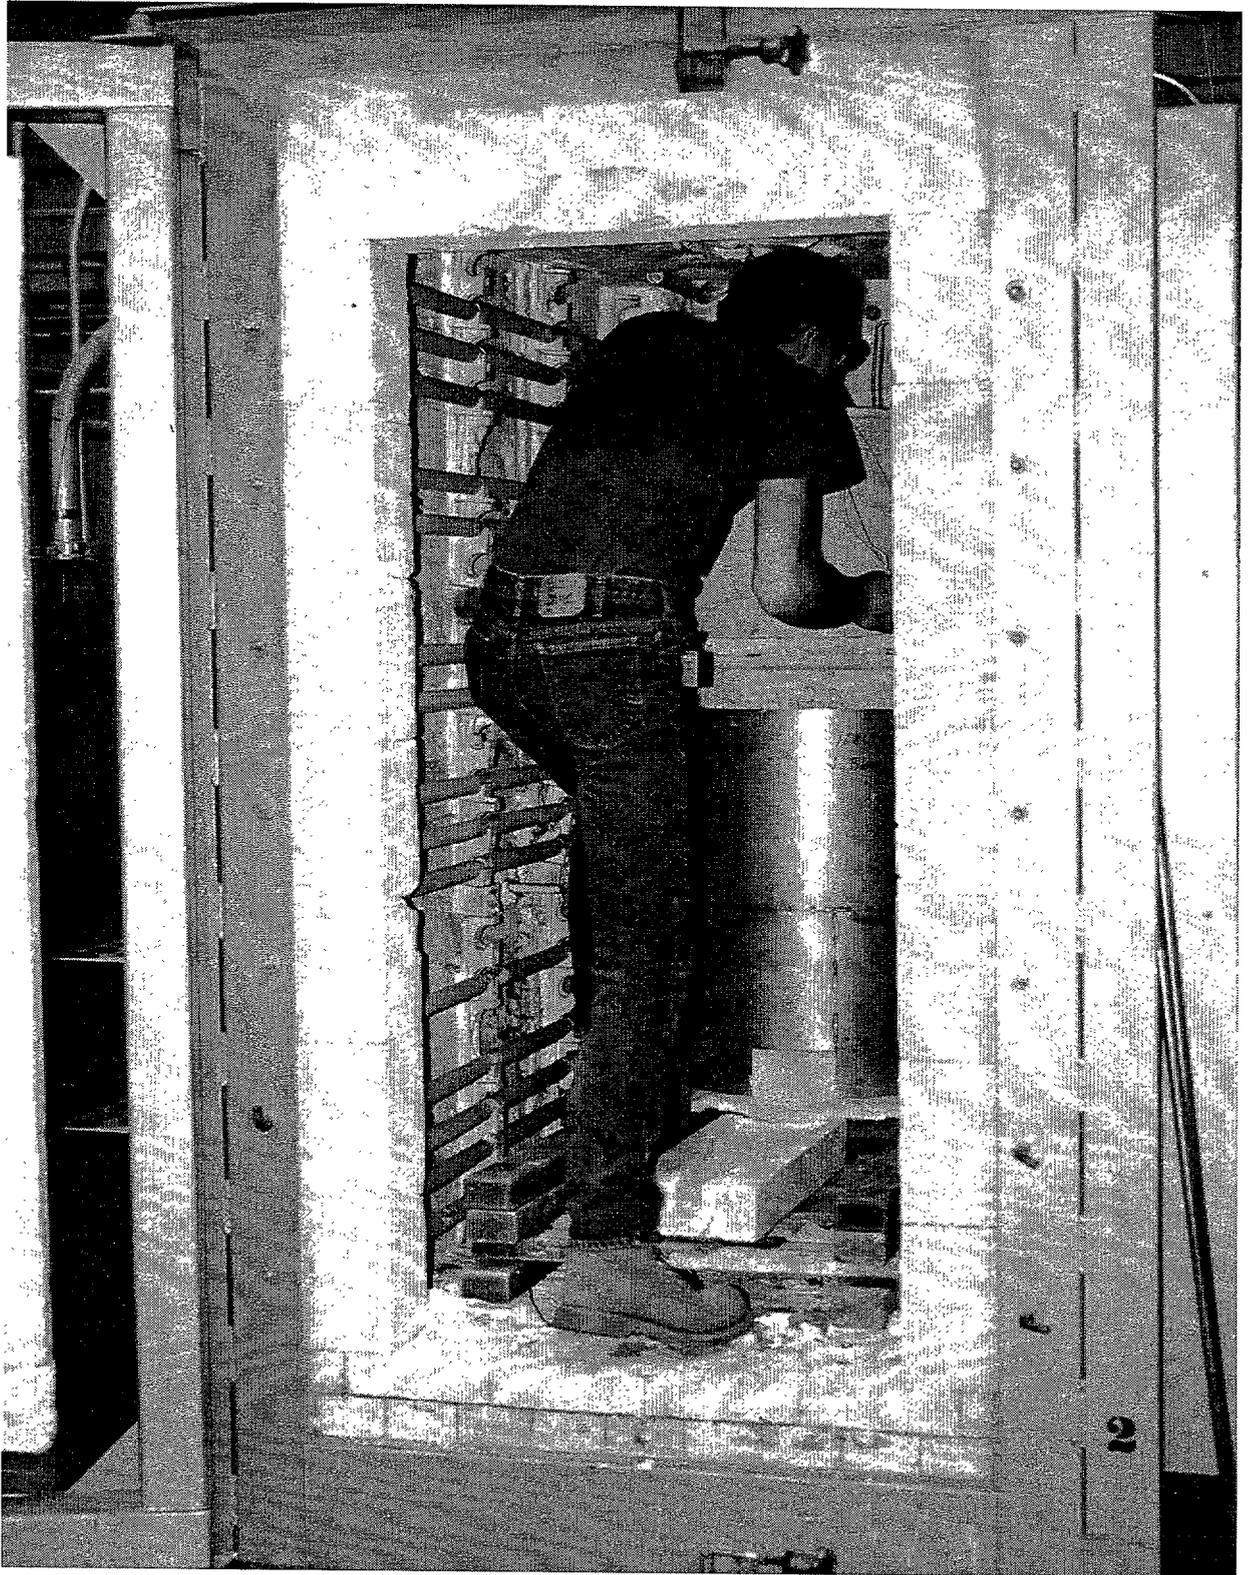
Figure 11. Growth shell being prepared inside the furnace.
