Structural Performance of Cylindrical Pressure Housings of Different Ceramic Compositions Under External Pressure Loading

Part IV, Silicon Carbide Particulate Reinforced Alumina Ceramic

Technical Report 1594
December 1993

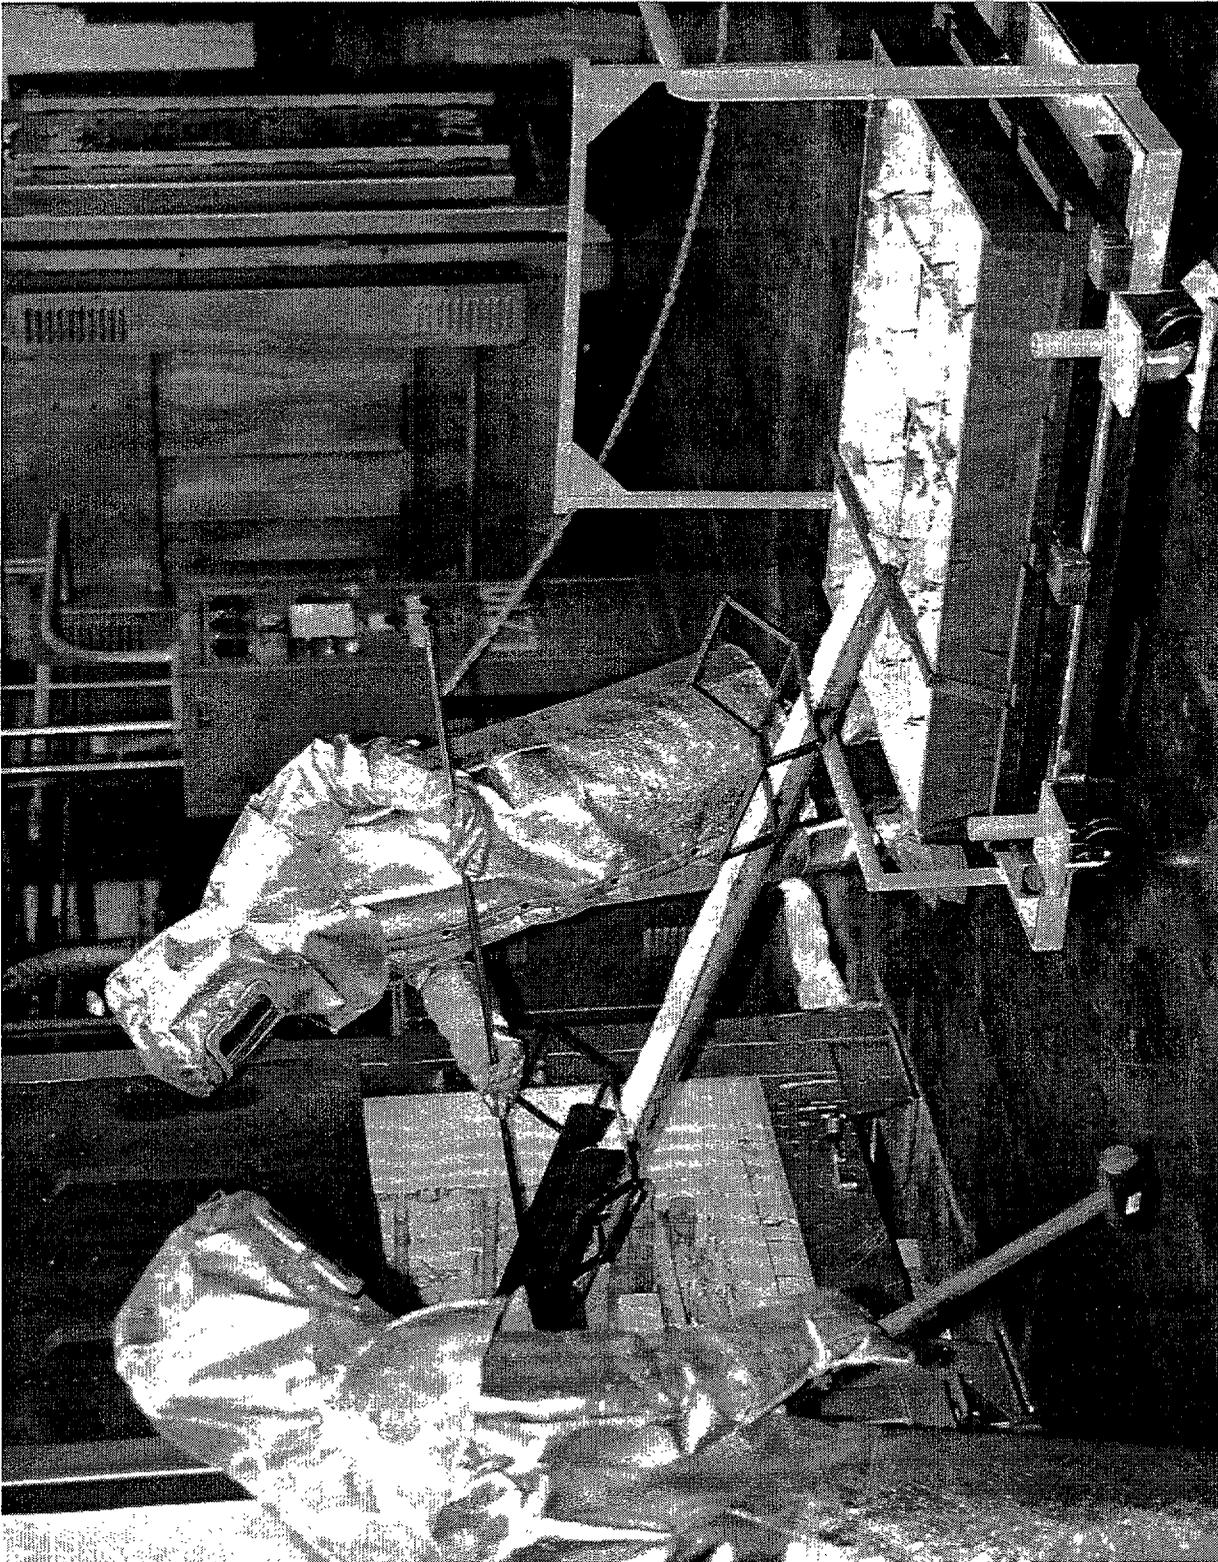
Figure 12. Draining of molten aluminum alloy from growth shells after completion of matrix growth.

A considerable quantity of aluminum alloy is required for the infiltration of a preform as large as these cylinders. Once the growth process has been completed, the infiltration part has to be removed from the molten alloy during cooling of the part. In this case, several hundred pounds of molten aluminum alloy is involved. A procedure has been developed to drain this alloy safely while the infiltrated part remains undisturbed while cooling in its refractory shell inside the furnace. Figures 12 and 13 show technicians draining the alloy from a shell inside the furnace. The alloy is drained into a graphite mold where it solidifies into ingots of a size convenient for reuse.

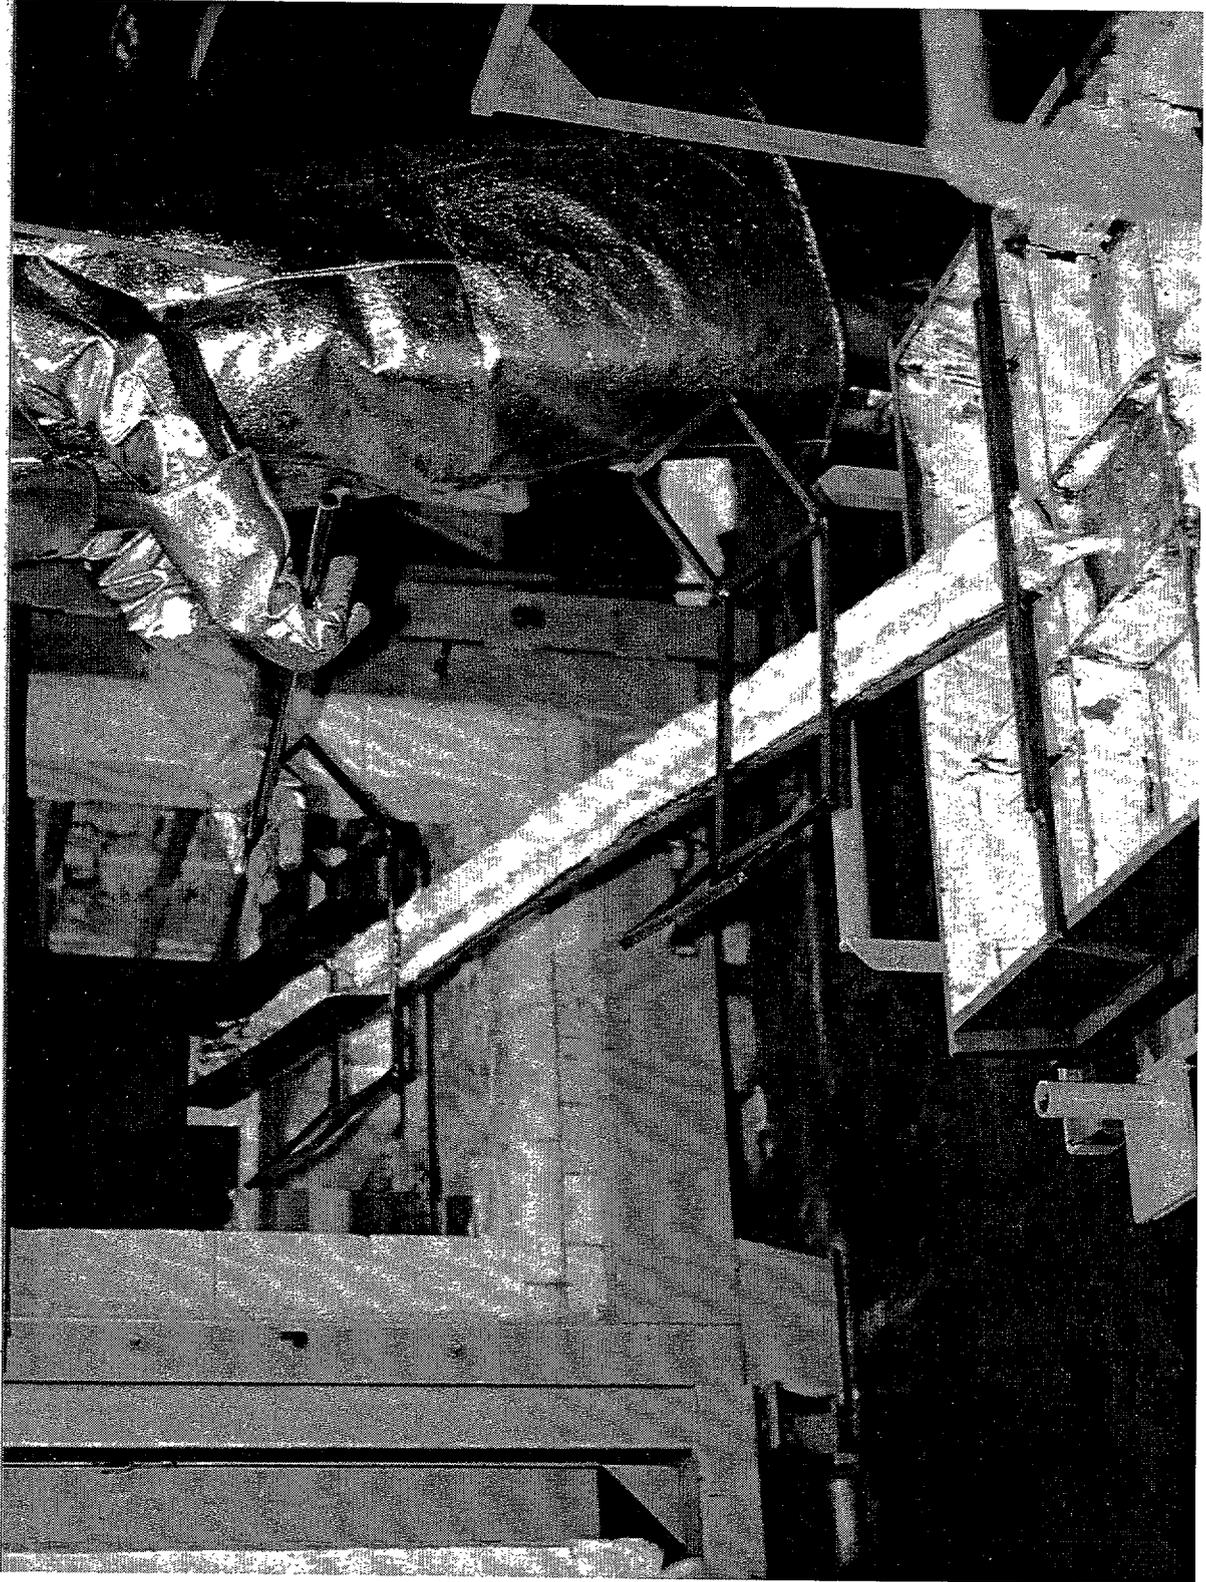
Figure 13. Closeup of the draining of molten aluminum alloy from growth shells after completion of matrix growth.

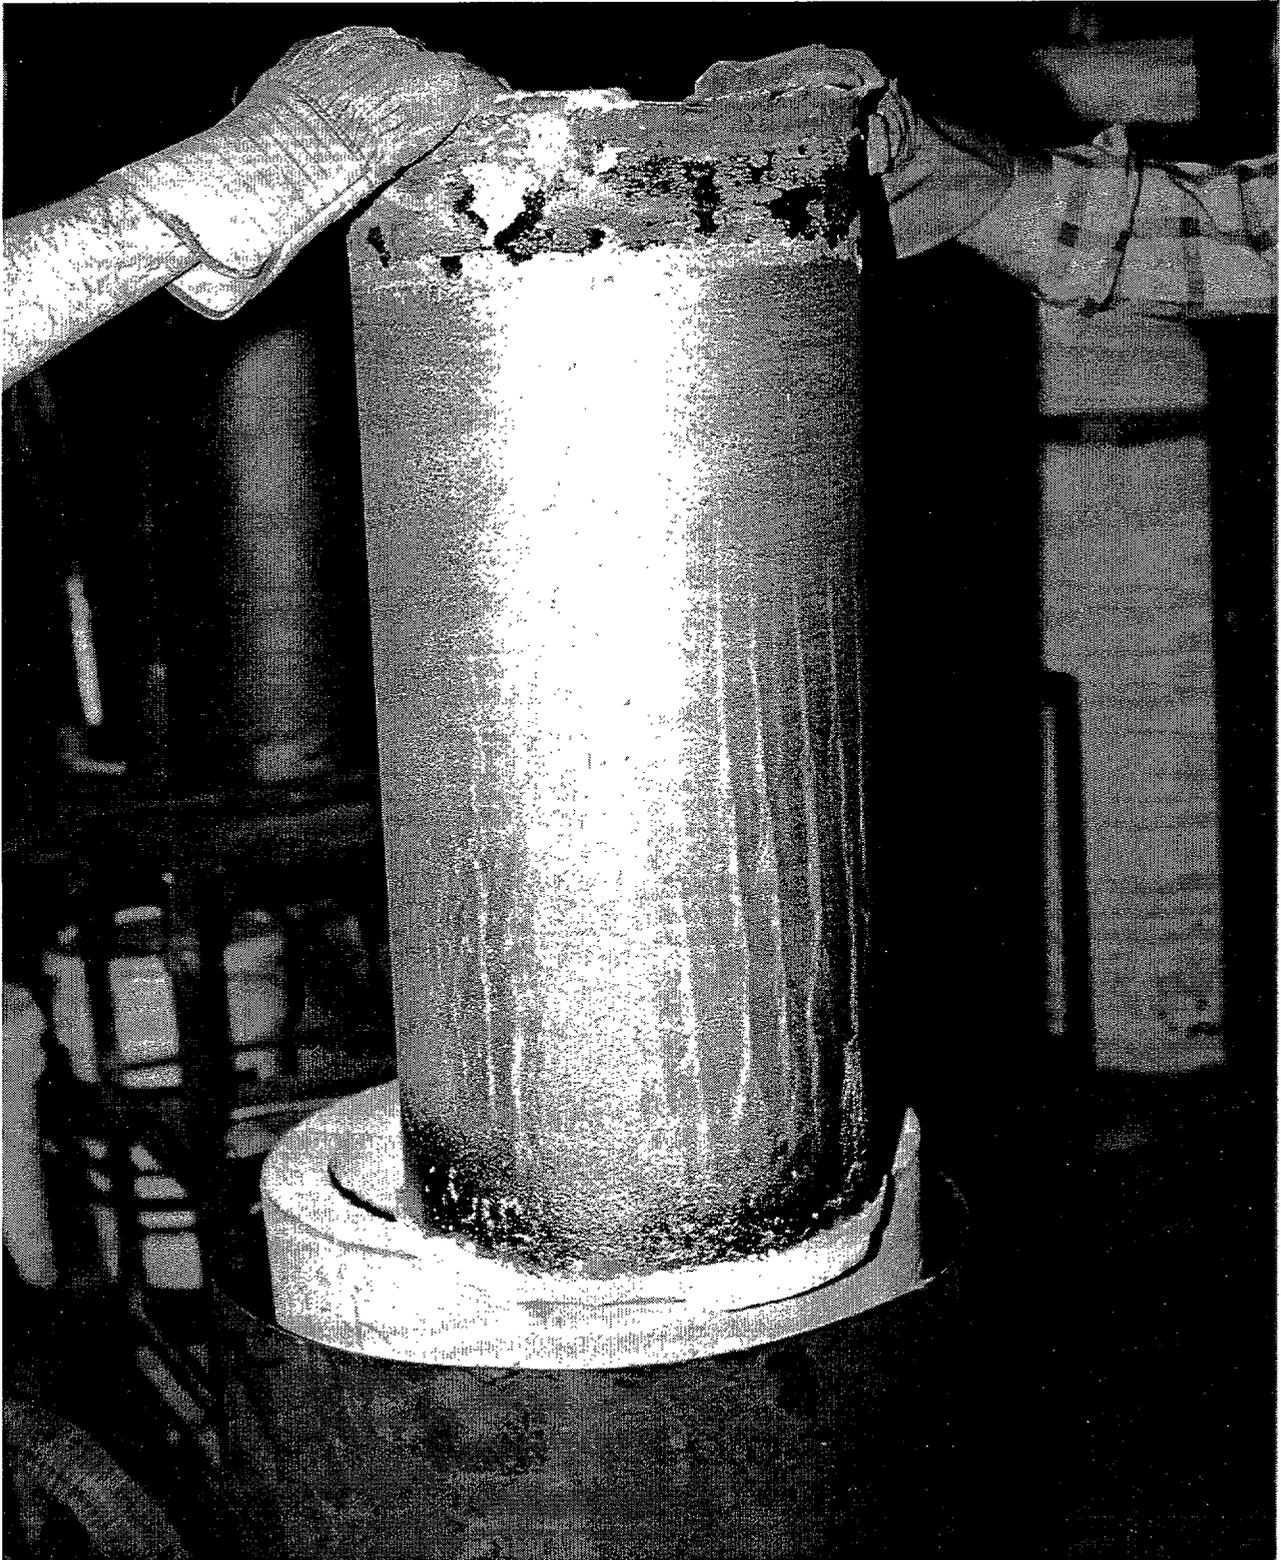
Figure 14. A fully infiltrated cylinder after removal from the refractory shell.

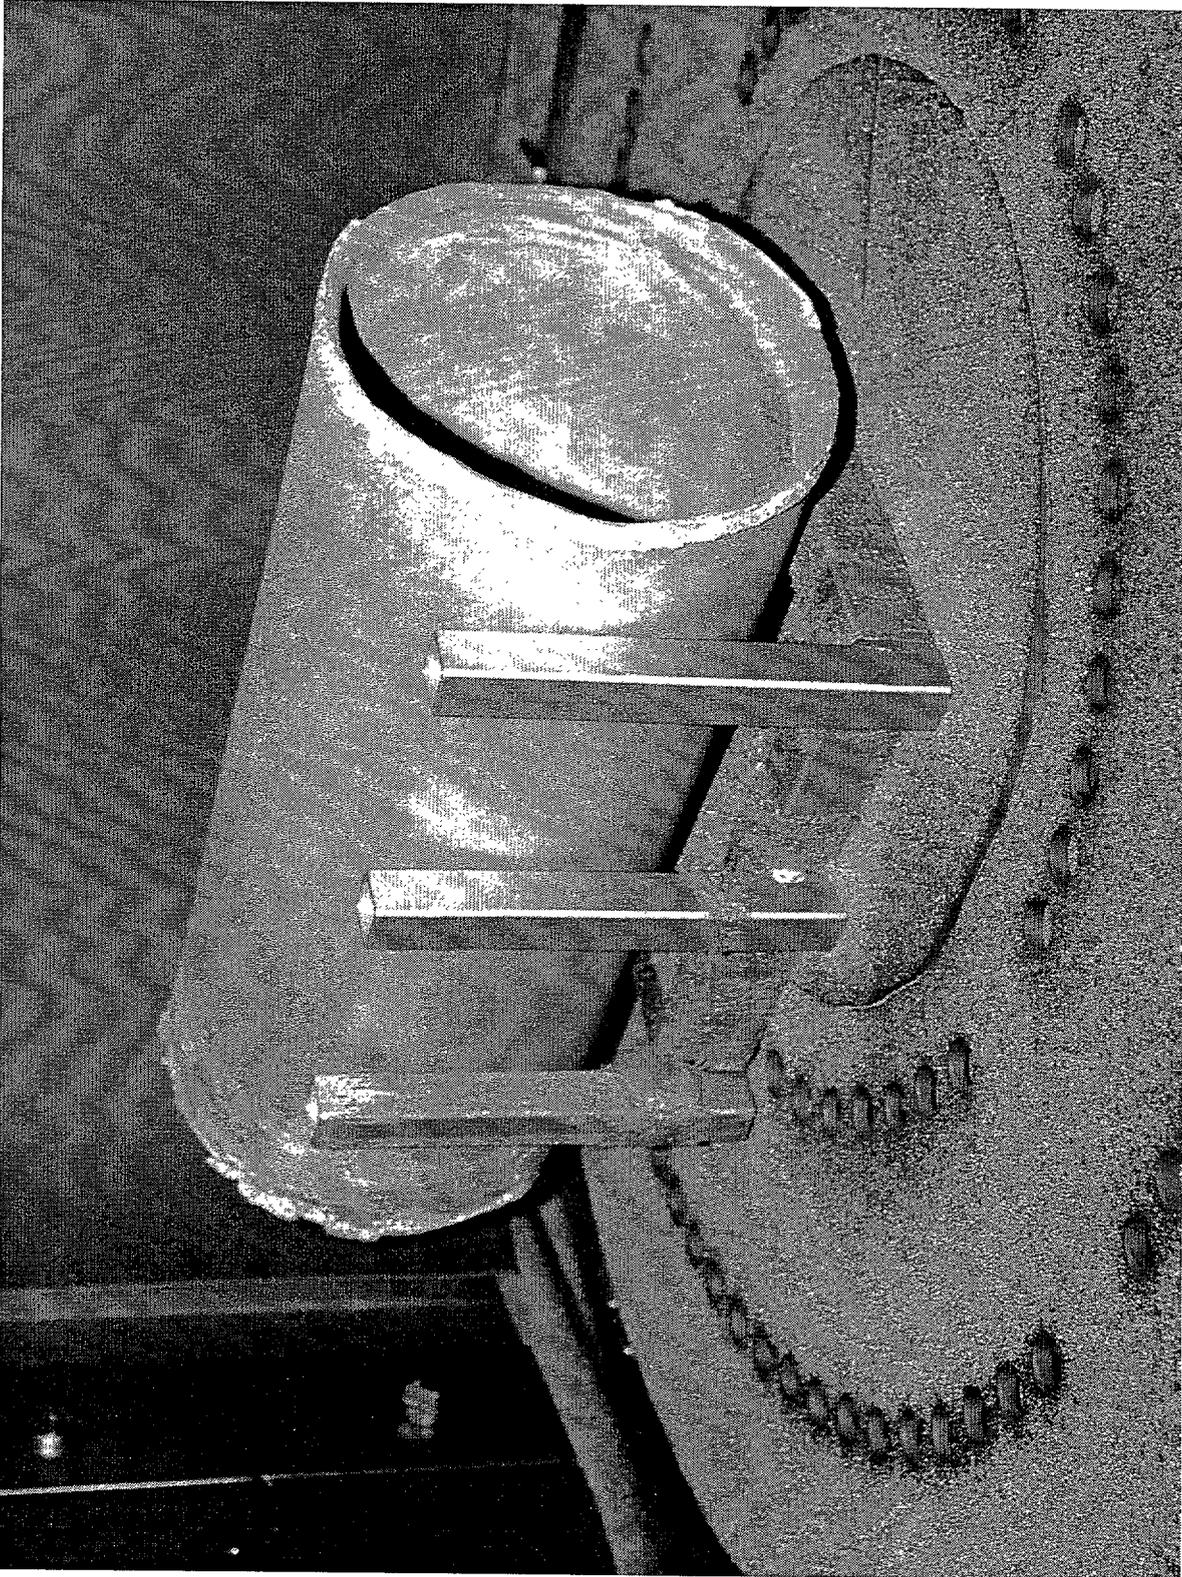
Figure 15. A fully infiltrated cylinder after shot blasting.

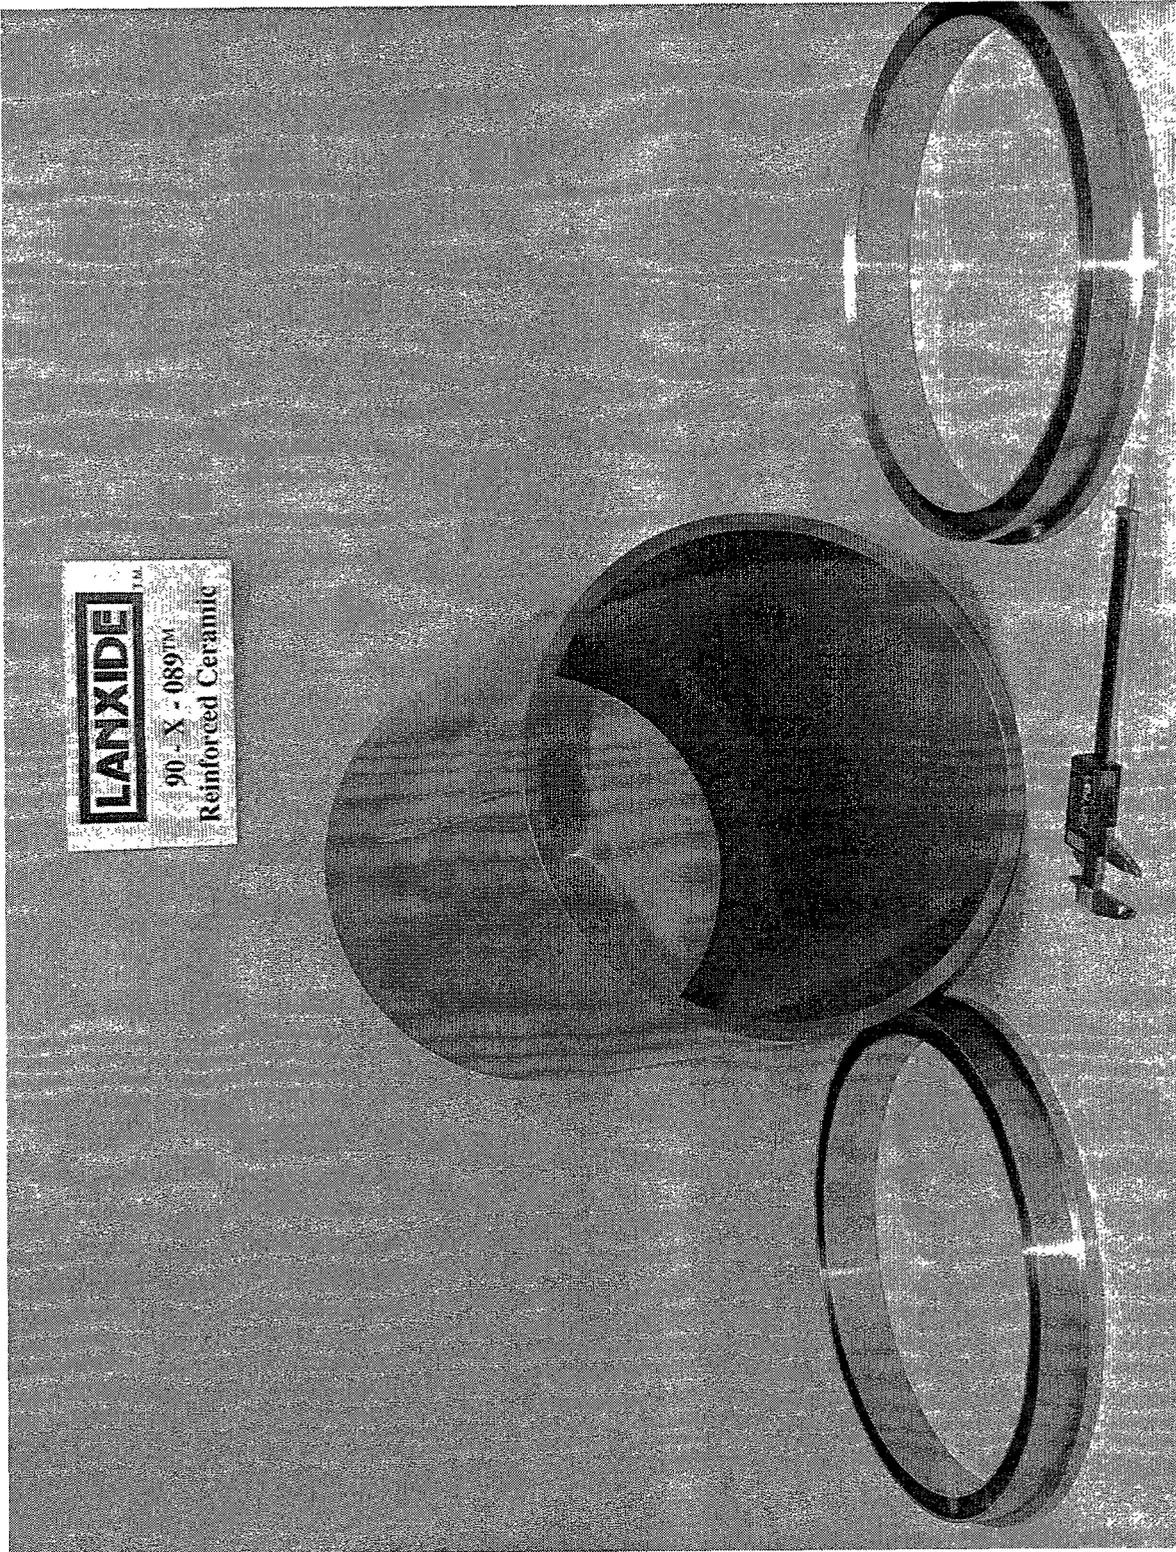
Figure 16. Fully machined SiC/Al₂O₃/Al composite cylinder with titanium end caps prior to bonding.

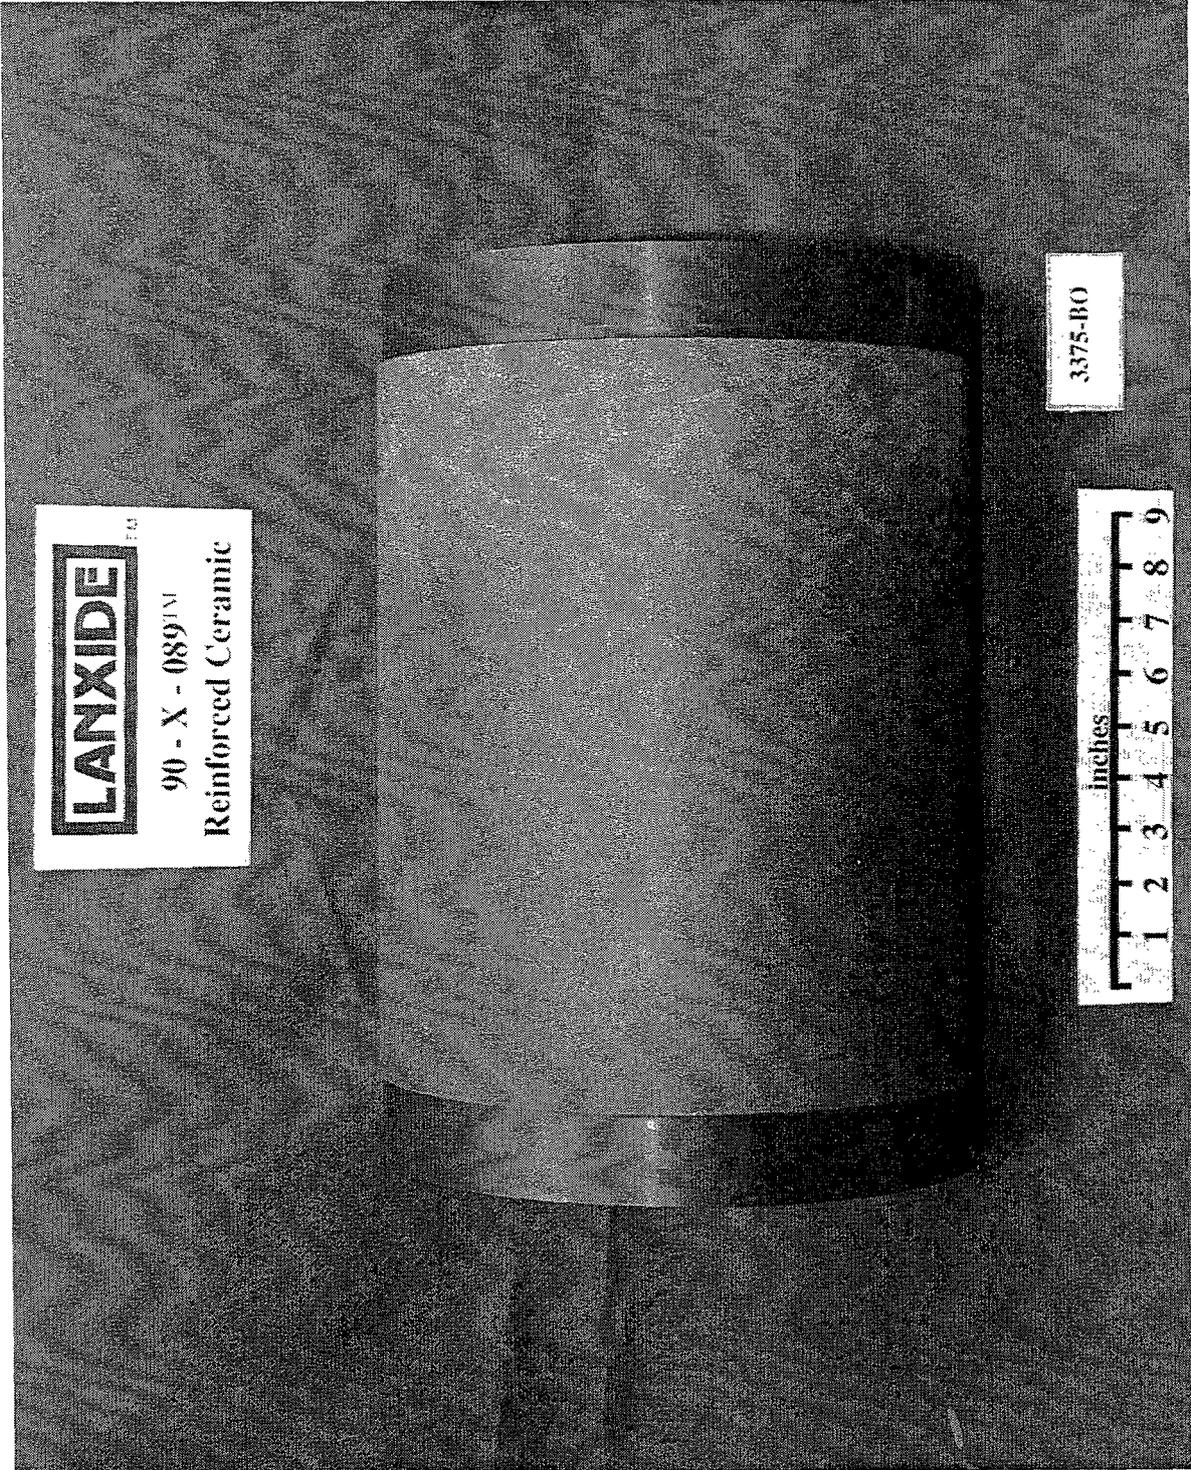
Figure 17. "As-cast" cylinder. Only the ends and the bearing surfaces of this cylinder have been machined.

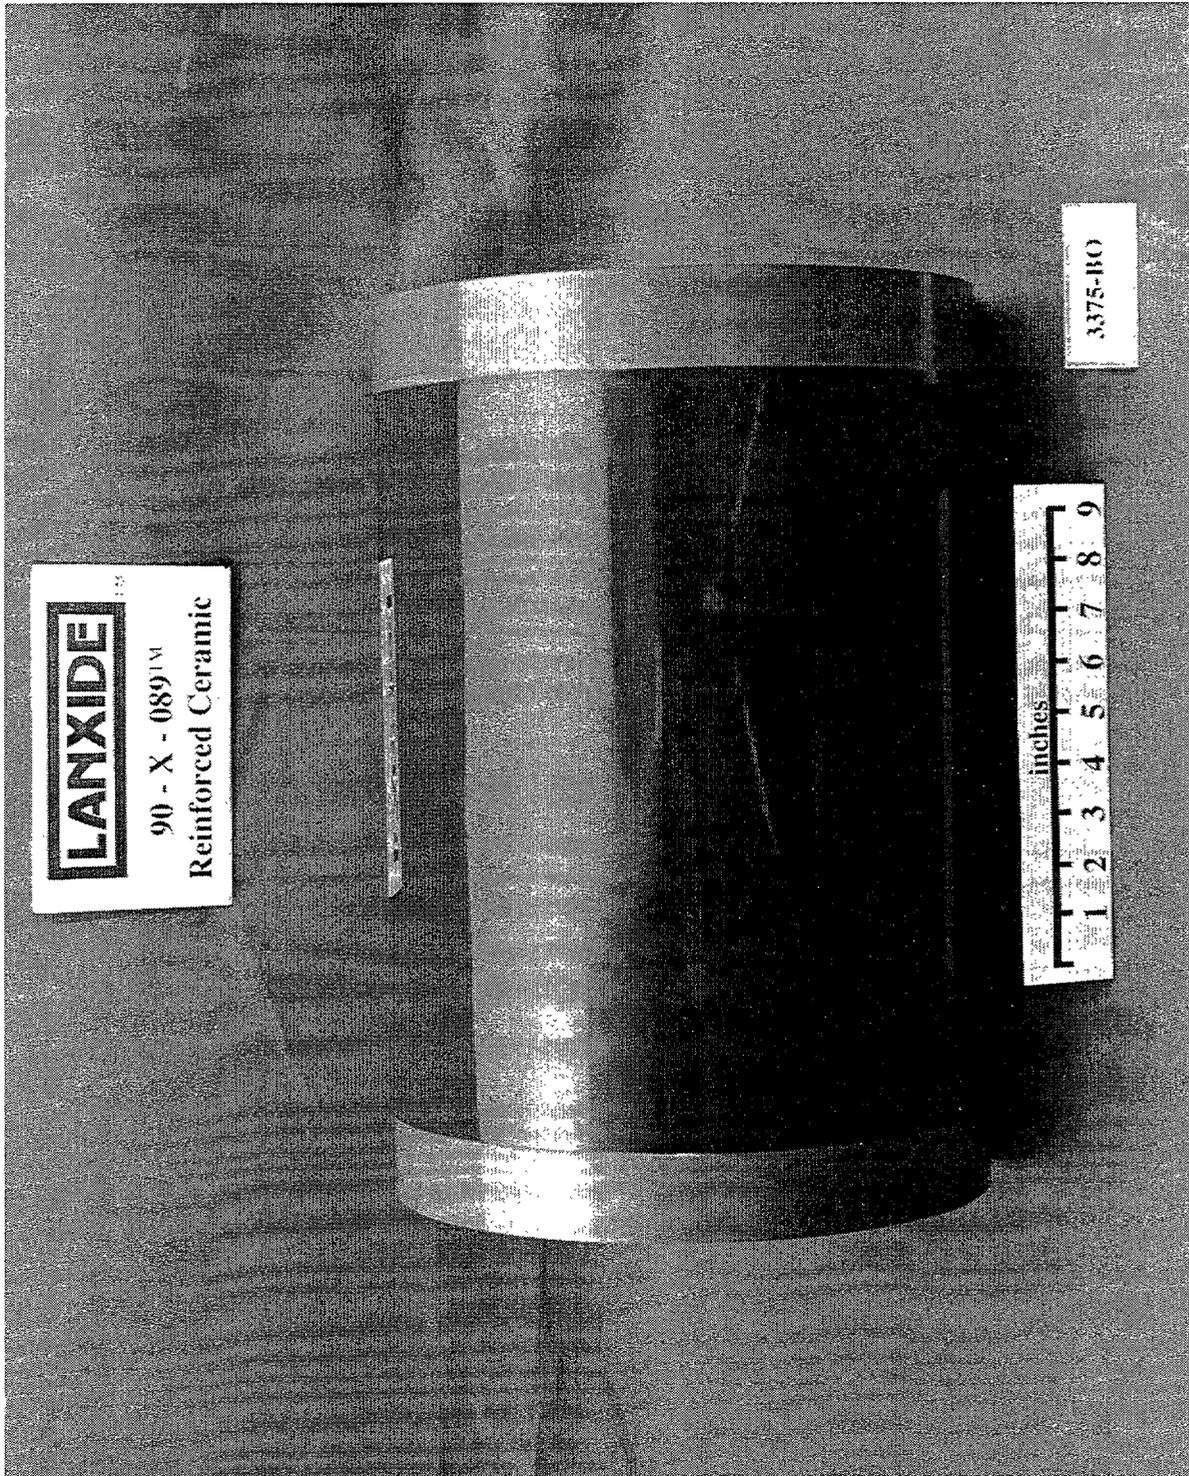
Figure 18. "As-cast" cylinder with Technicote, epoxy coating per WS22351, Rev C.

A sample was sent to Technicote, coated, and returned. The cure was inadequate; areas of the epoxy could be easily flaked off the surface. Two more samples were sent to Technicote for more trials. These samples had greater integrity than the first coated sample; the bond with the substrate was very good. Technicote performed tests on the surface of one of the samples showing acceptable performance of the coating.

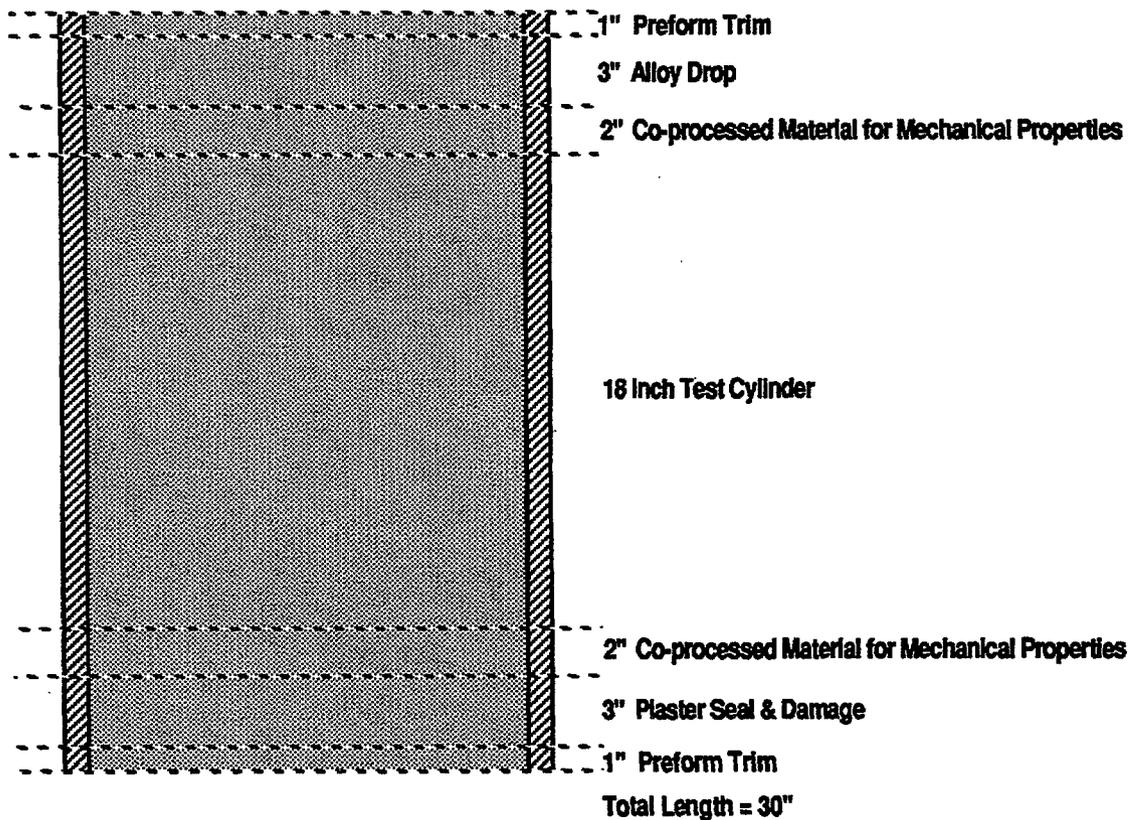
Figure 19. Schematic of preform and the location of the co-processed rings that were removed for material characterization.

Samples from each test ring were mounted and polished for microstructural evaluation. The evaluation was made using a Cambridge Quantimet 520 Image Analysis System and an optical microscope. Multiple fields (minimum of 200, 0.01784 mm, 2 per field) of each sample were analyzed at 500 \times magnification for: SiC filler, metal phases, porosity, and alumina matrix. The fields were averaged and the results for each cylinder are summarized in appendix D and table 8, sheet 1.

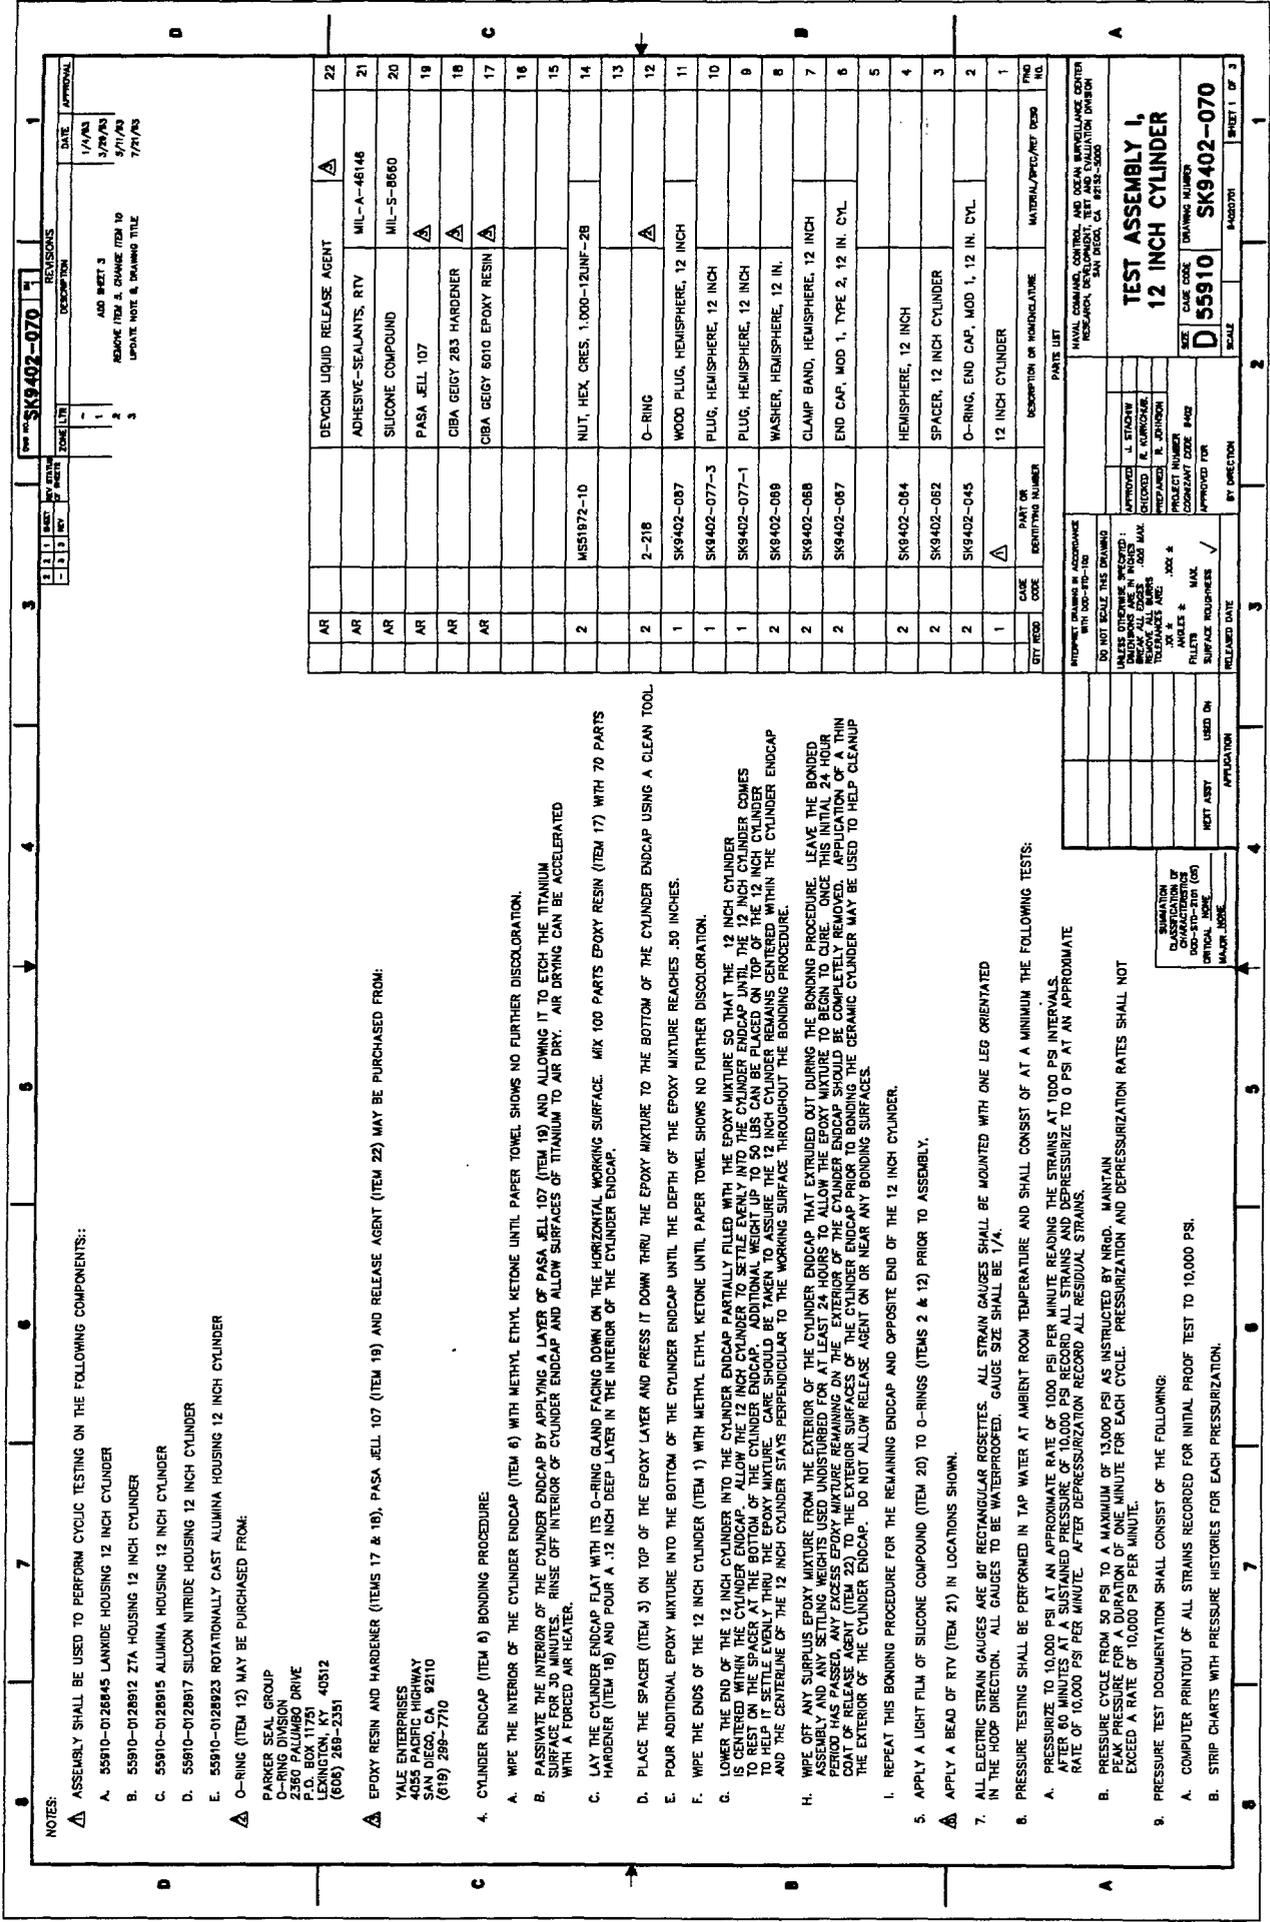
NOTES:
 △ ASSEMBLY SHALL BE USED TO PERFORM CYCLIC TESTING ON THE FOLLOWING COMPONENTS:

Figure 20. 12-inch cylinder test assembly, Type 1 configuration, Sheet 1.

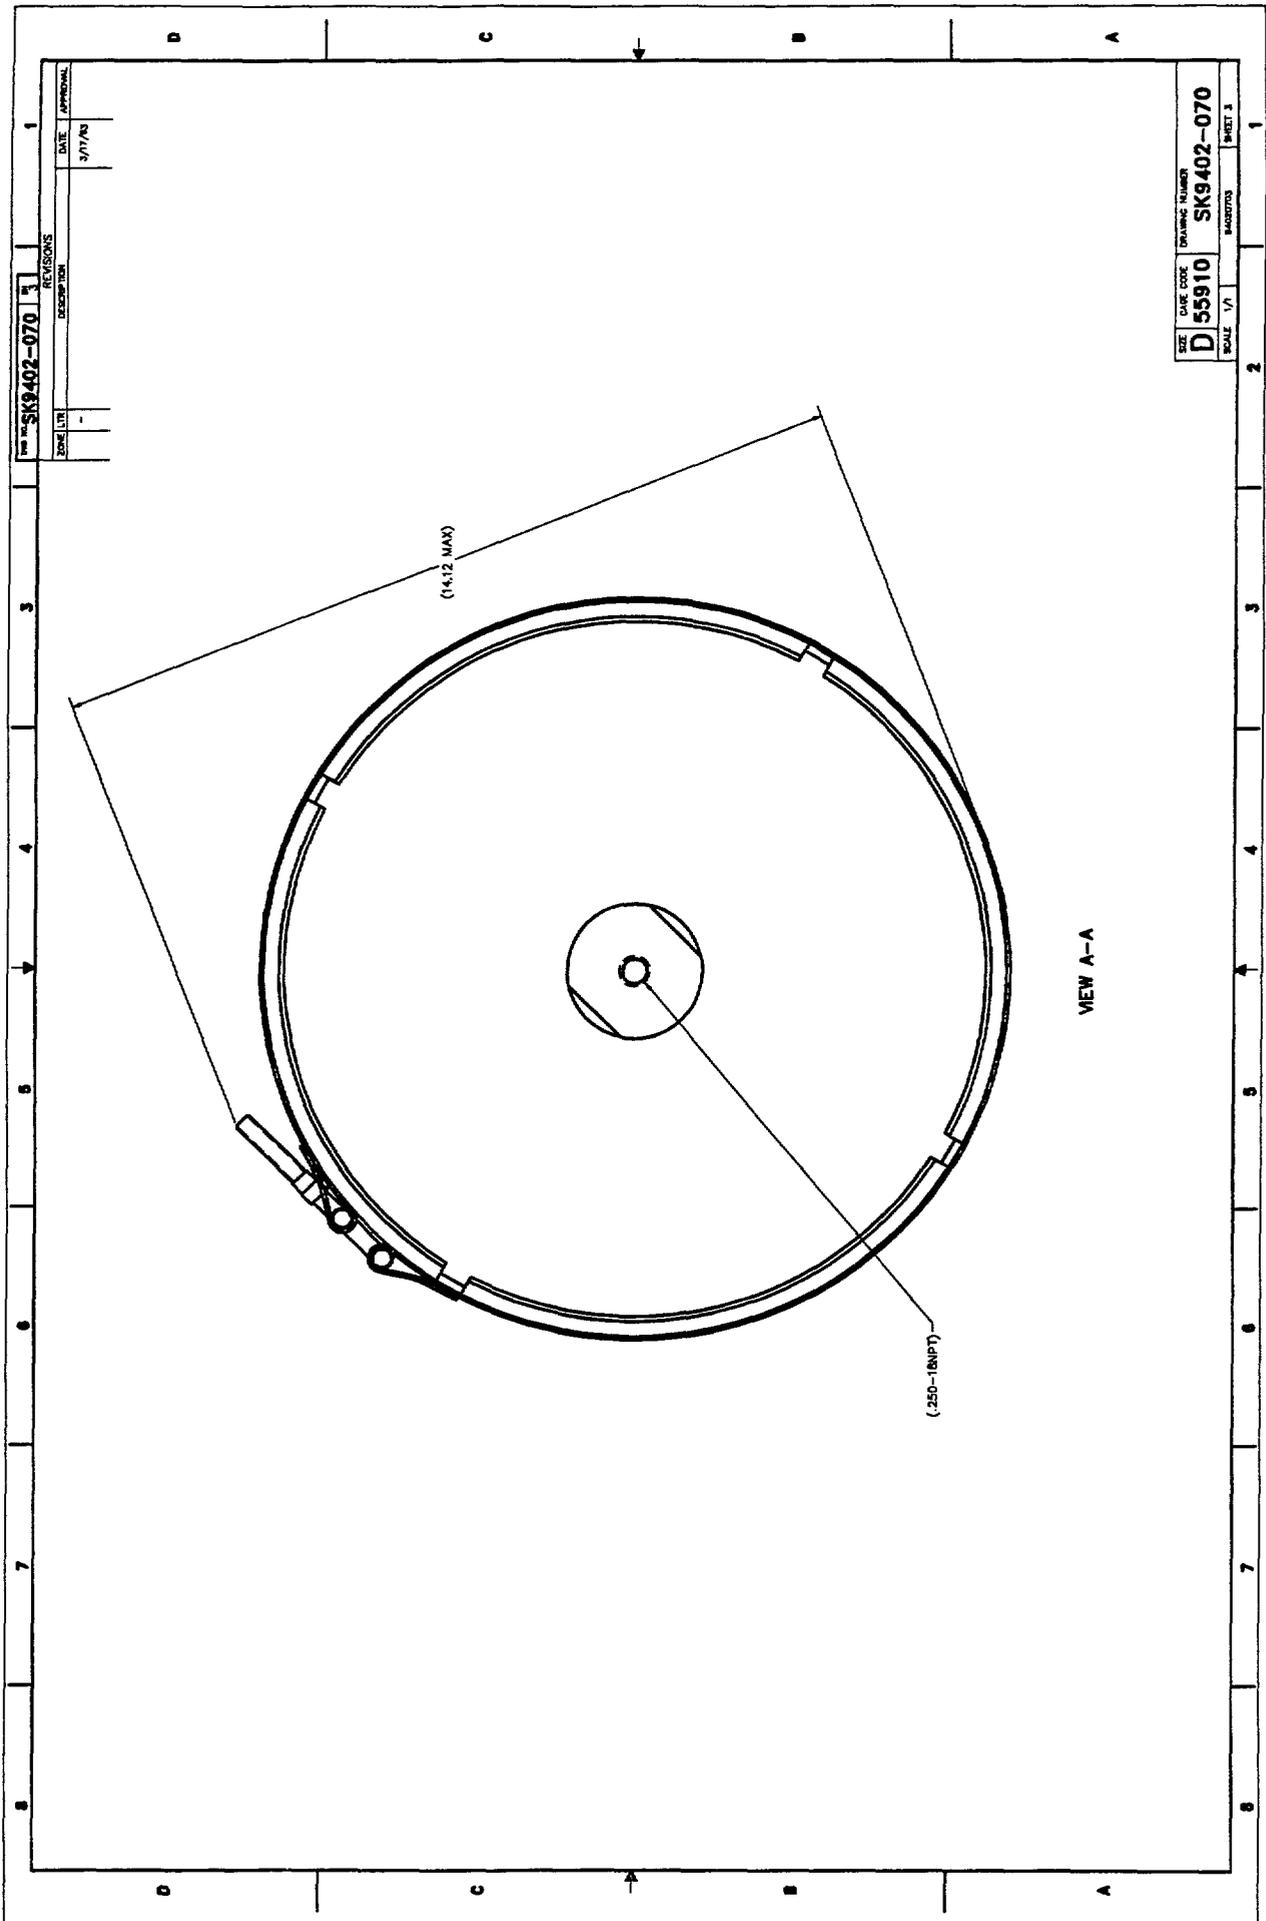
Figure 20. 12-inch cylinder test assembly, Type I configuration, Sheet 3.

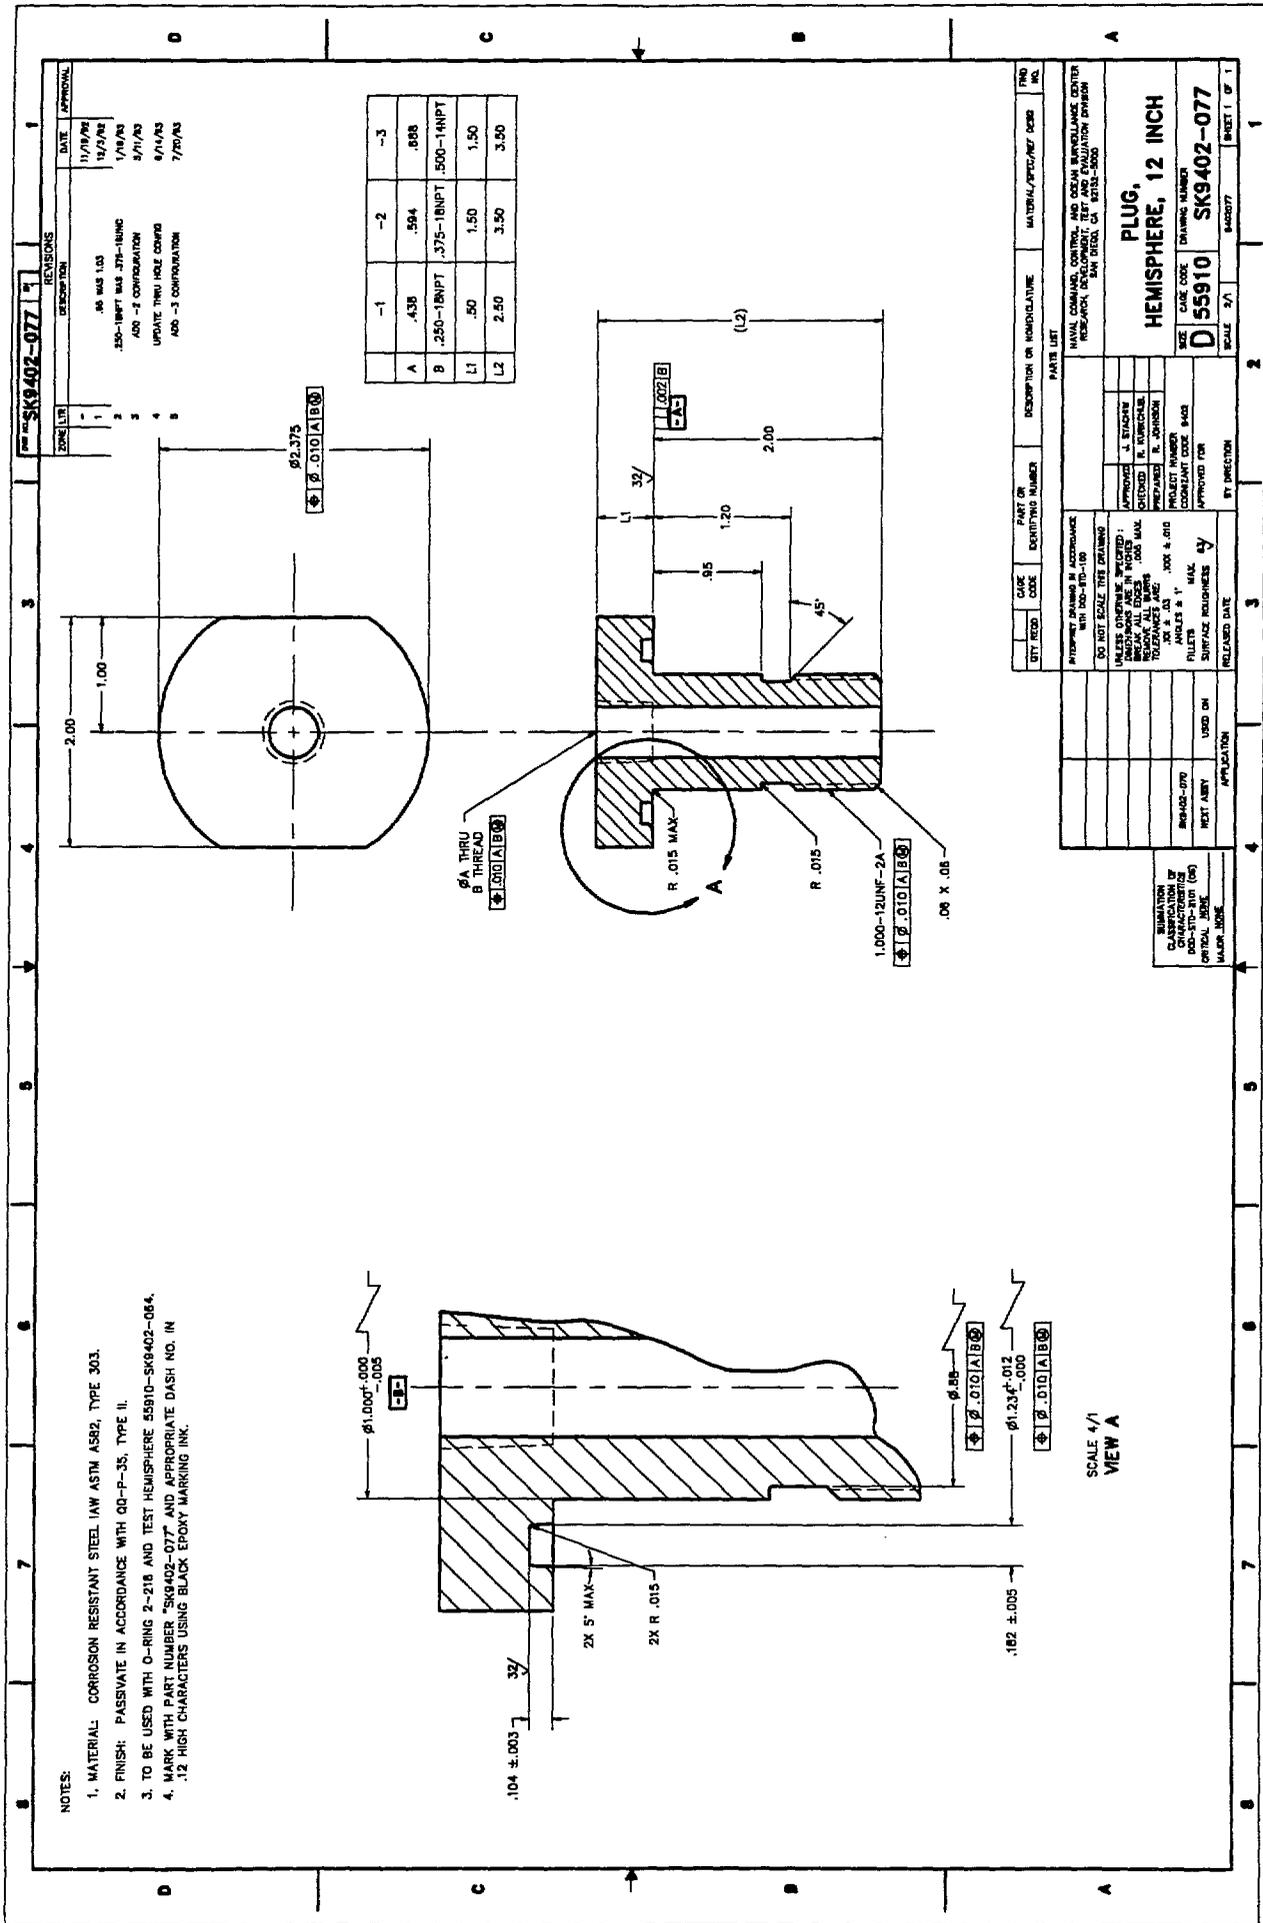
Figure 26. 12-inch hemisphere plug.
