Structural Performance of Cylindrical Pressure Housings of Different Ceramic Compositions Under External Pressure Loading

Part IV, Silicon Carbide Particulate Reinforced Alumina Ceramic

Technical Report 1594
December 1993

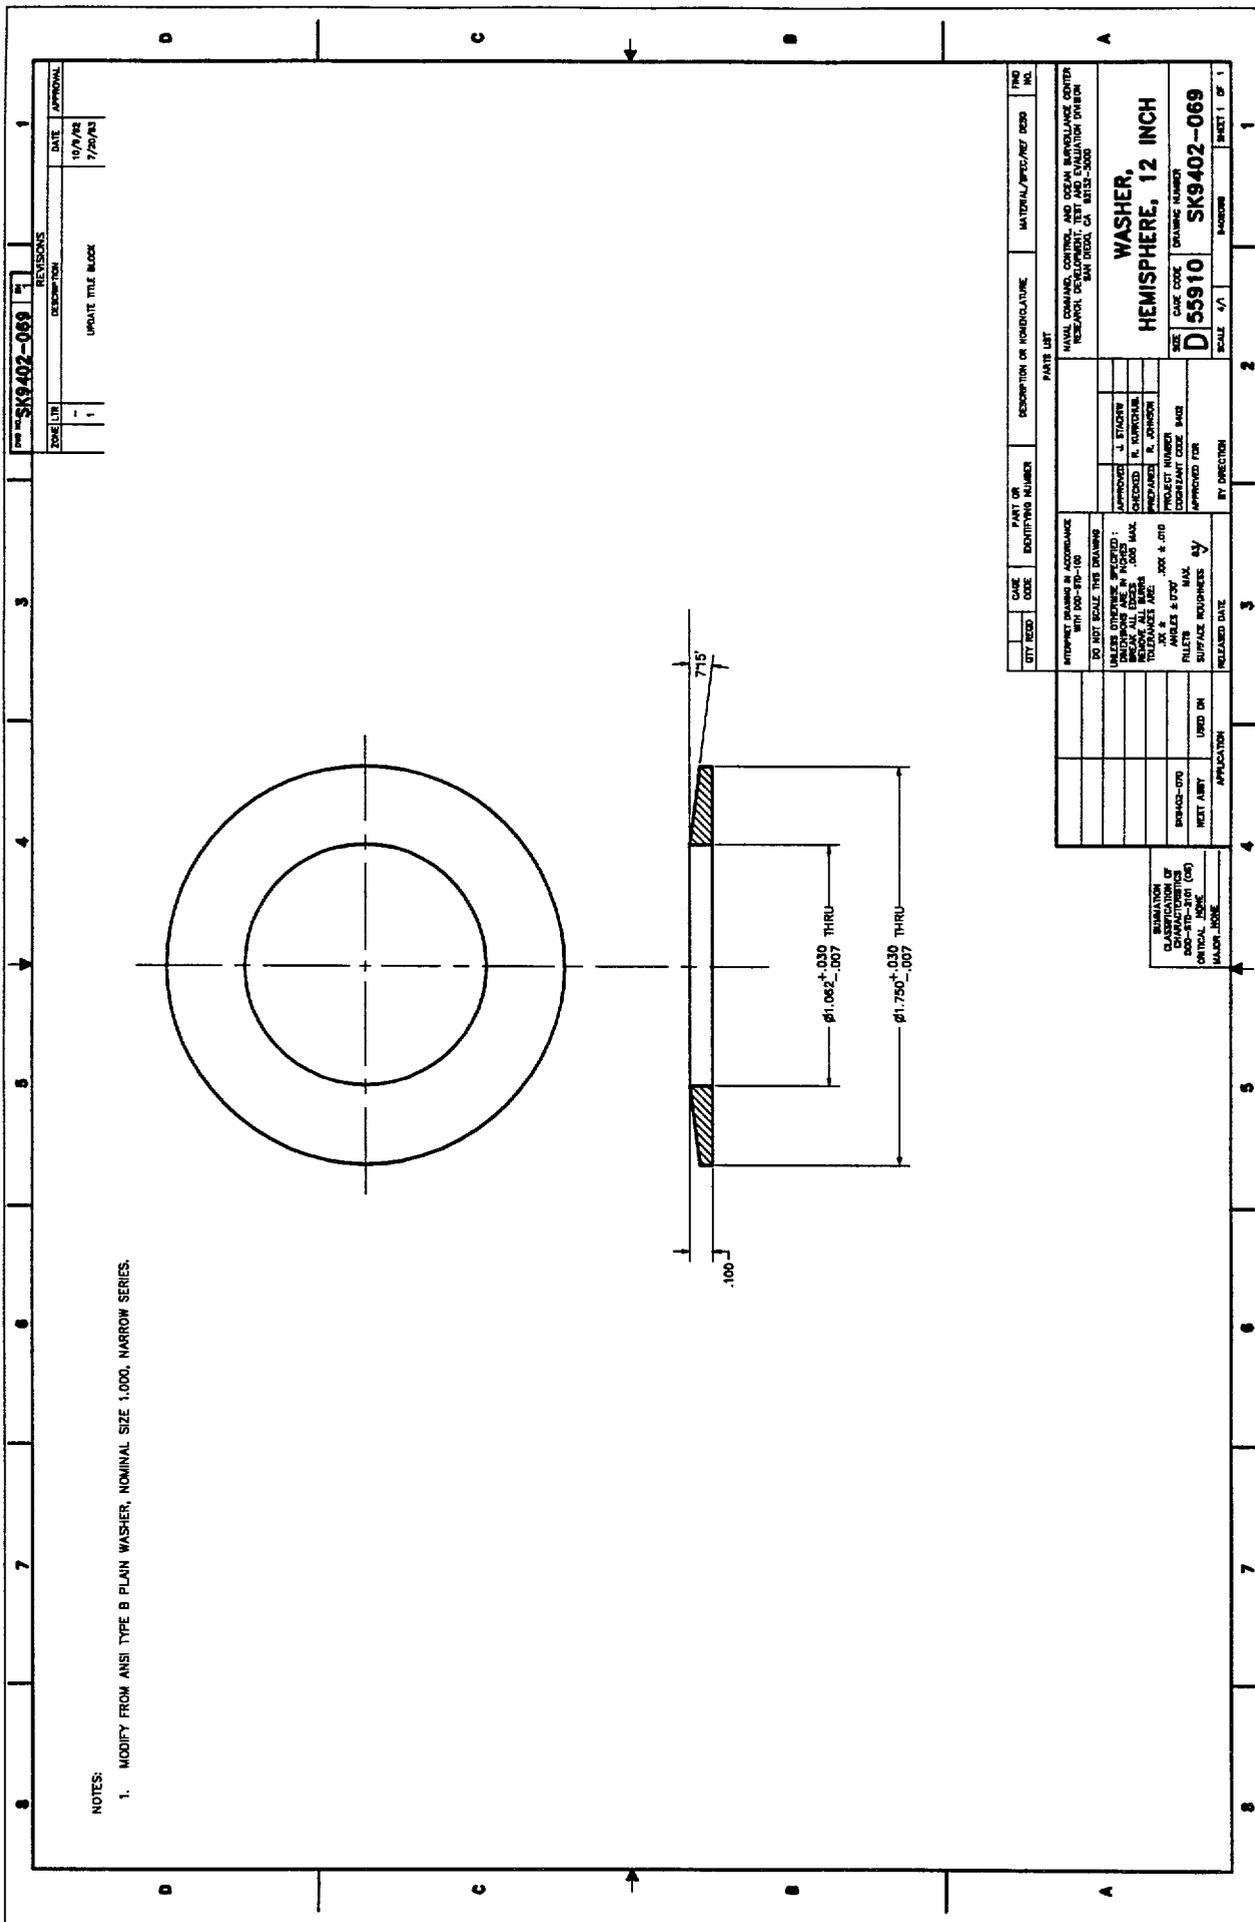
Figure 27. 12-inch hemisphere washer.

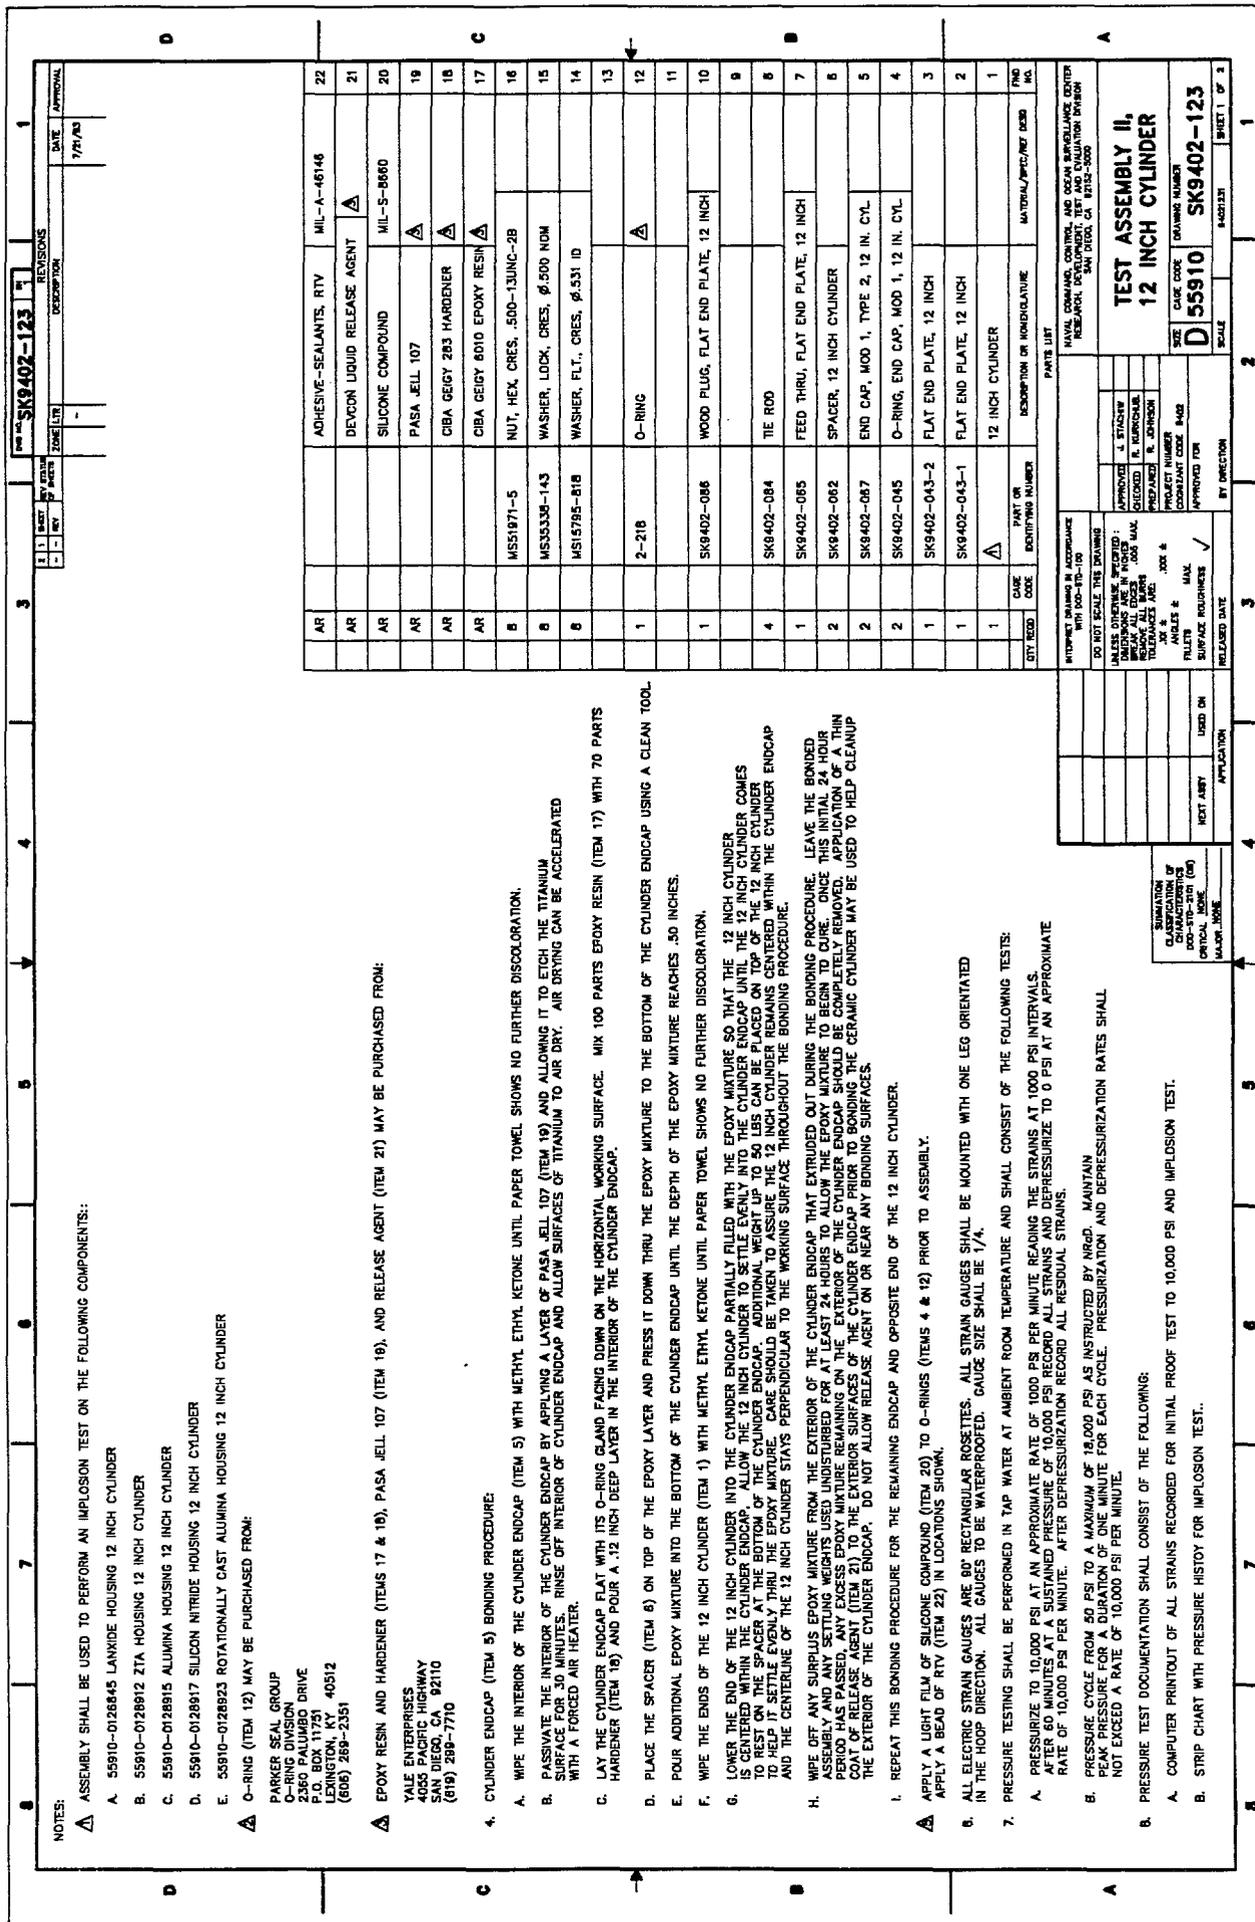
1. ASSEMBLY SHALL BE USED TO PERFORM AN IMPLSION TEST ON THE FOLLOWING COMPONENTS:
 - A. 55910-0126845 LAMKIDE HOUSING 12 INCH CYLINDER
 - B. 55910-0728912 ZTA HOUSING 12 INCH CYLINDER
 - C. 55910-0128915 ALUMINA HOUSING 12 INCH CYLINDER
 - D. 55910-0128917 SILICON NITRIDE HOUSING 12 INCH CYLINDER
 - E. 55910-0128923 ROTATIONALLY CAST ALUMINA HOUSING 12 INCH CYLINDER
2. O-RING (ITEM 12) MAY BE PURCHASED FROM:

Figure 29. 12-inch cylinder test assembly, Type II configuration, Sheet 1.

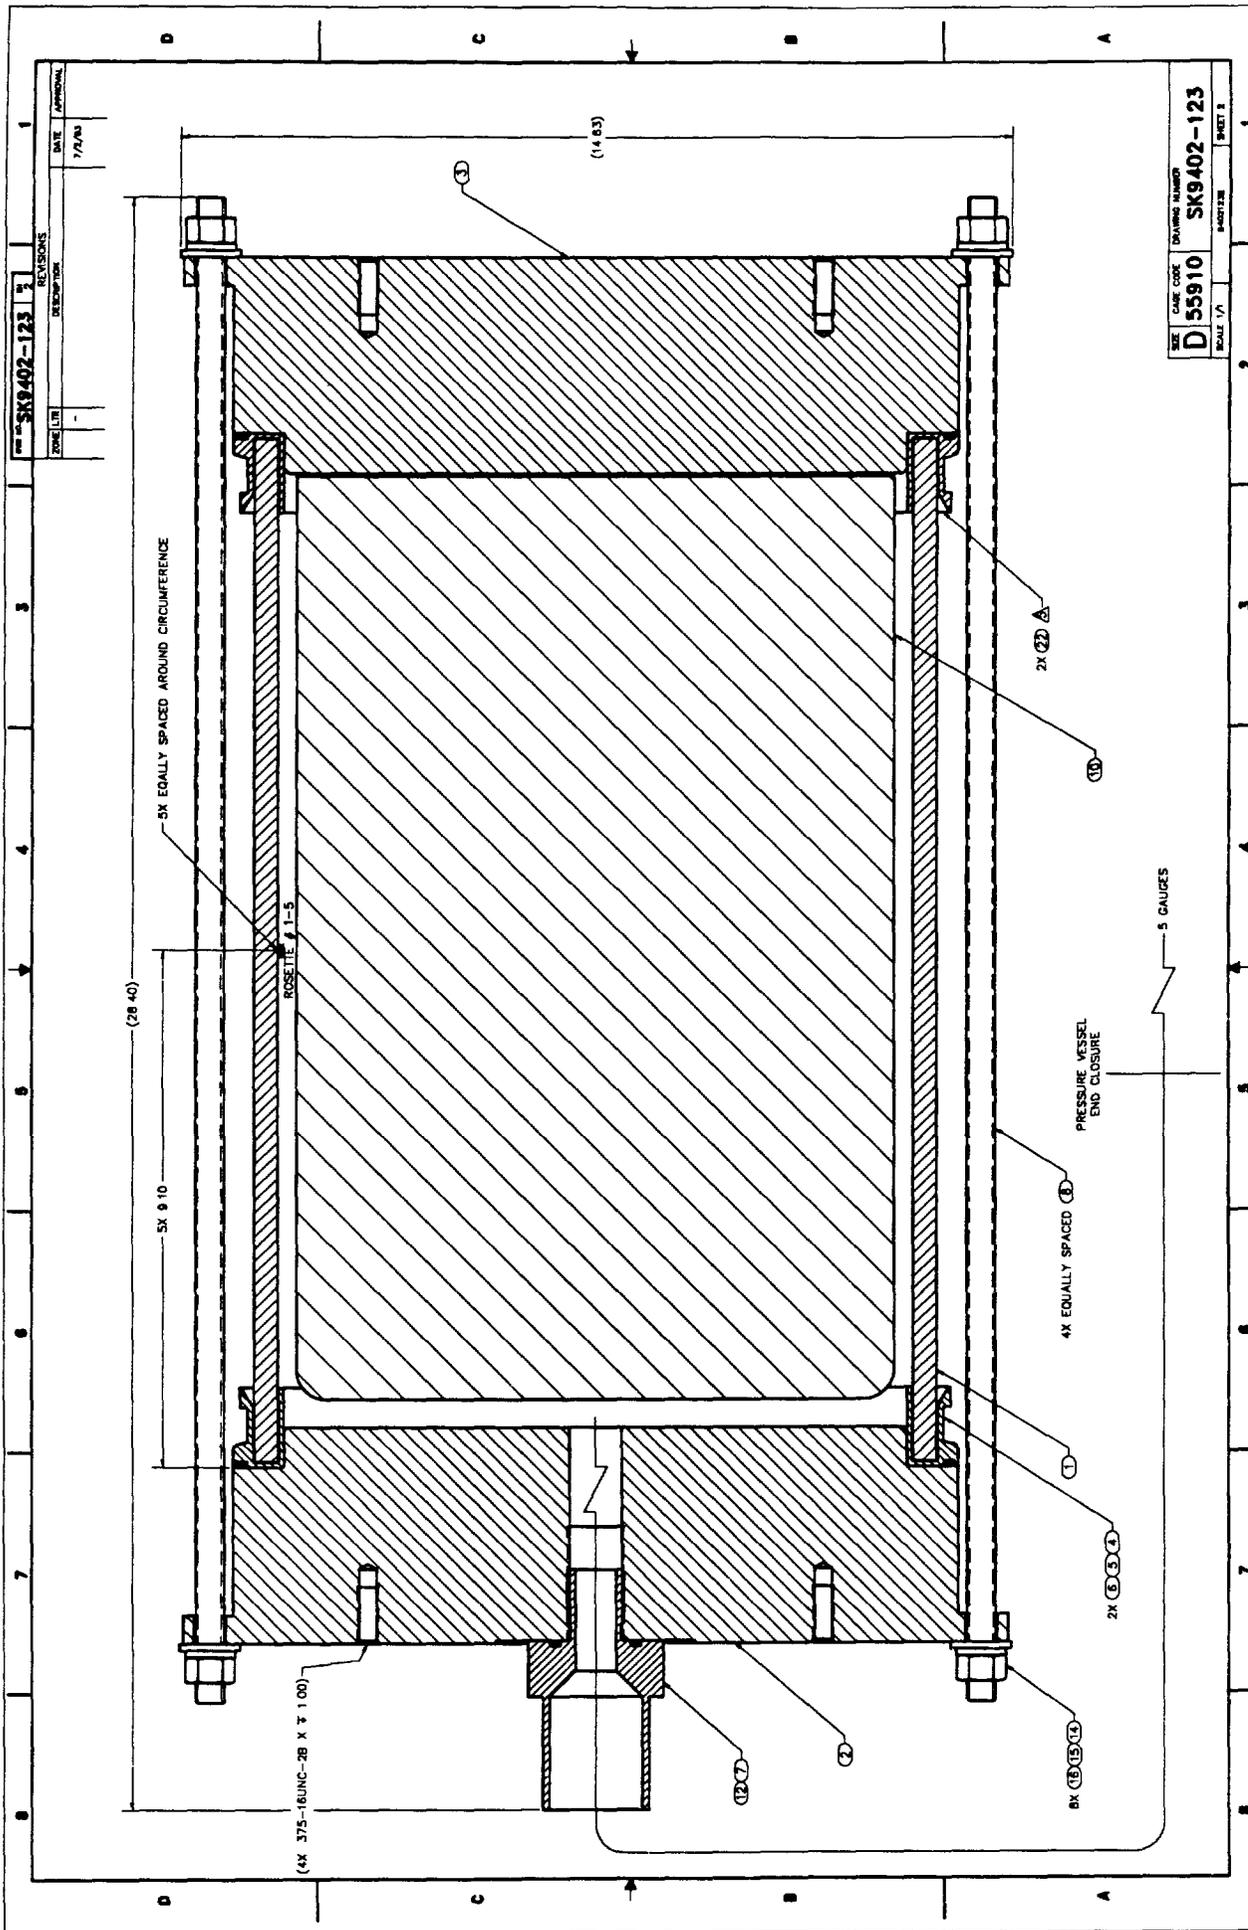
Figure 29. 12-inch cylinder test assembly, Type II configuration, Sheet 2.

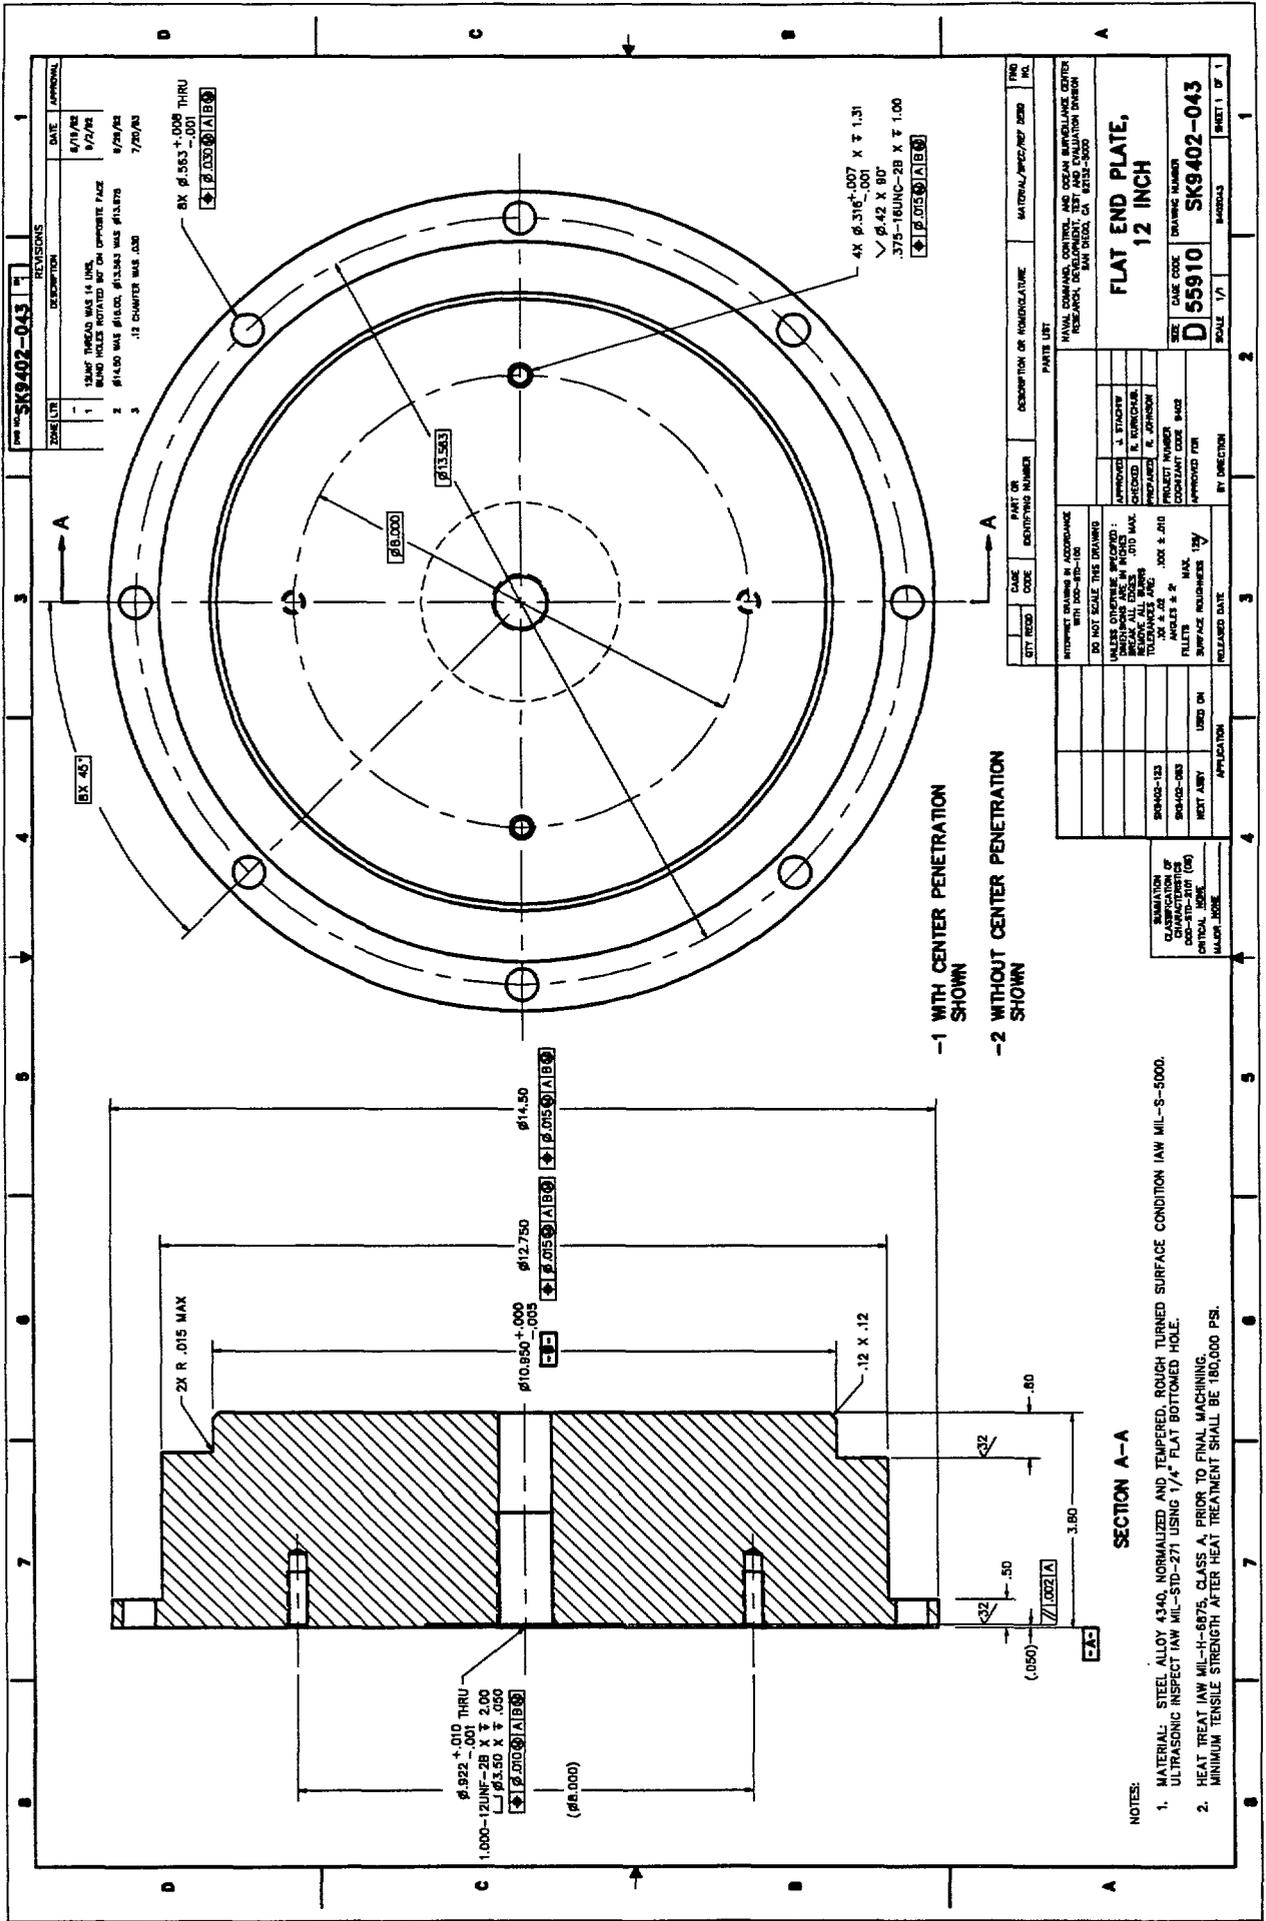
Figure 30. 12-inch flat end plate.

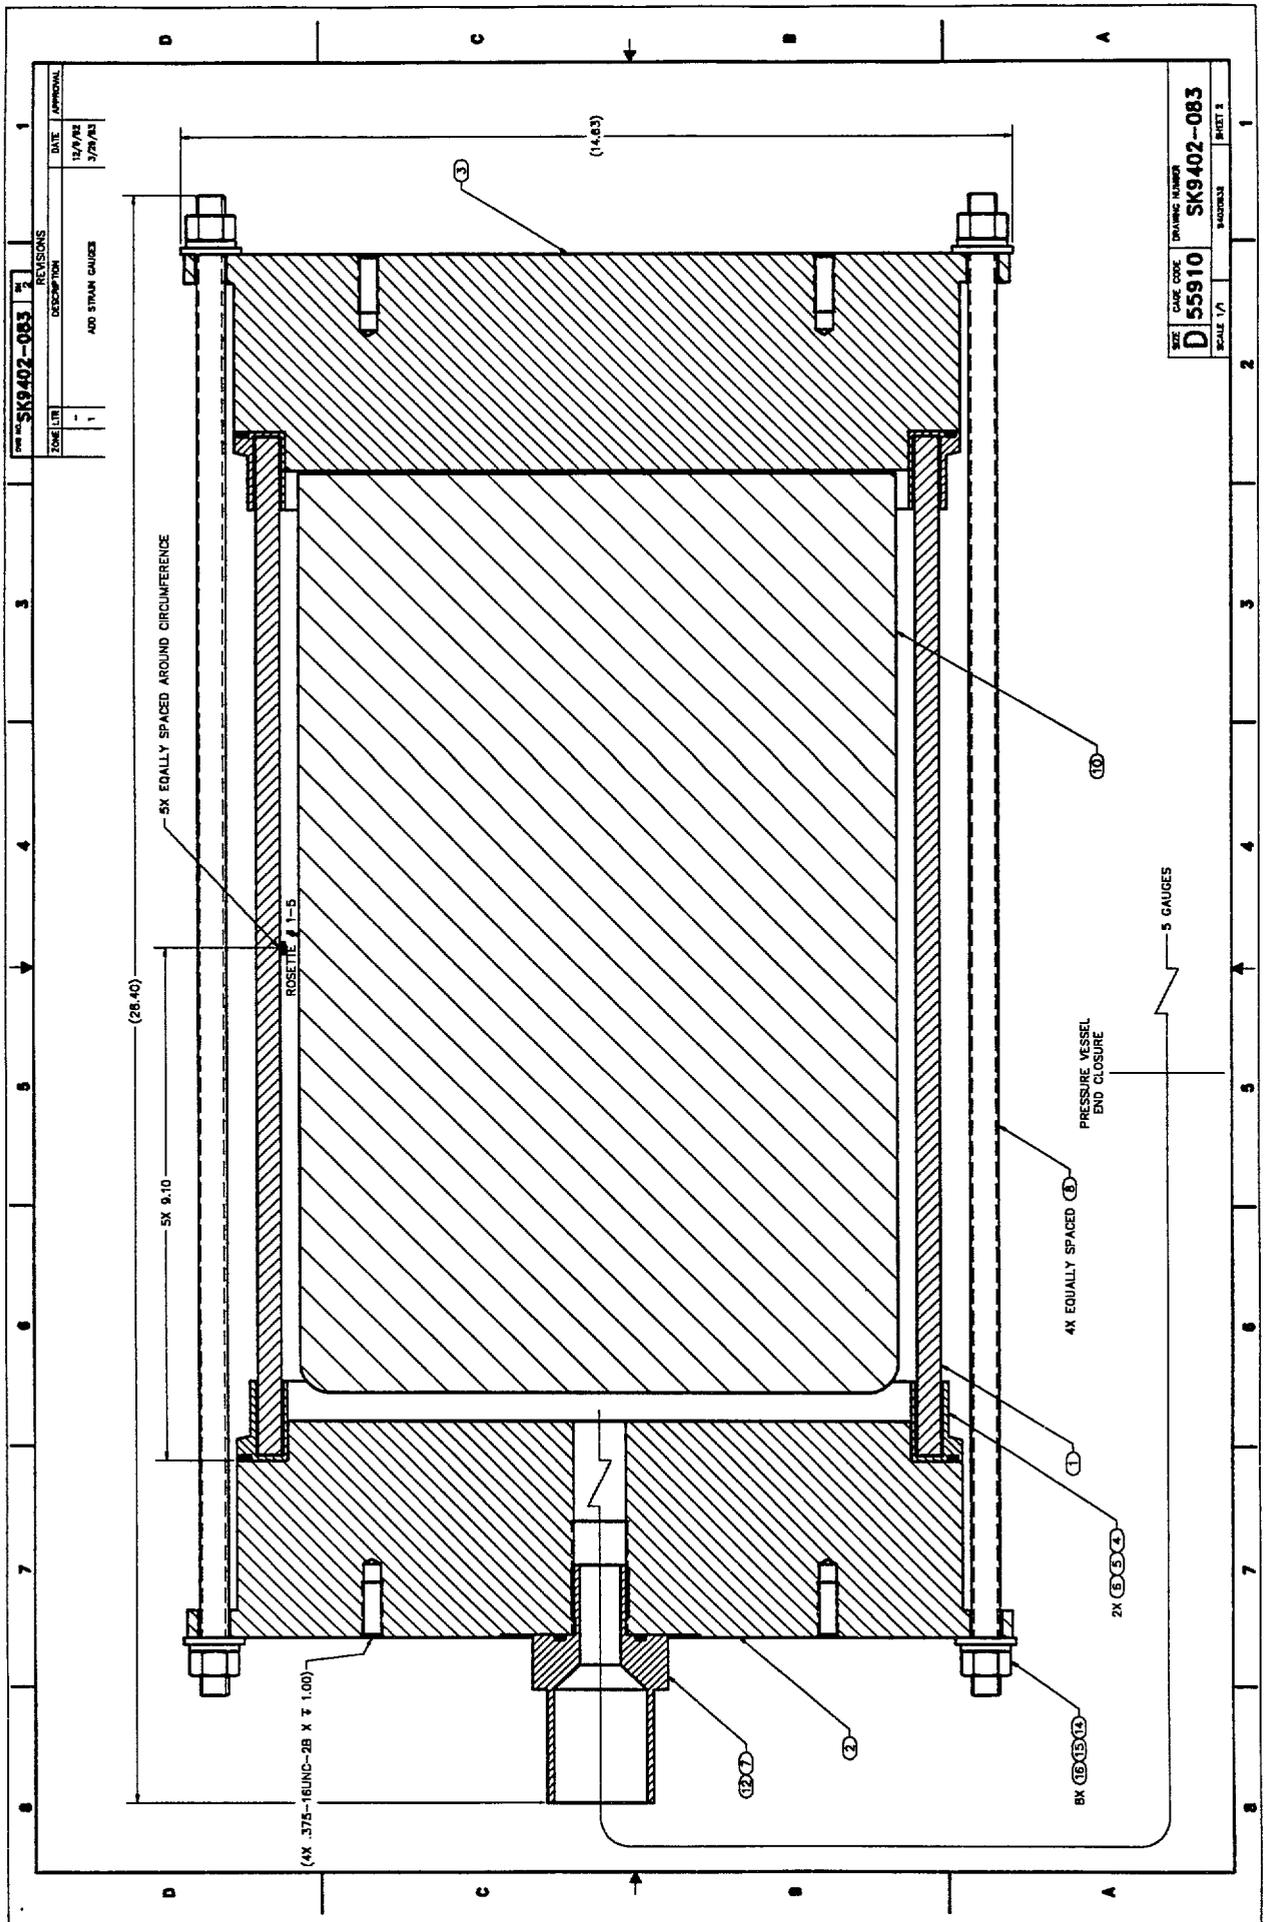
Figure 31. 12-inch cylinder test assembly, Type III configuration, Sheet 2.

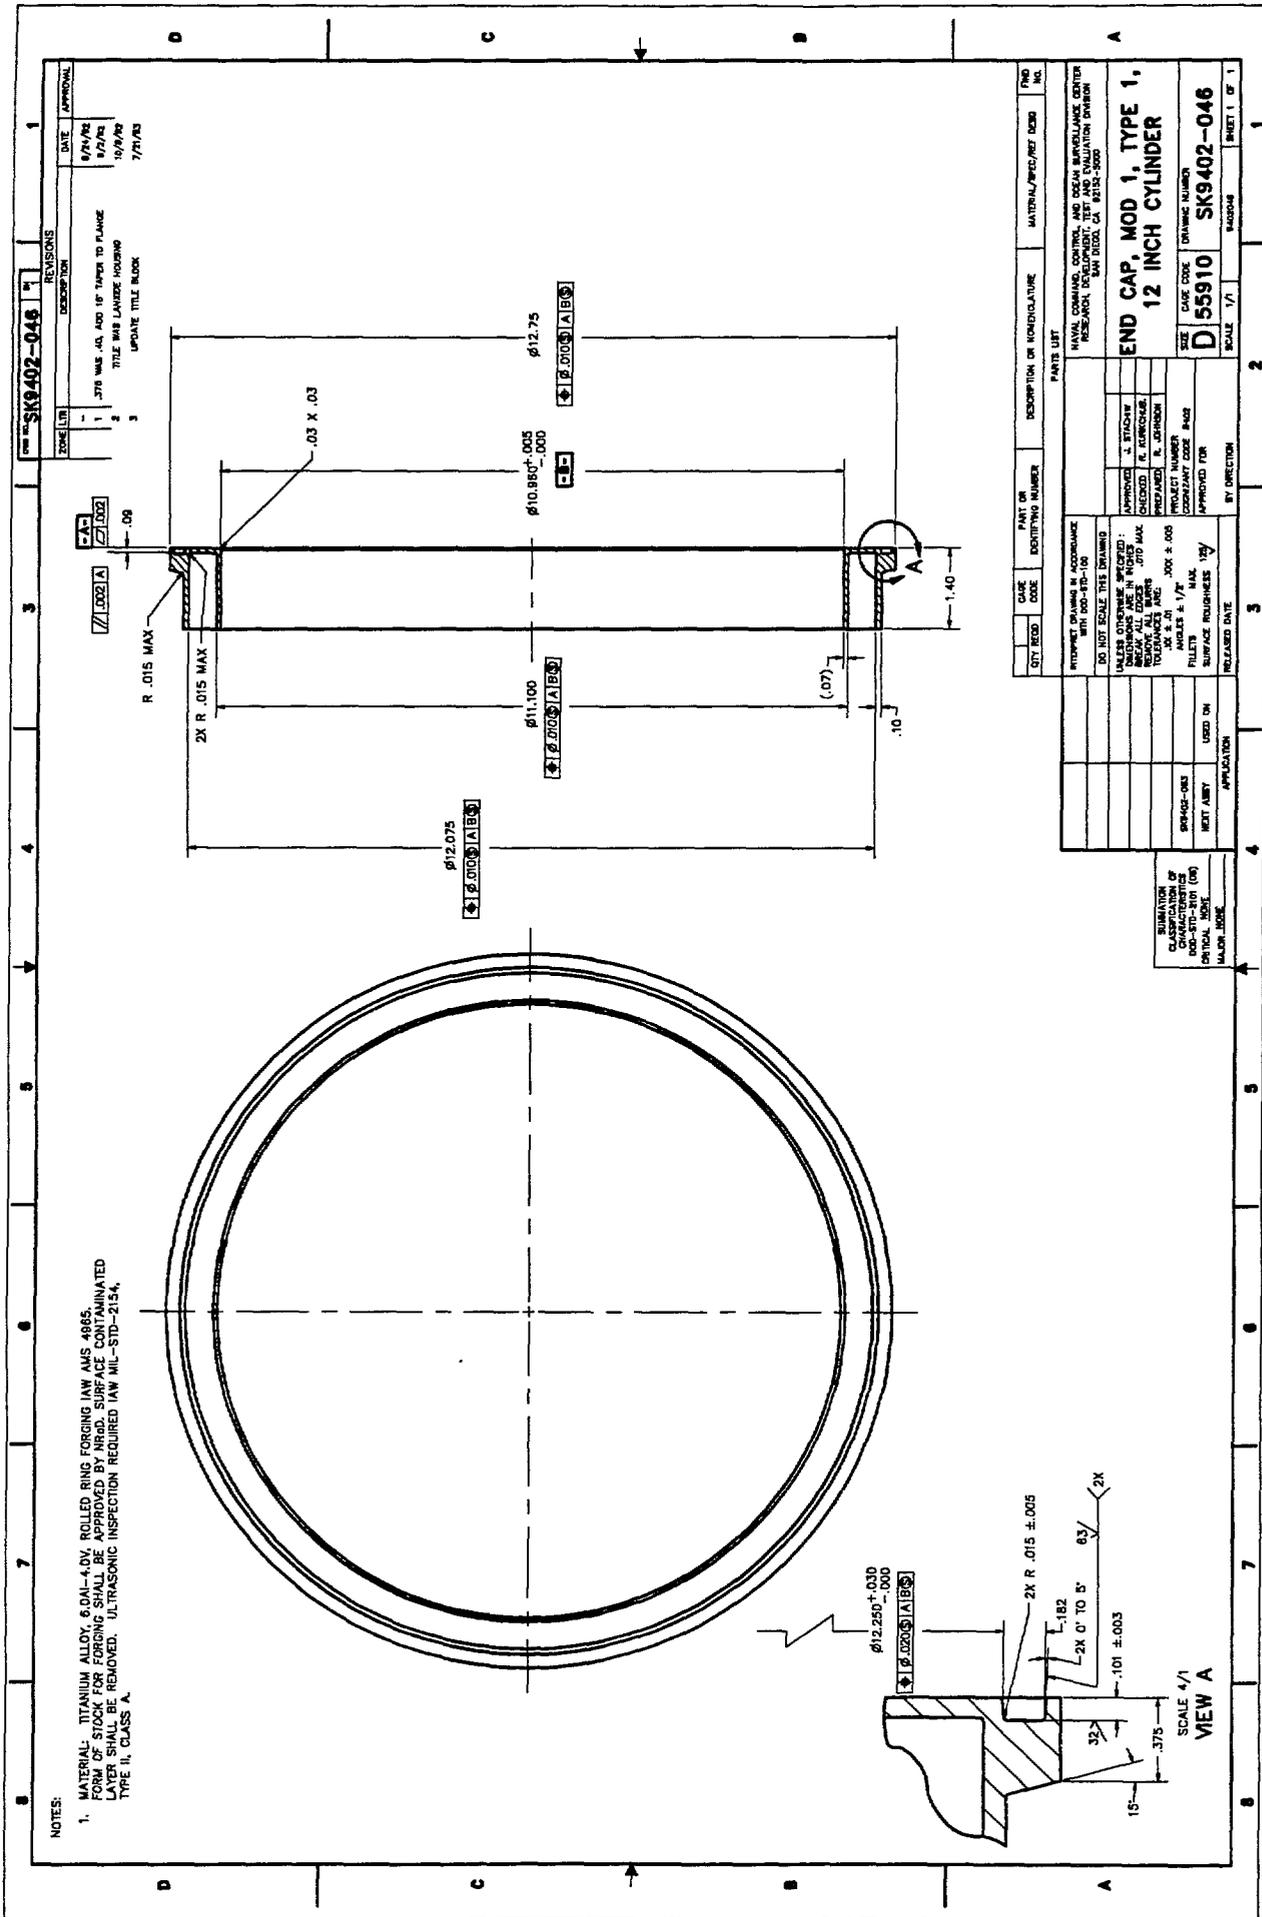
Figure 32. 12-inch cylinder Mod 1, Type 1 end-cap joint ring.

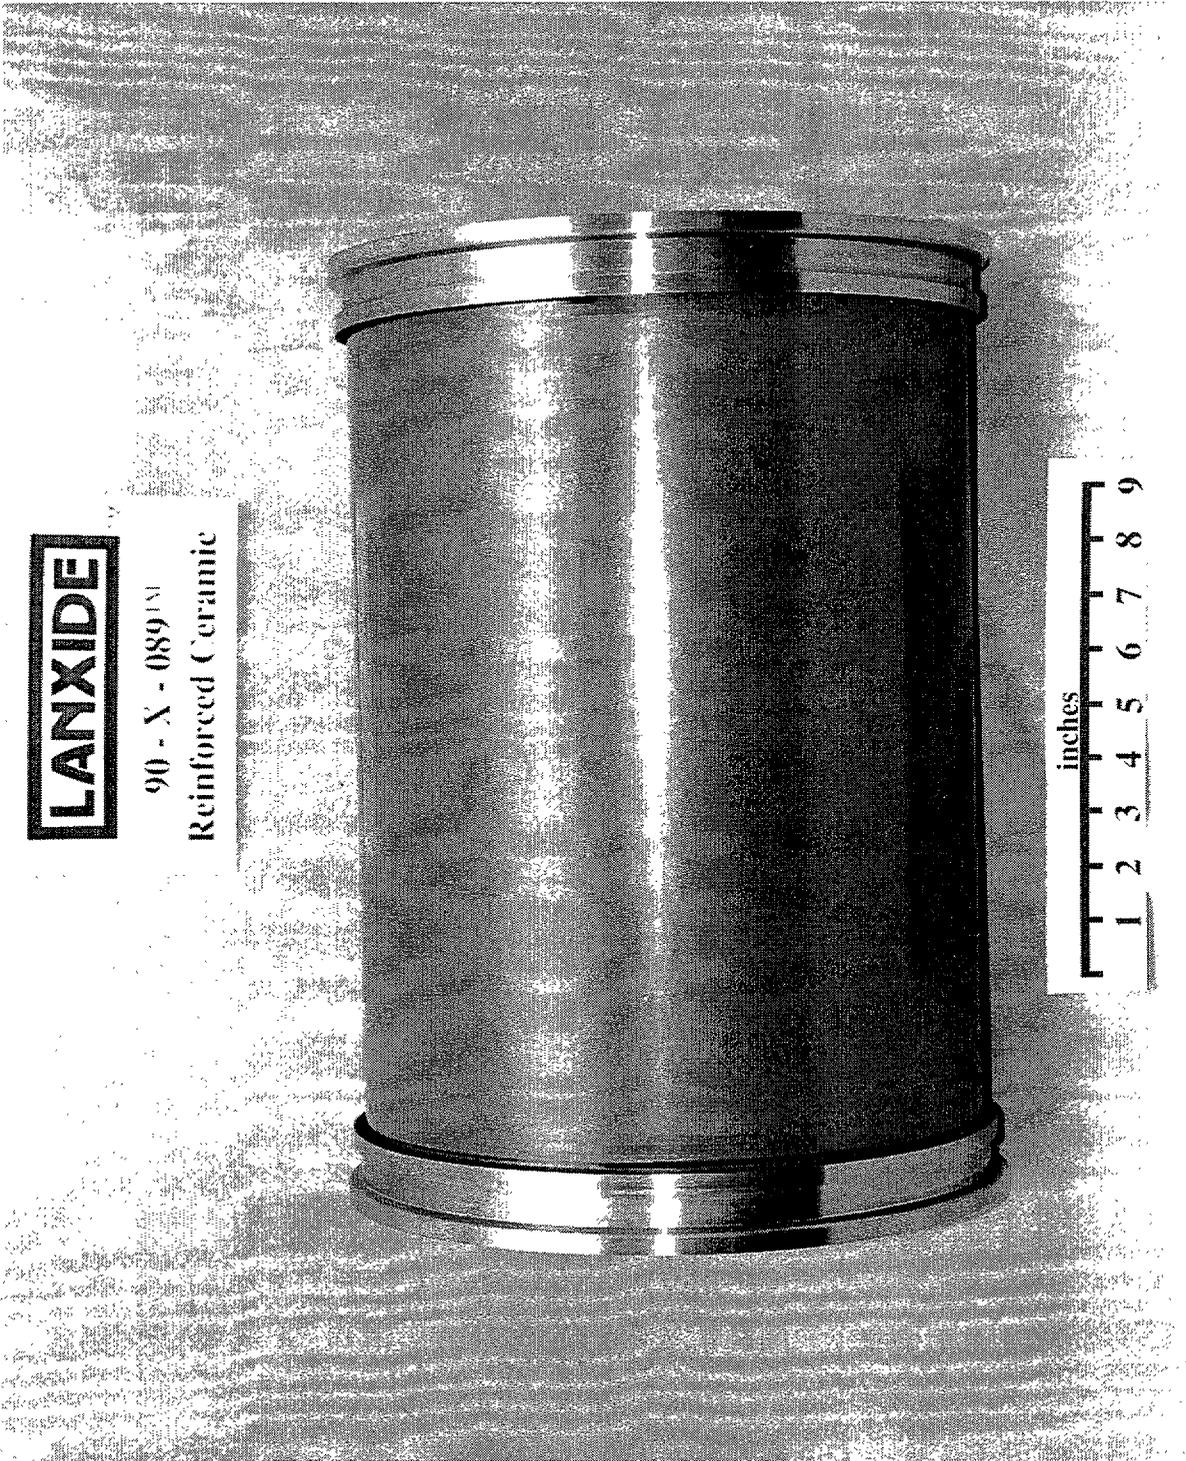
Figure 36. Fully machined cylinder with Type 2 titanium end caps bonded in place.

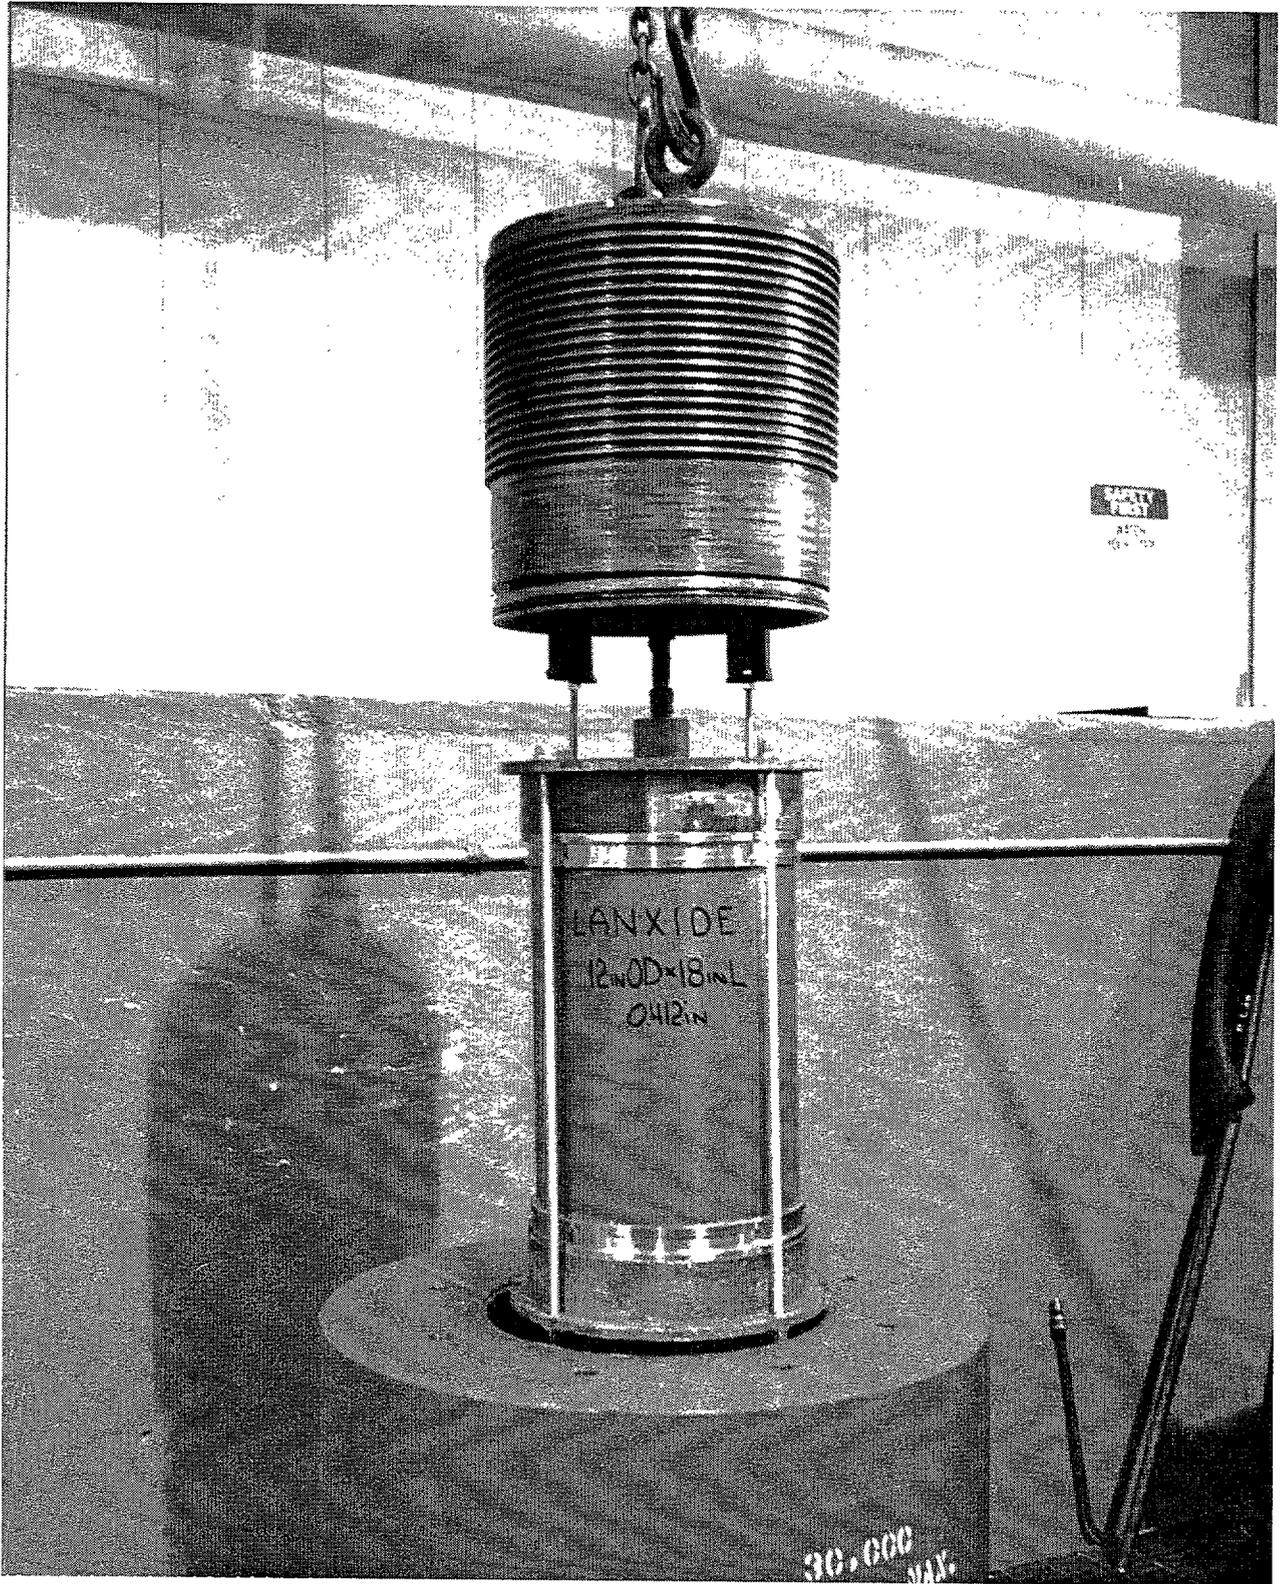
Figure 37. Type II test assembly being lowered into pressure chamber.

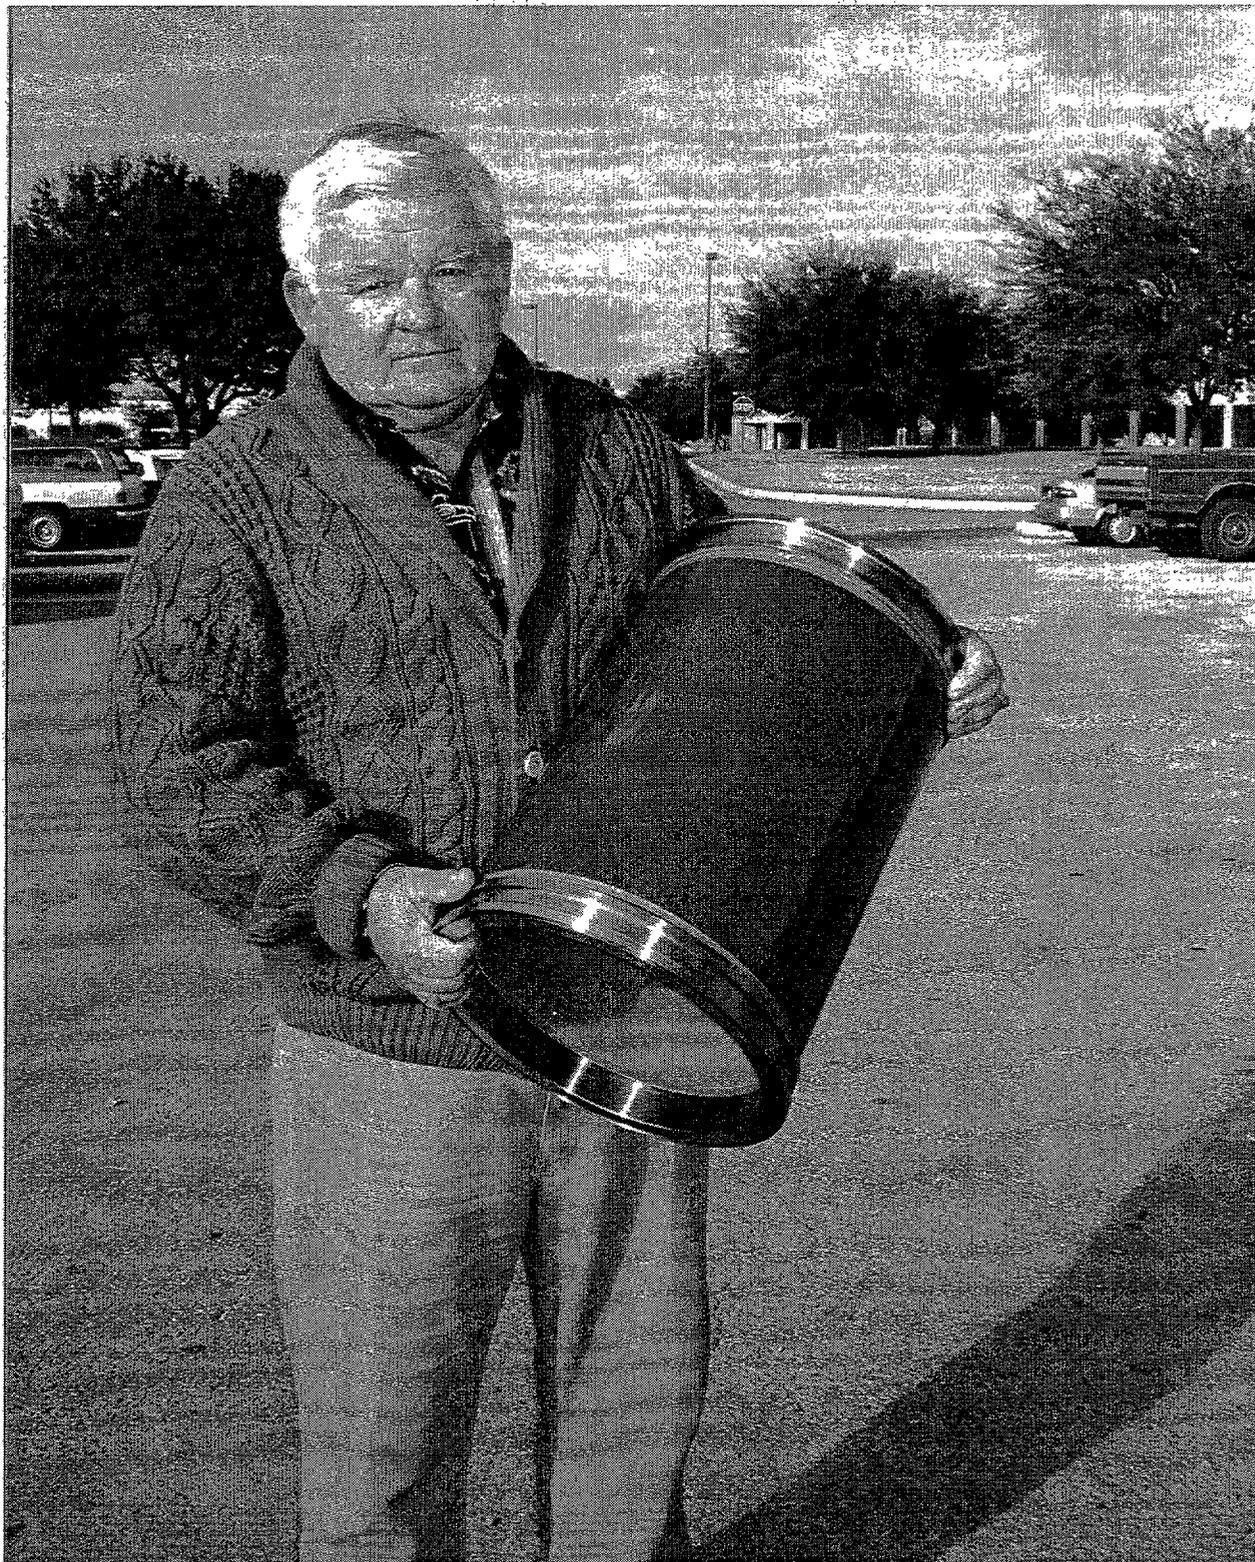
Figure 38. "As-cast" cylinder with green epoxy coating, prior to testing.

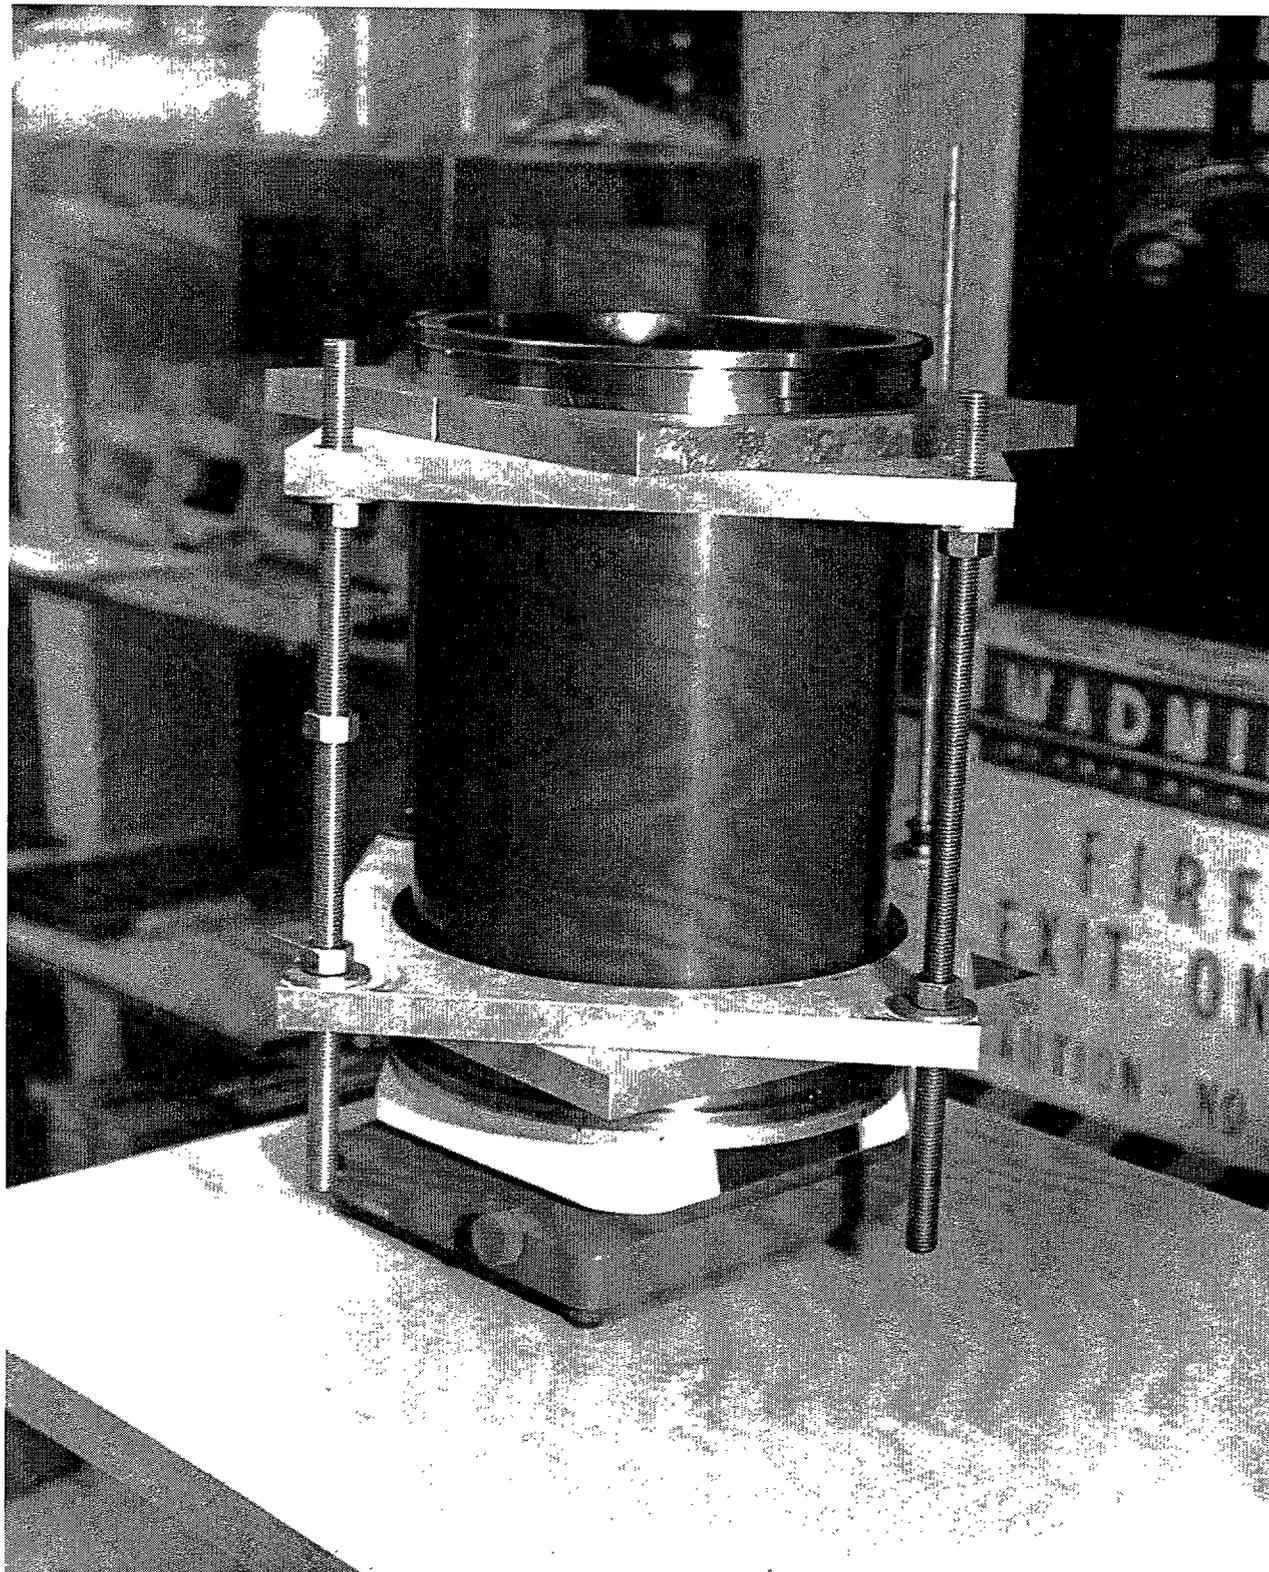
Figure 39. Fixture used to remove titanium end caps from ceramic cylinders for crack inspection after pressure testing.

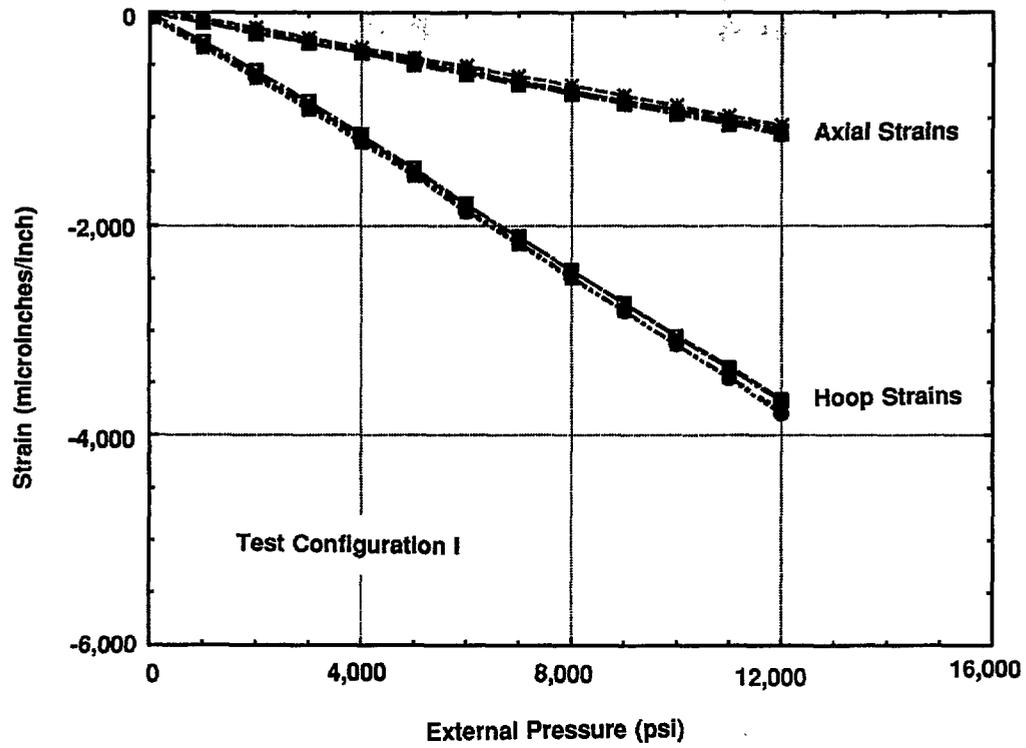
Figure 40. Pressure vs. strain plot for cylinder LAN 001.
