Structural Performance of Cylindrical Pressure Housings of Different Ceramic Compositions Under External Pressure Loading

Part IV, Silicon Carbide Particulate Reinforced Alumina Ceramic

Technical Report 1594
December 1993

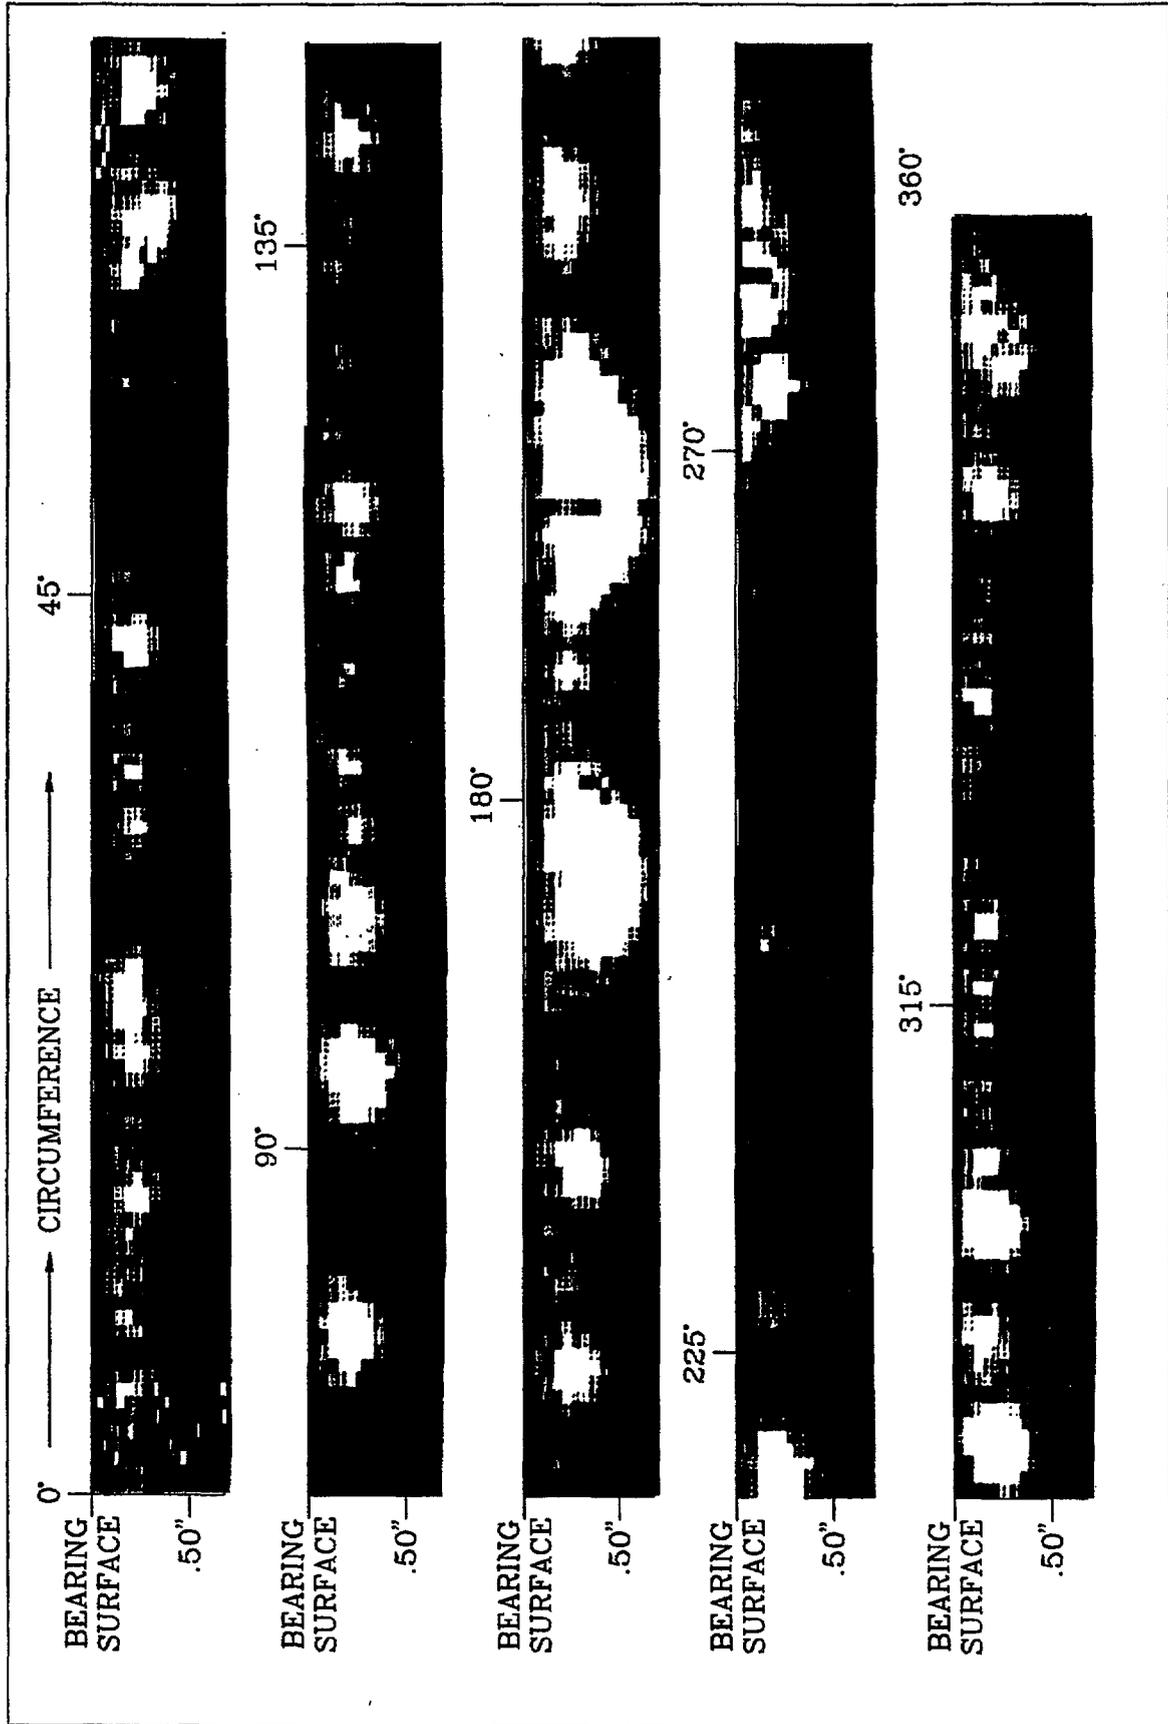
Figure 41. Pulse-echo C-scan of one end of cylinder LAN 001. The ultrasonic inspection was performed using a 3/8-inch diameter, 3-inch focal length, 10 MHz transducer.

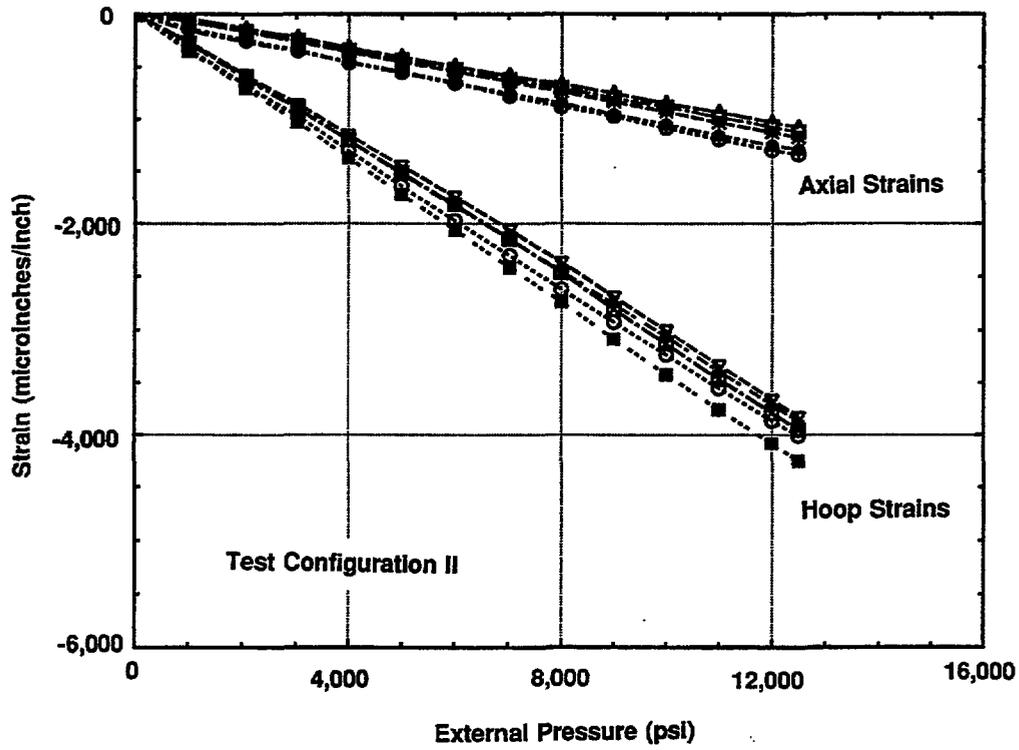
Figure 42. Pressure vs. strain plot for cylinder LAN 002.

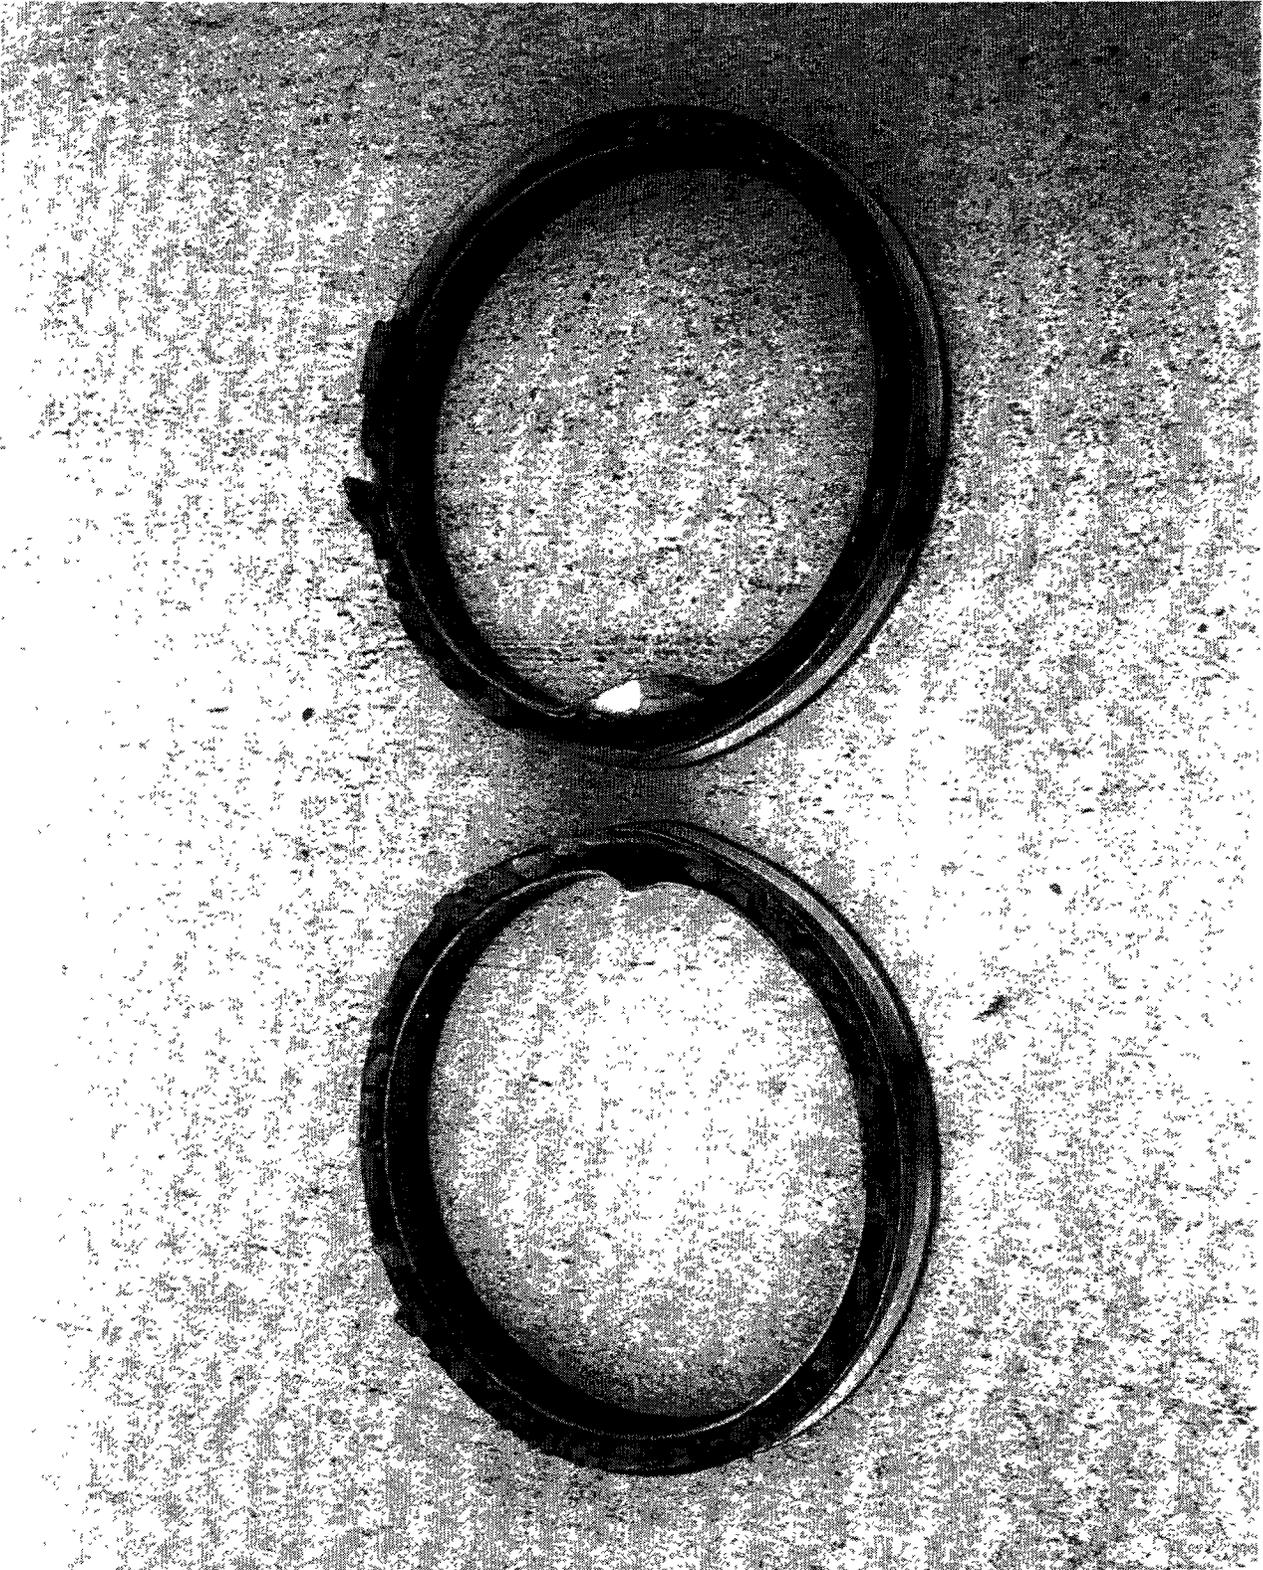
Figure 43. End cap remains of failed cylinder LAN 002.

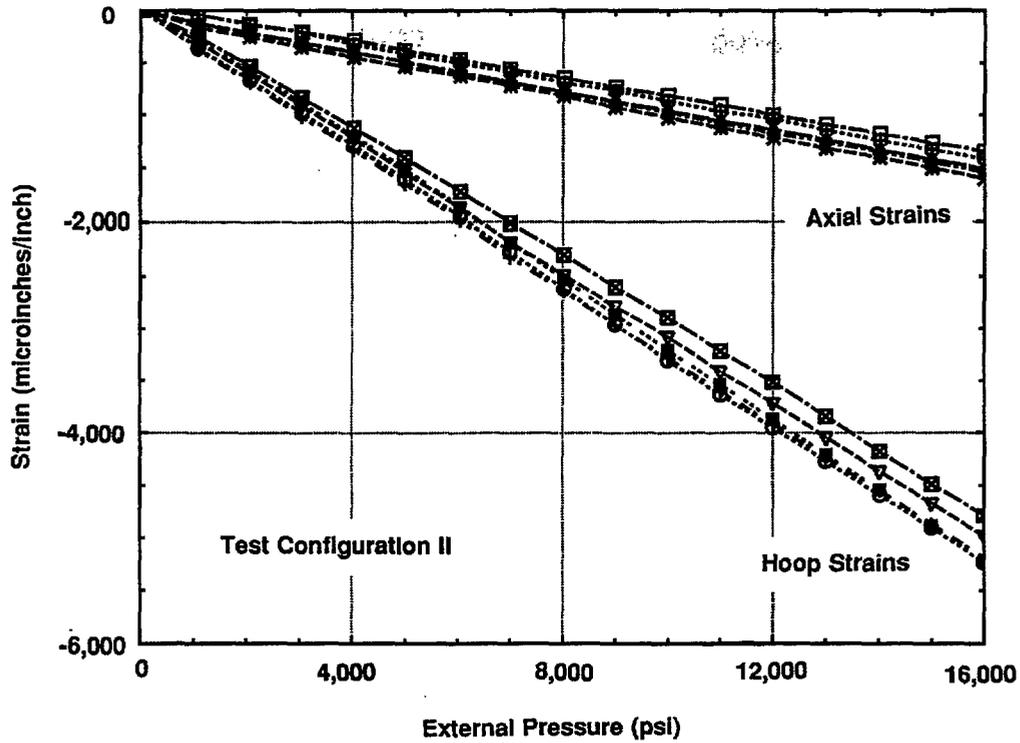
Figure 44. Pressure vs. strain plot for cylinder LAN 003.

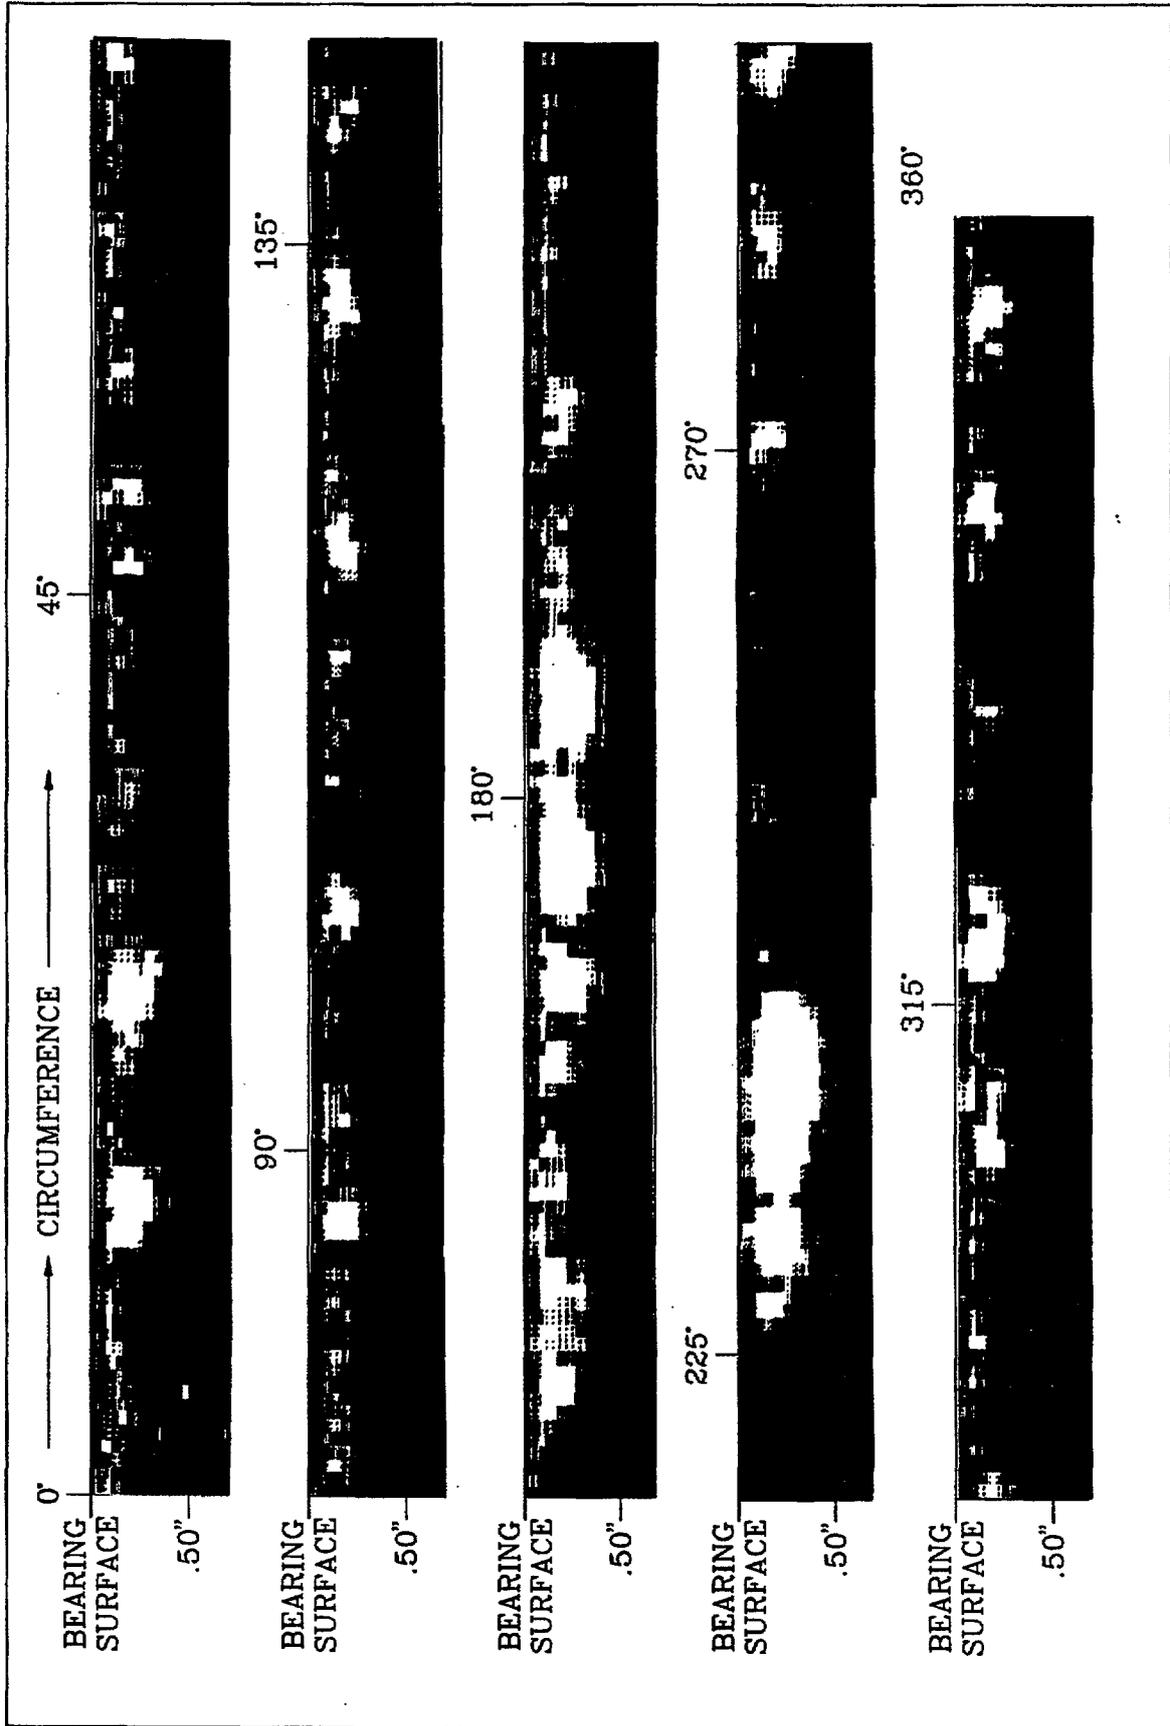
Figure. 45. Pulse-echo C-scan of one end of cylinder LAN 003. The other end was also inspected, but no internal circumferential cracking was found.

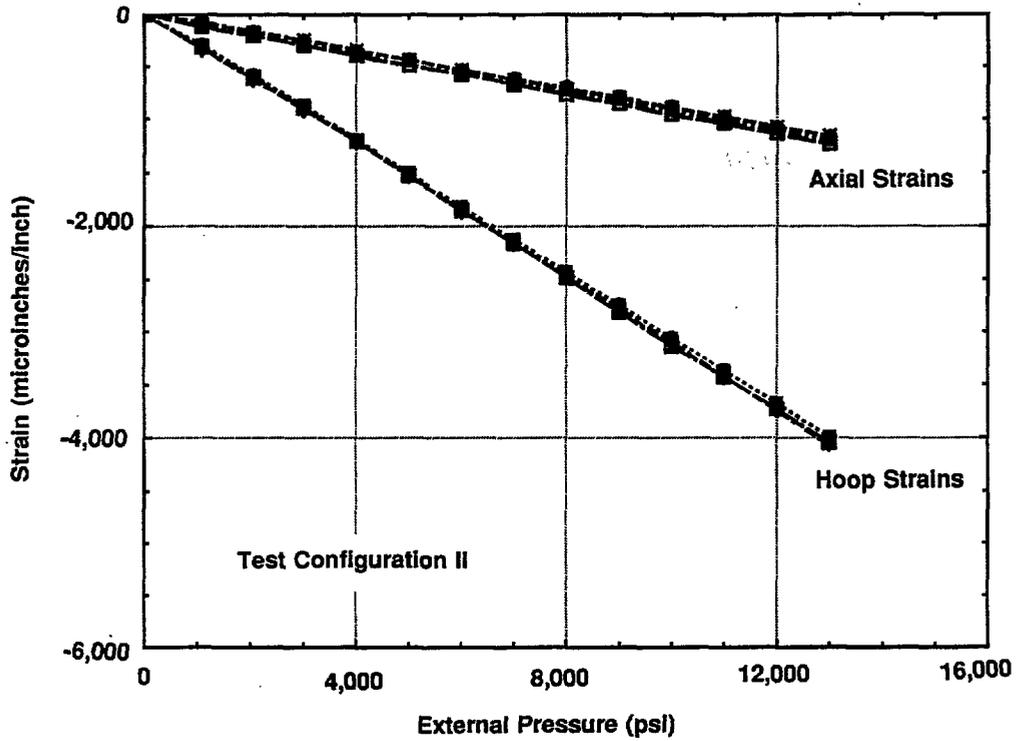
Figure 46. Pressure vs. strain plot for cylinder LAN 004.

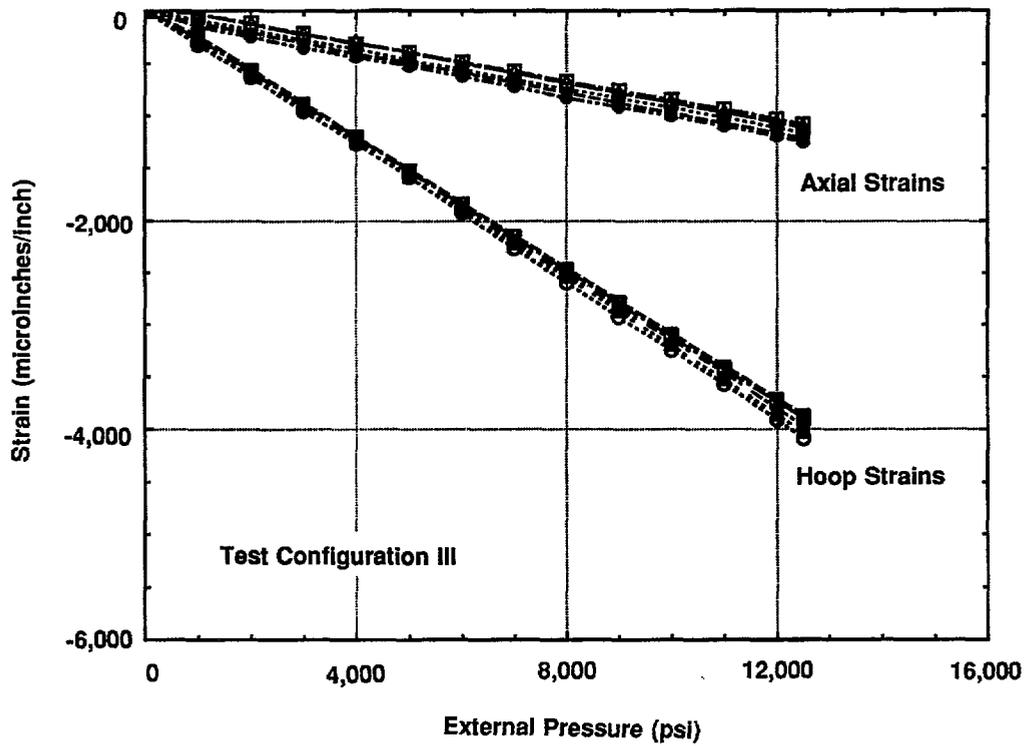
Figure 47. Pressure vs. strain plot for cylinder LAN 005.

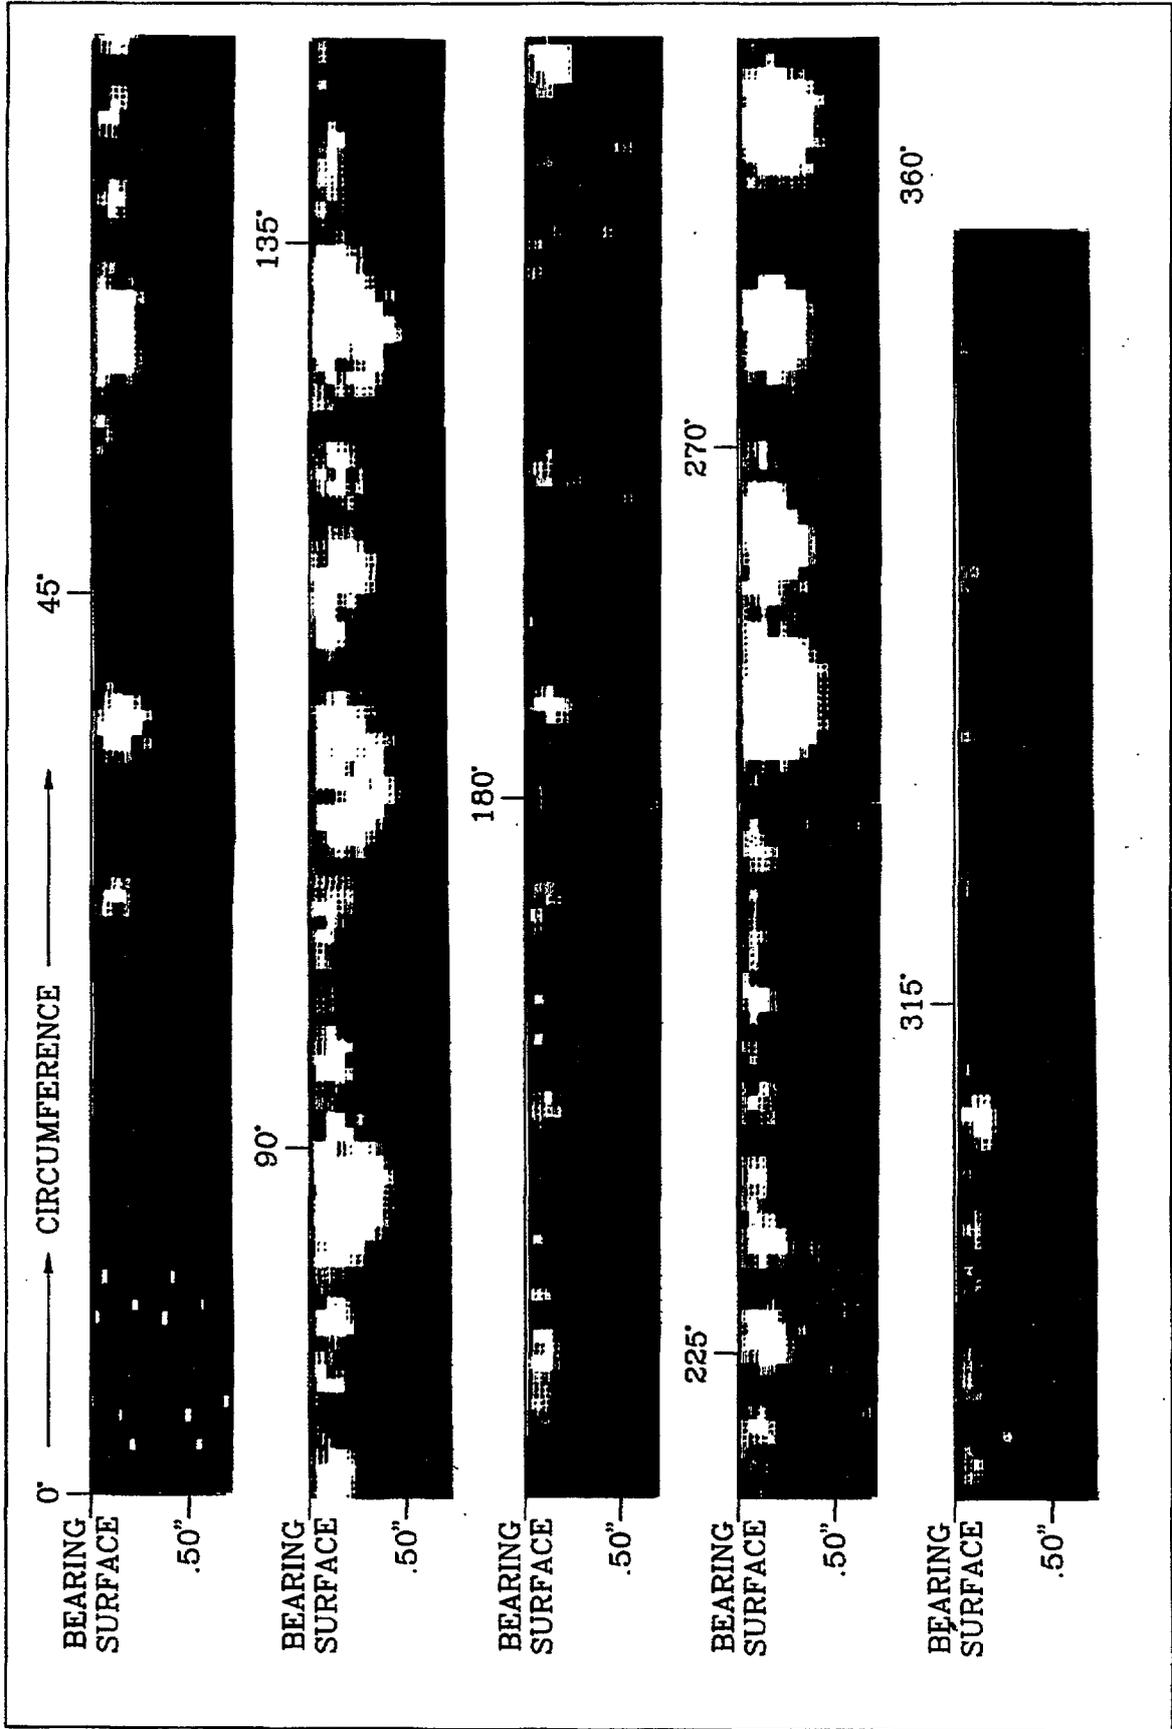
Figure 48. Pulse-echo C-scan of one end of cylinder LAN 005.

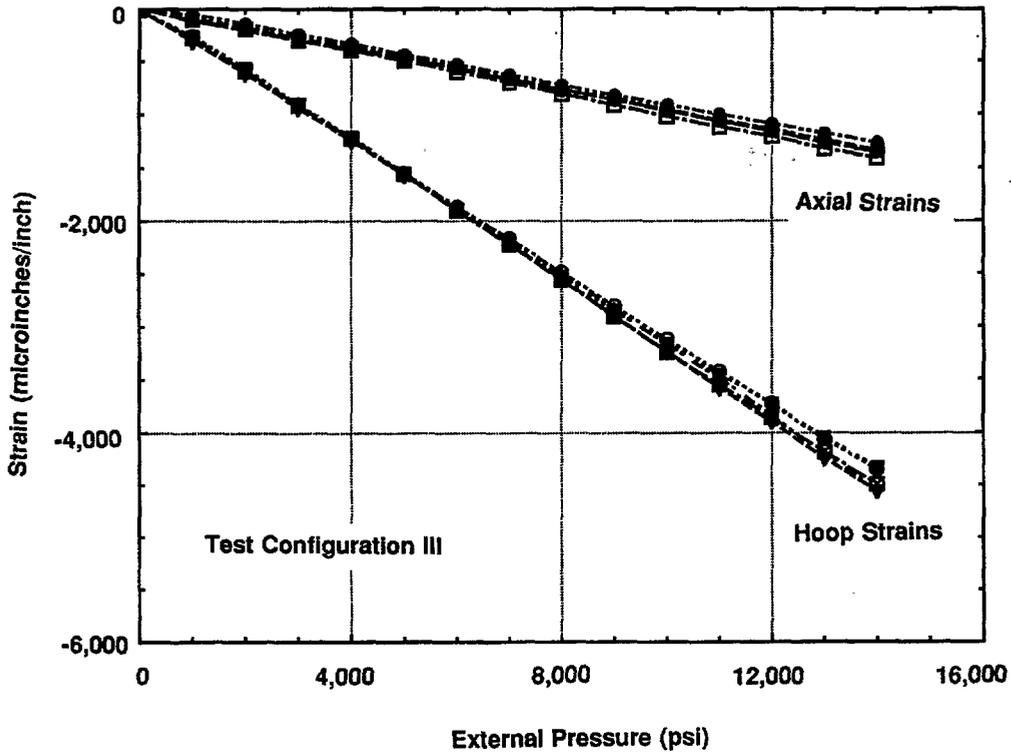
Figure 49. Pressure vs. strain plot for cylinder LAN 006.

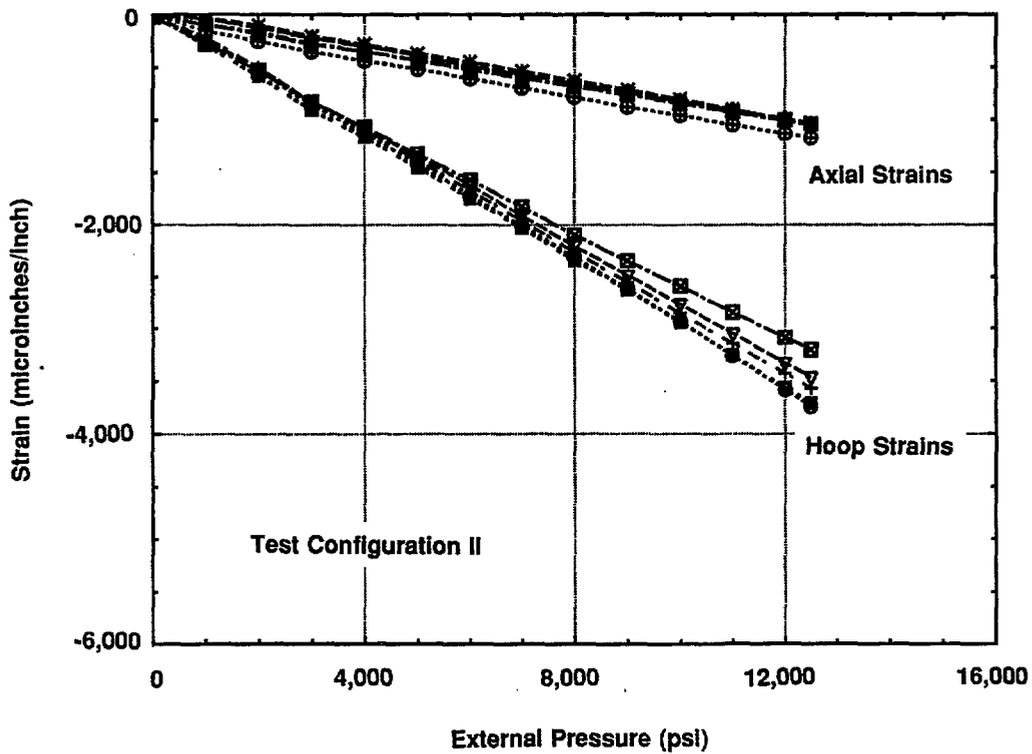
Figure 50. Pressure vs. strain plot for cylinder LAN 007.

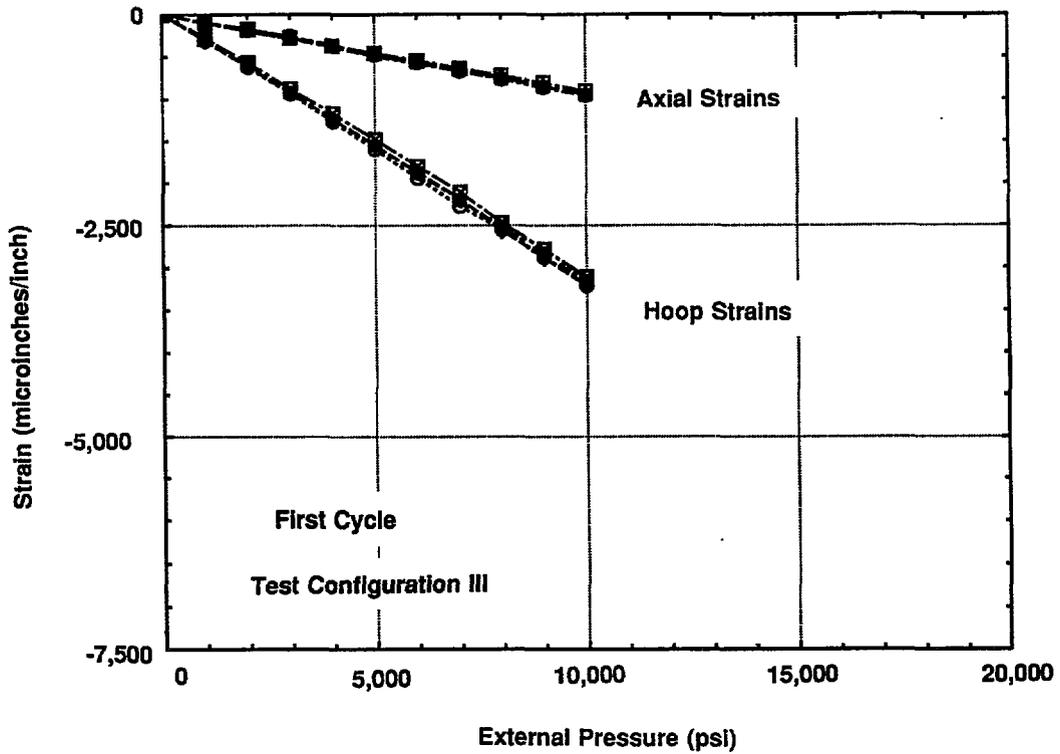
Figure 51. Pressure vs. strain plot for the first pressurization of cylinder LAN 008.

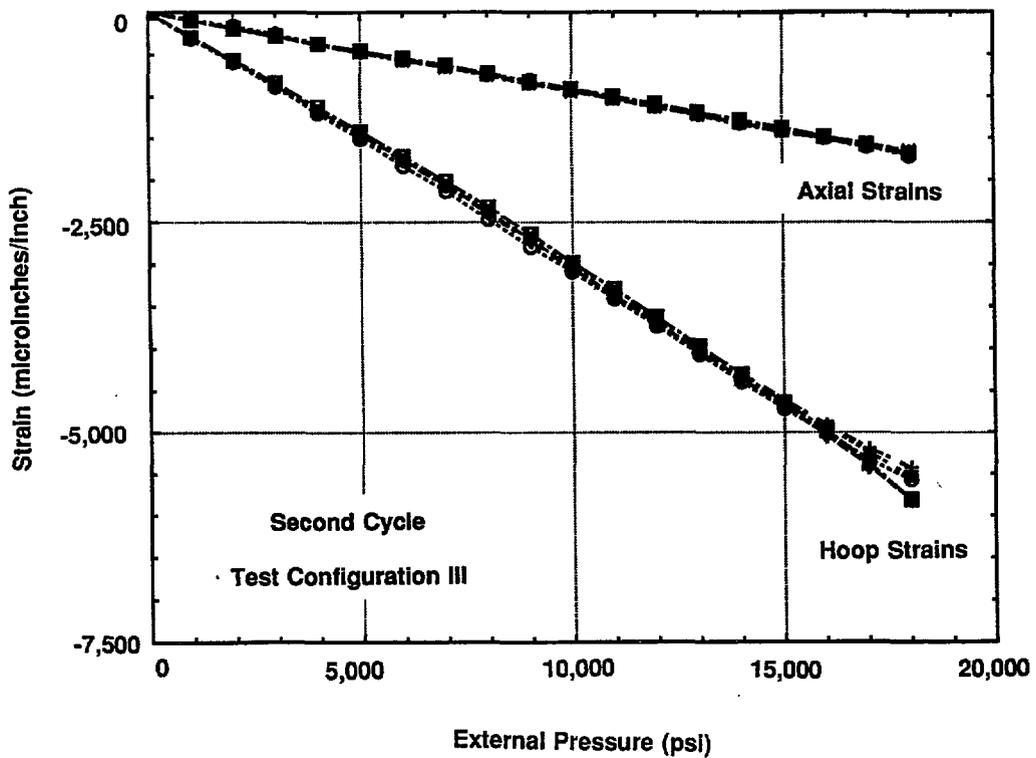
Figure 52. Pressure vs. strain plot for the second pressurization of cylinder LAN 008.

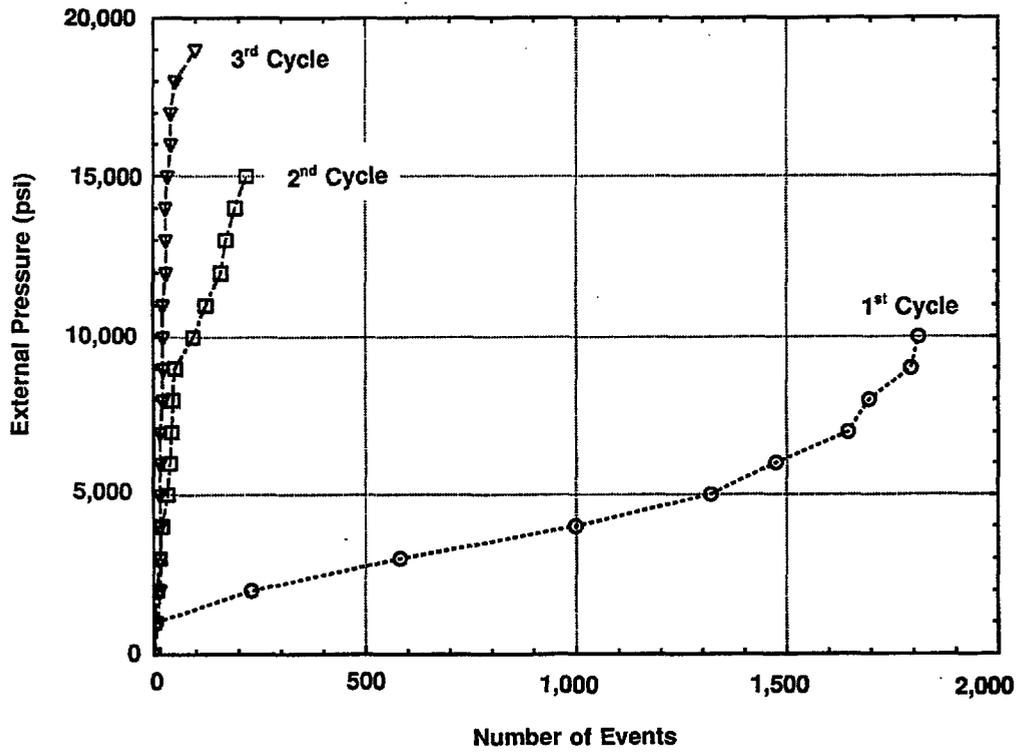
Figure 53. Acoustic emissions for first, second, and third pressurizations of cylinder LAN 008.

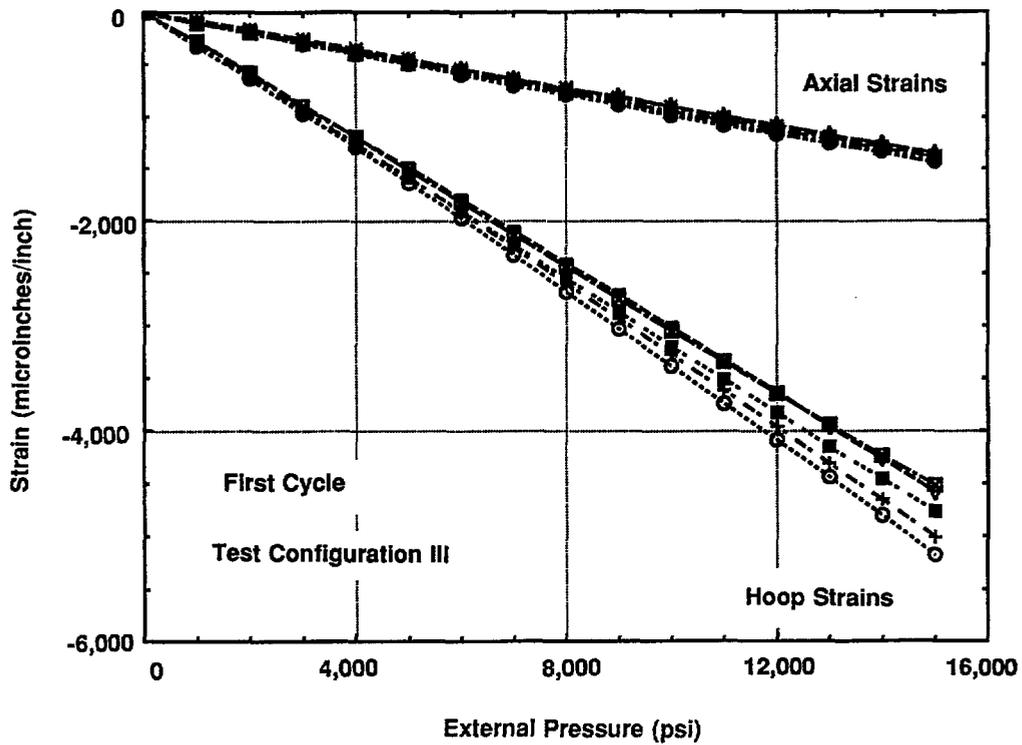
Figure 54. Pressure vs. strain plot for the first pressurization of cylinder LAN 009.

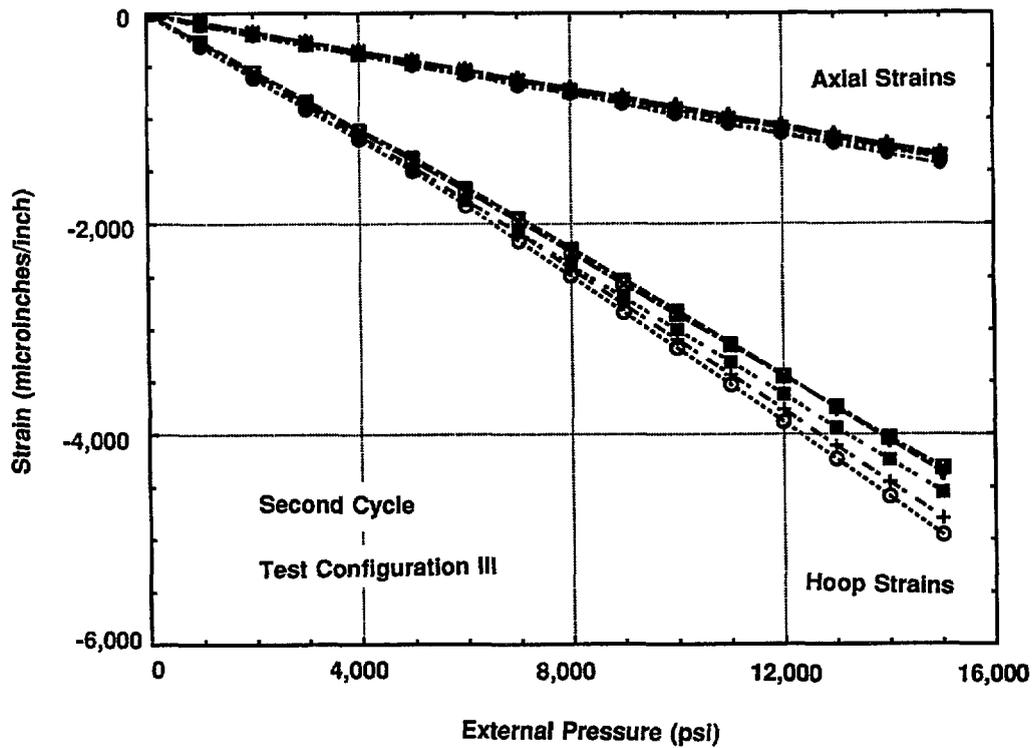
Figure 55. Pressure vs. strain plot for the second pressurization of cylinder LAN 009.

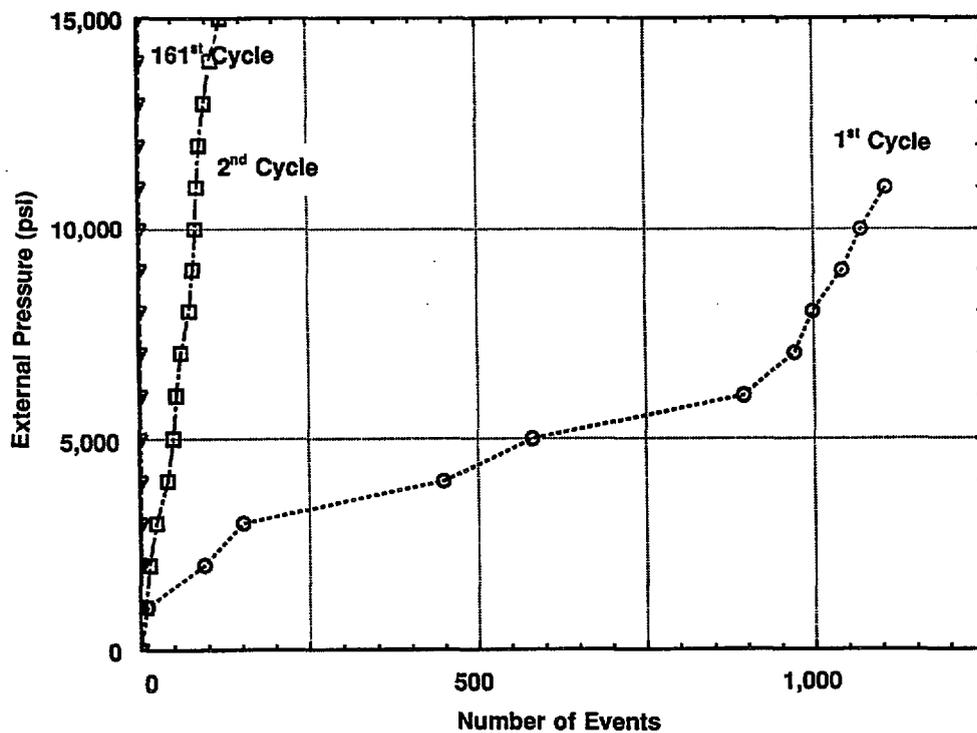
Figure 56. Acoustic emissions for first, second, and 161st pressurizations of cylinder LAN 009.

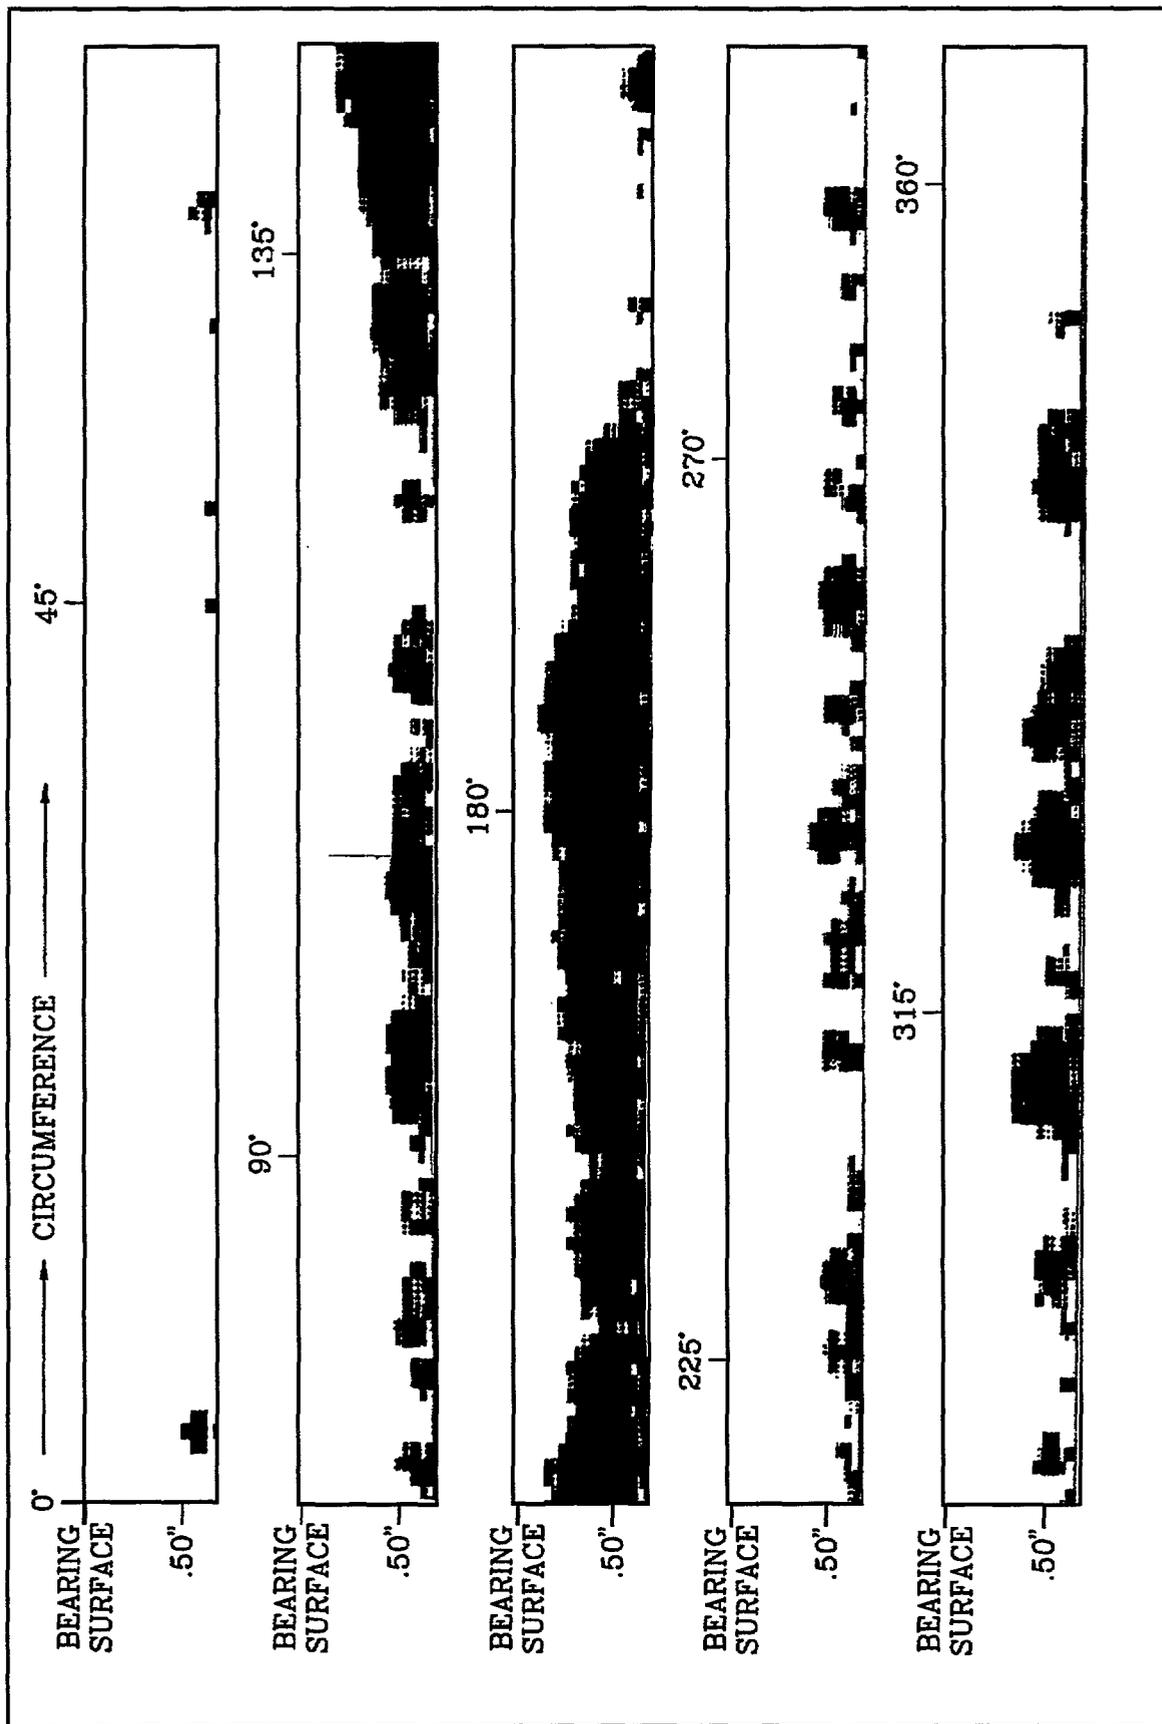
Figure. 57. Pulse-echo C-scan of one end of cylinder LAN 009.

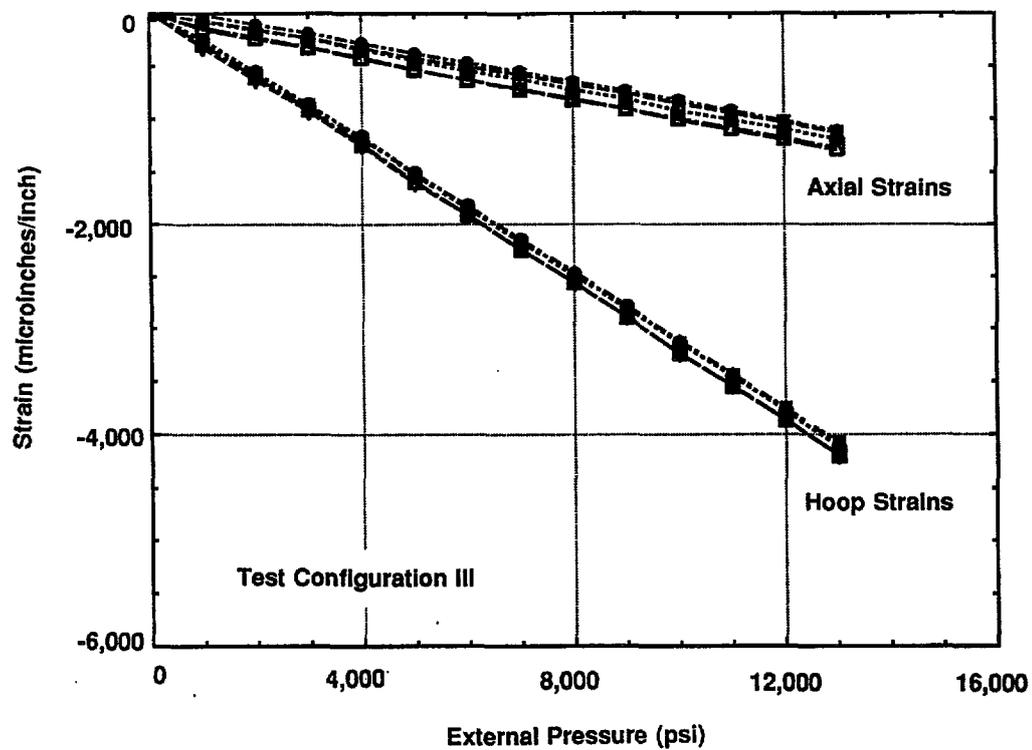
Figure 58. Pressure vs. strain plot for cylinder LAN 010.

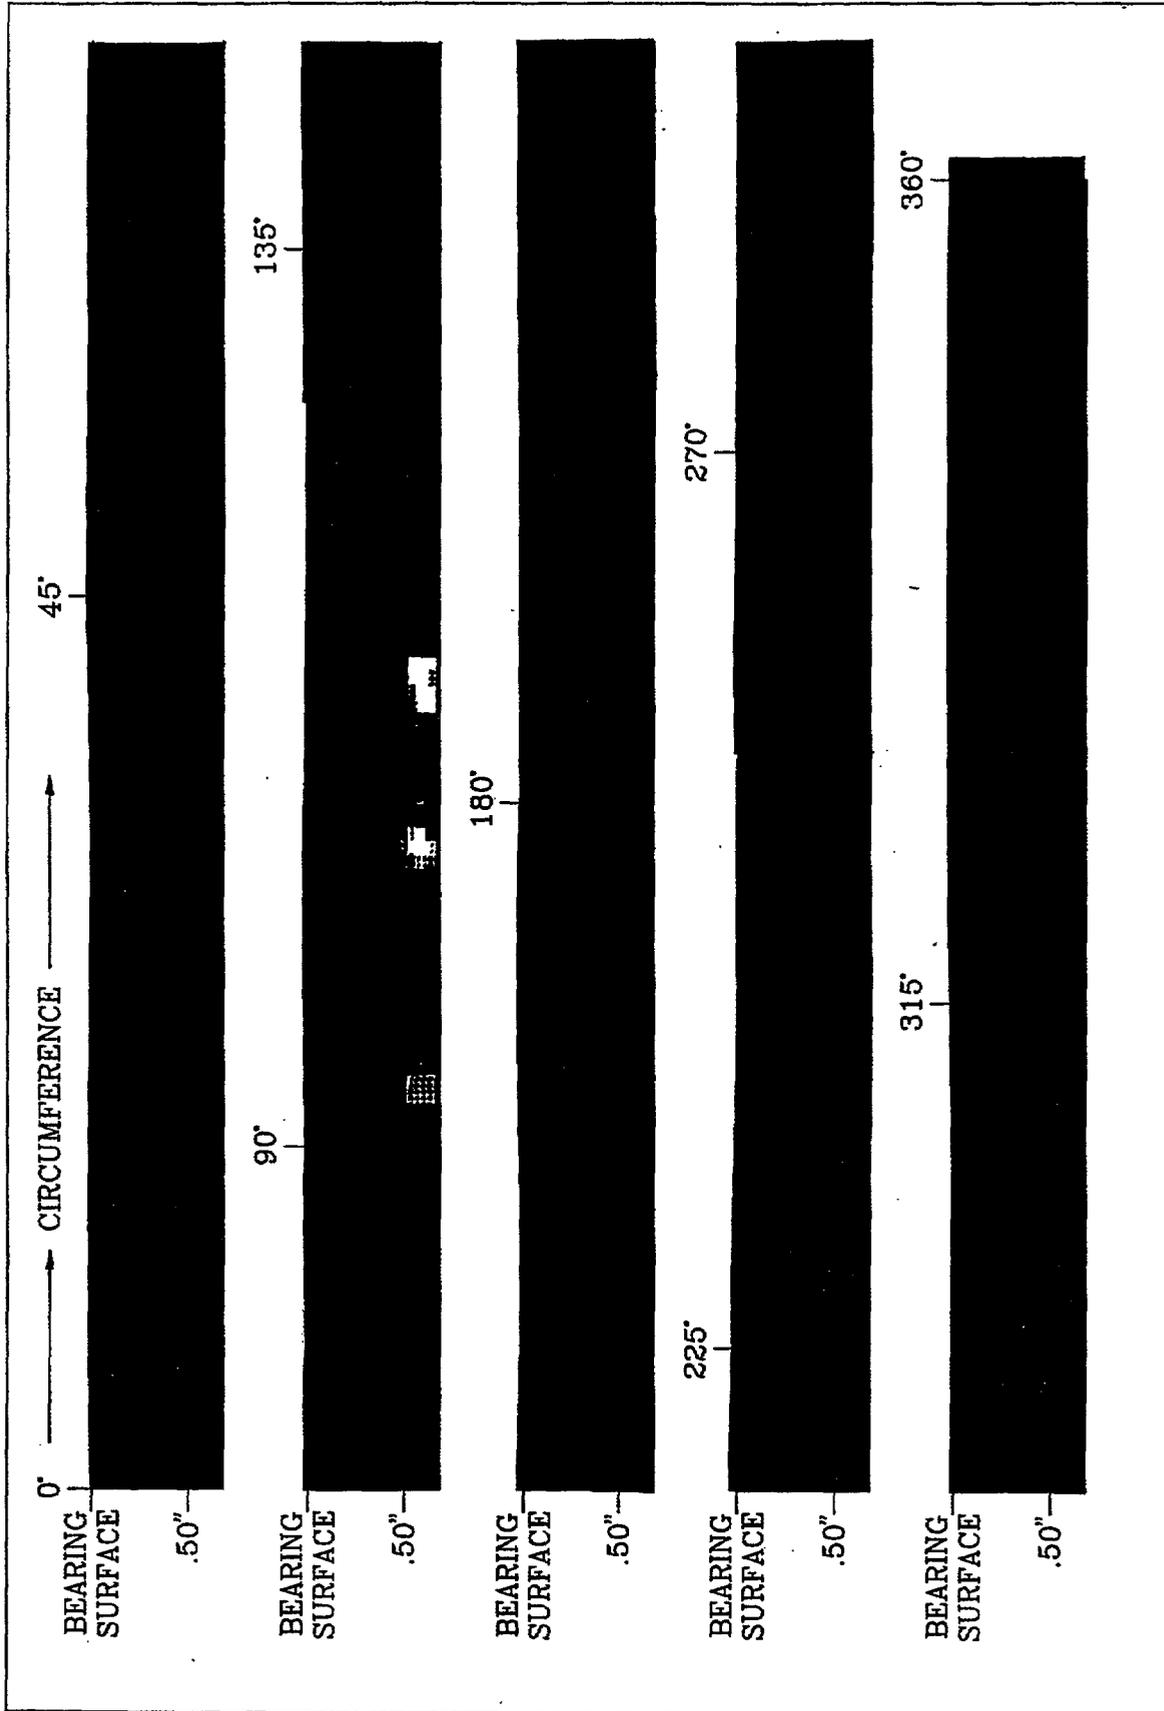
Figure 59. Pulse-echo C-scan of one end of cylinder LAN 010.

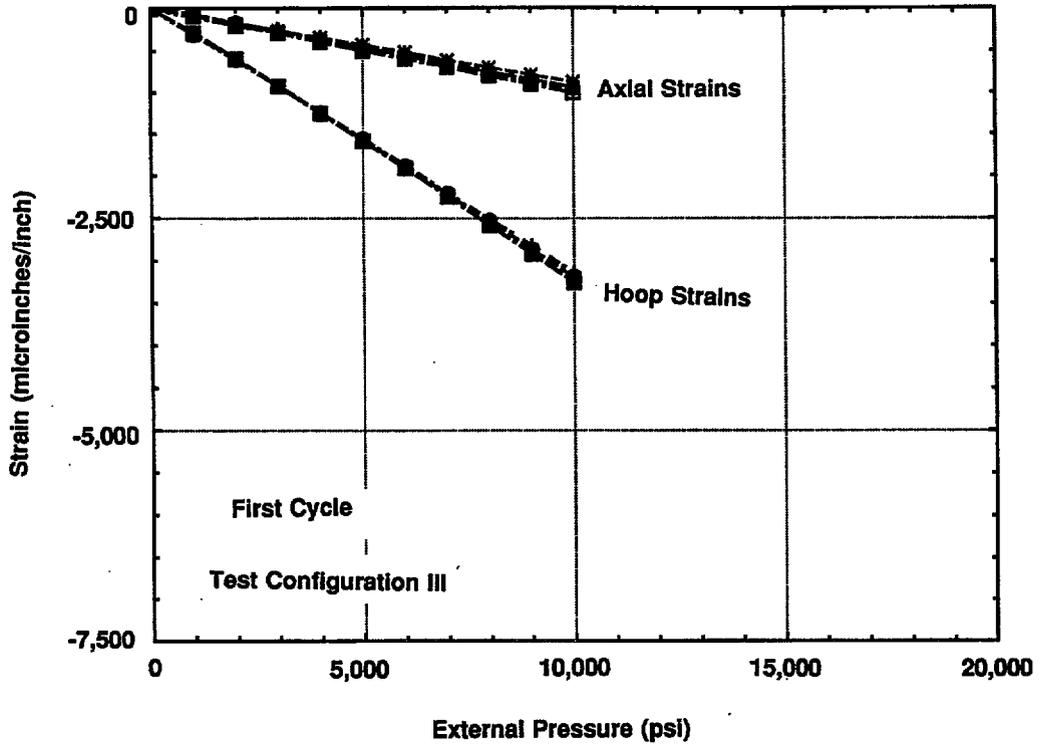
Figure 60. Pressure vs. strain plot for the first pressurization of cylinder LAN 011.
