Structural Performance of Cylindrical Pressure Housings of Different Ceramic Compositions Under External Pressure Loading

Part IV, Silicon Carbide Particulate Reinforced Alumina Ceramic

Technical Report 1594
December 1993

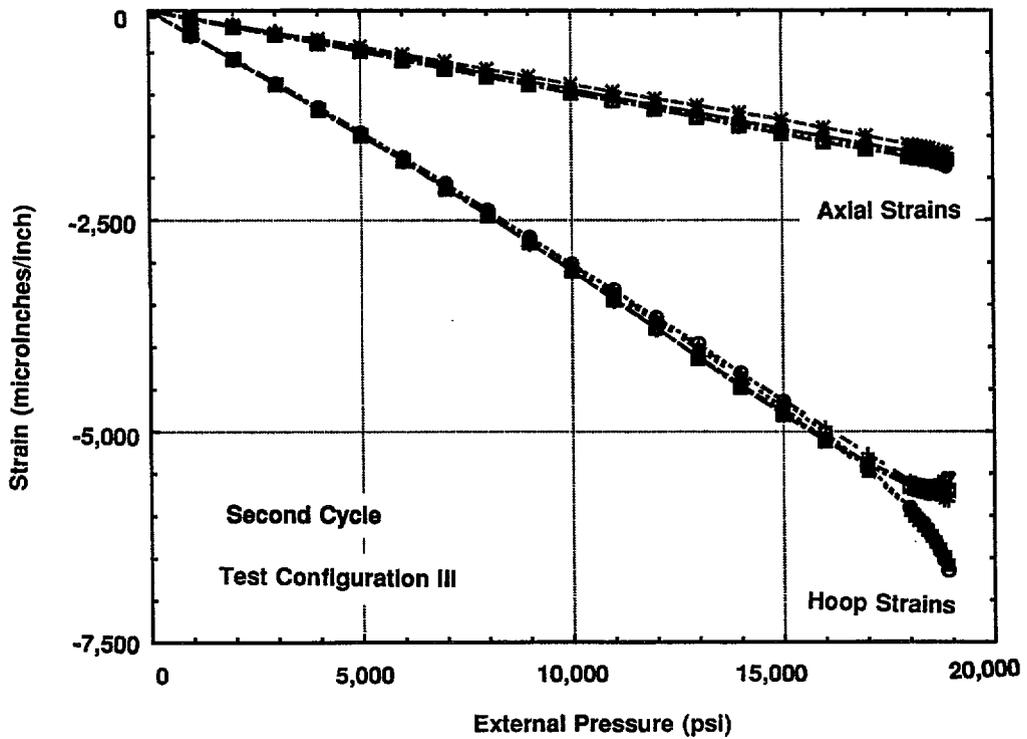
Figure 61. Pressure vs. strain plot for the second pressurization of cylinder LAN 011.

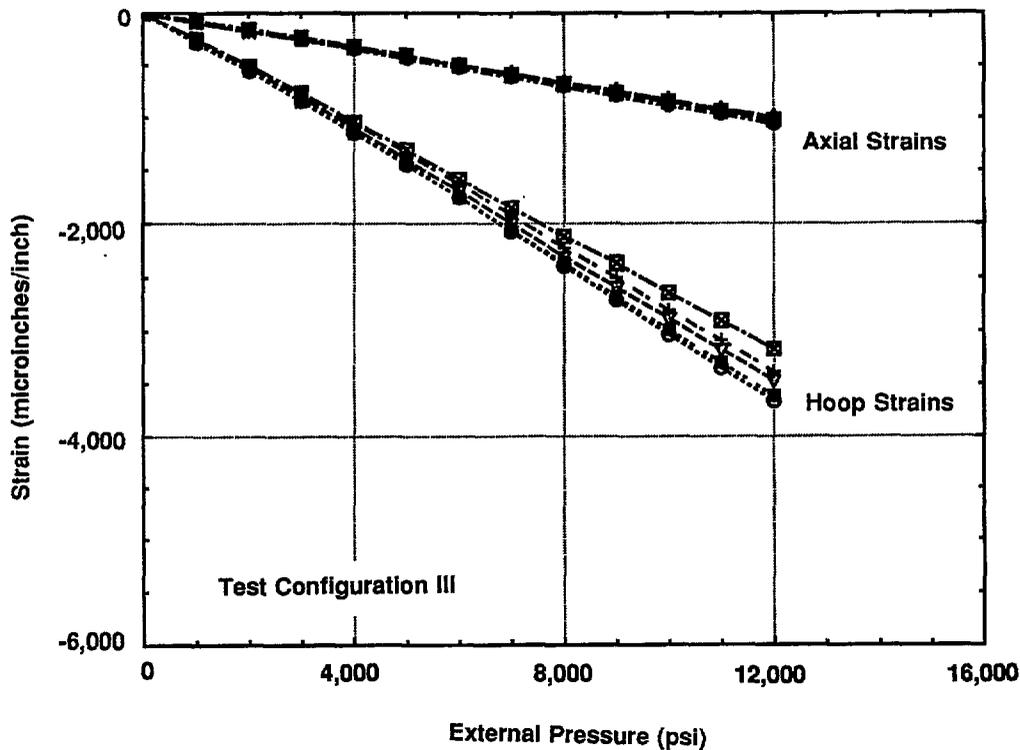
Figure 62. Pressure vs. strain plot for cylinder LAN 012.

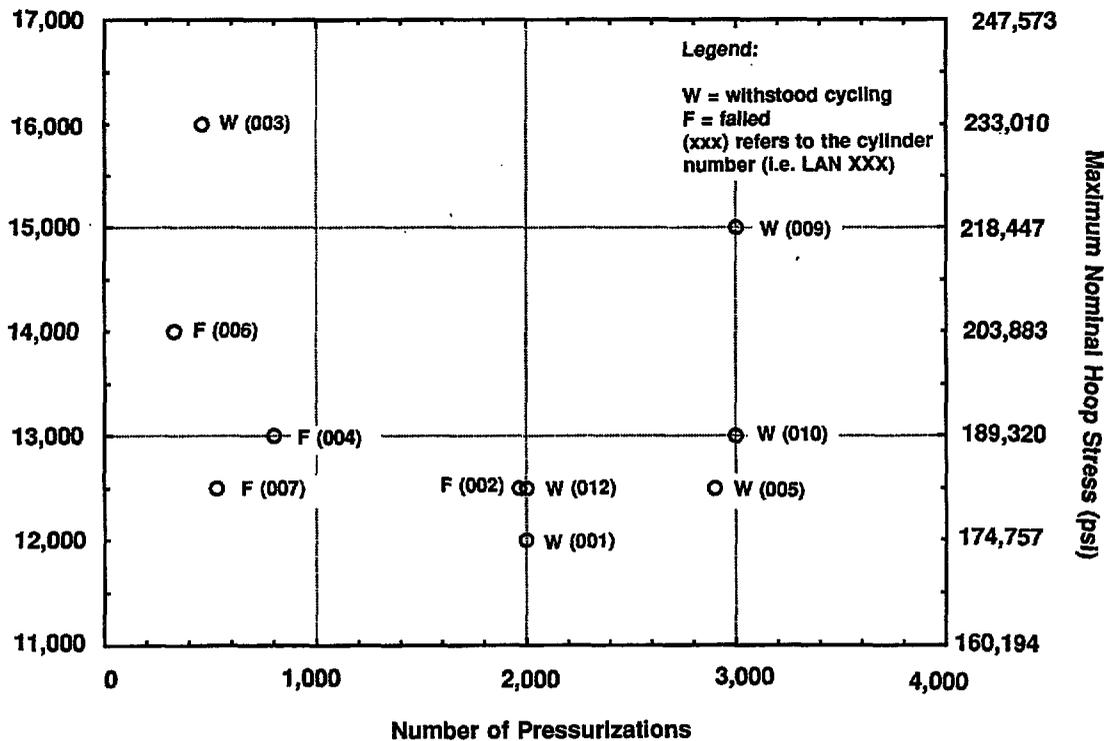
Figure 63. Number of pressurizations to failure, or pressurizations withstood vs. external hydrostatic pressure applied and maximum nominal membrane stress.

tion between the number of cycles to failure and stress levels. However, a maximum design stress level of 182,038 psi is recommended for a cyclic fatigue life of 1,000 cycles to design depth.

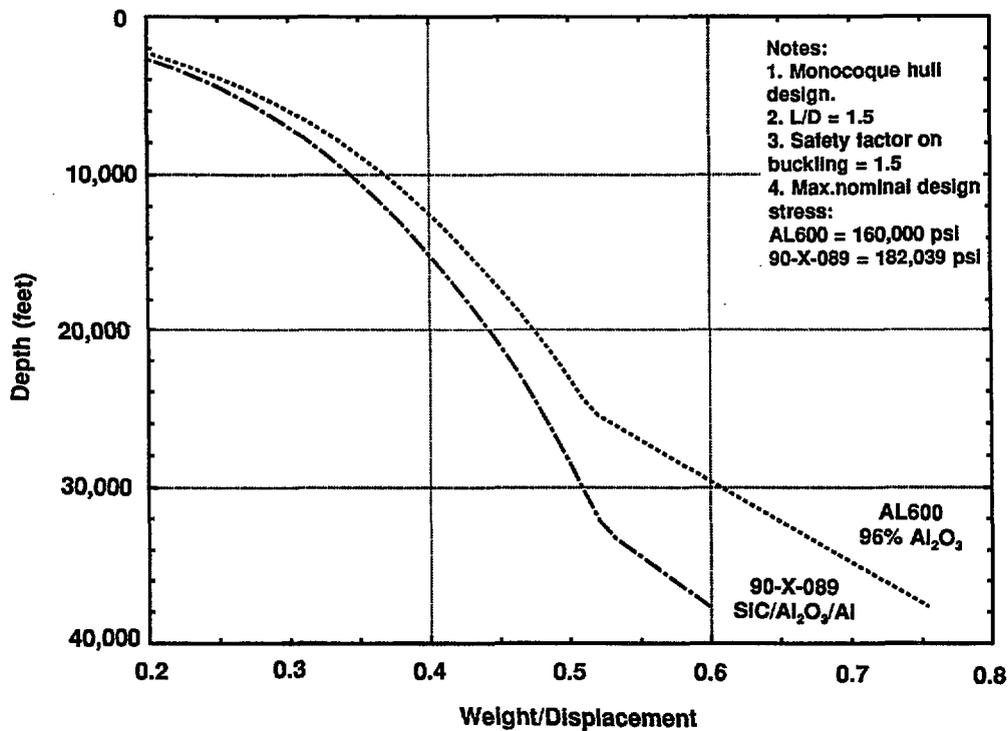
Figure 64. W/D ratio vs. depth curves for AL-600 96-percent alumina-ceramic and Lanxide 90-X-089 cylinders.

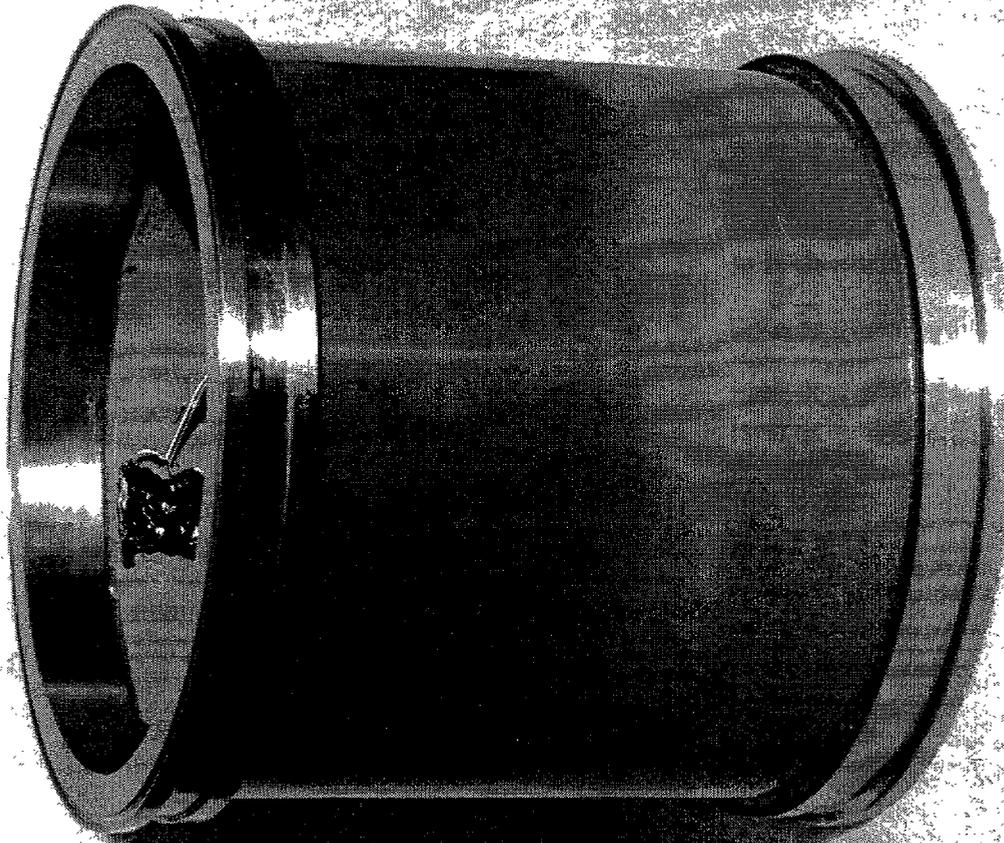
Figure A-1. A 12-inch-OD by 12-inch-long by 0.42-inch-thick ceramic cylinder with Mod 1 titanium end caps fabricated by Lanxide from SiC/Al₂O₃/Al composite by the DIMOX™ process.

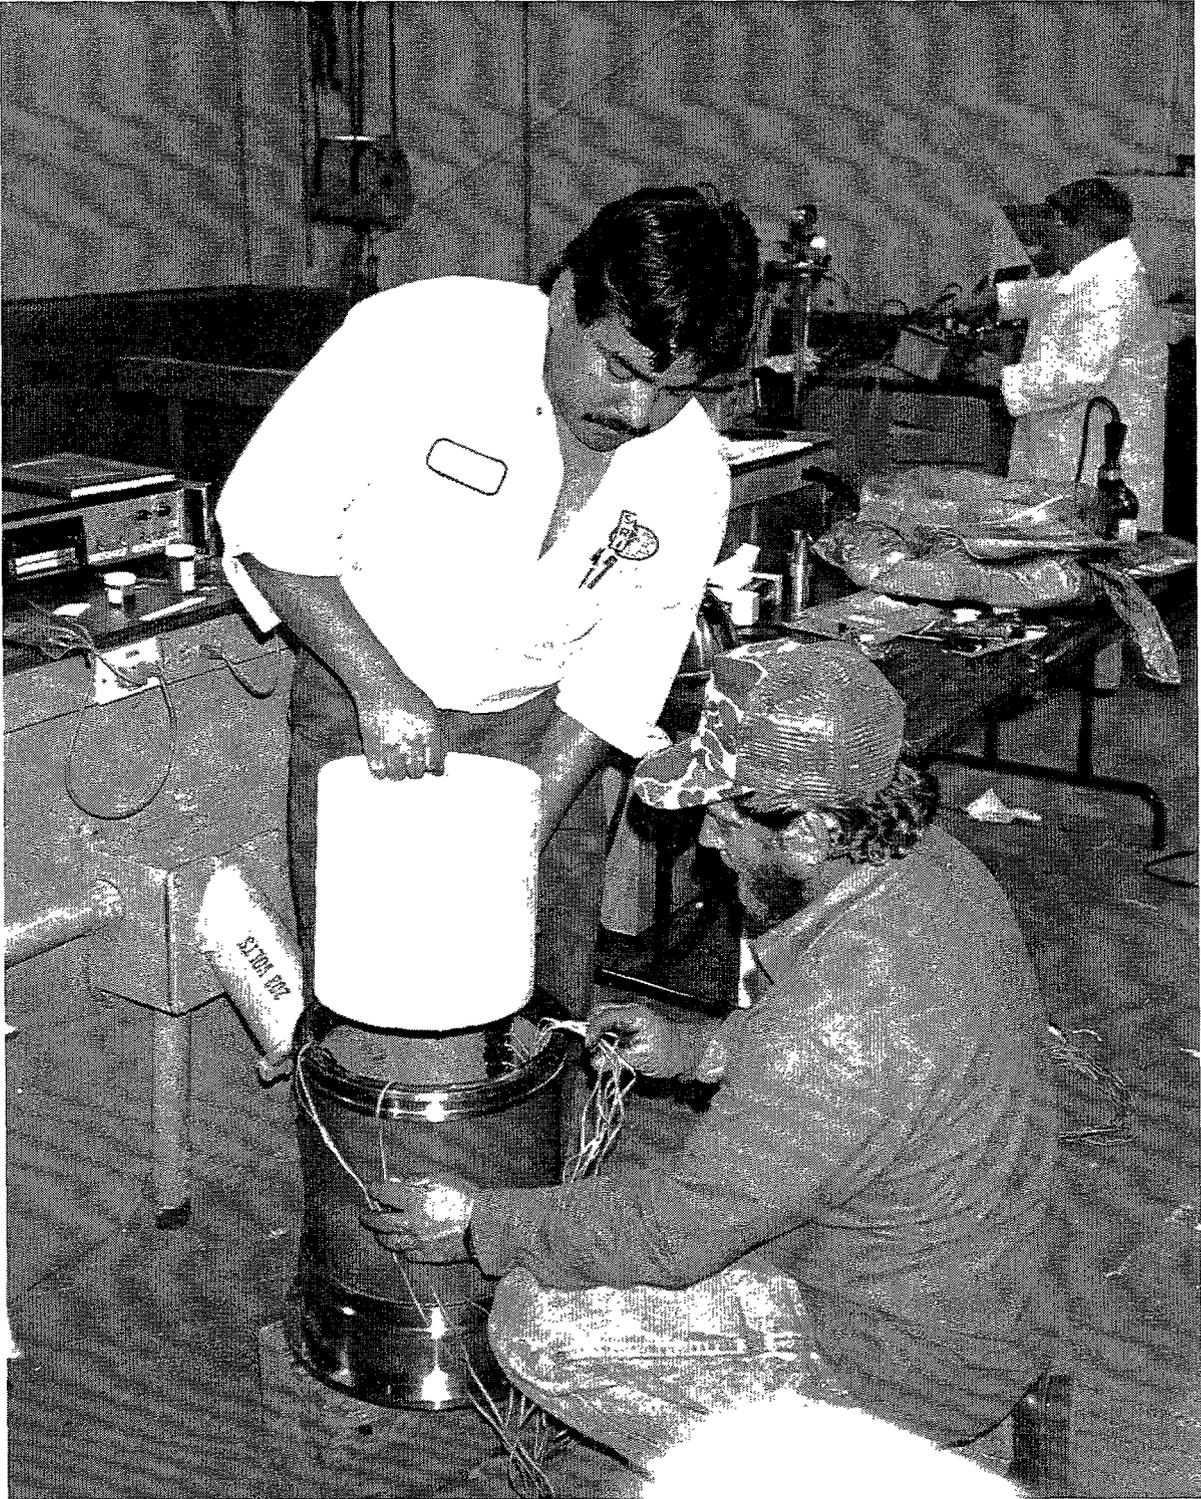
Figure A-2. Insertion of wooden plug inside the cylinder for shock mitigation.

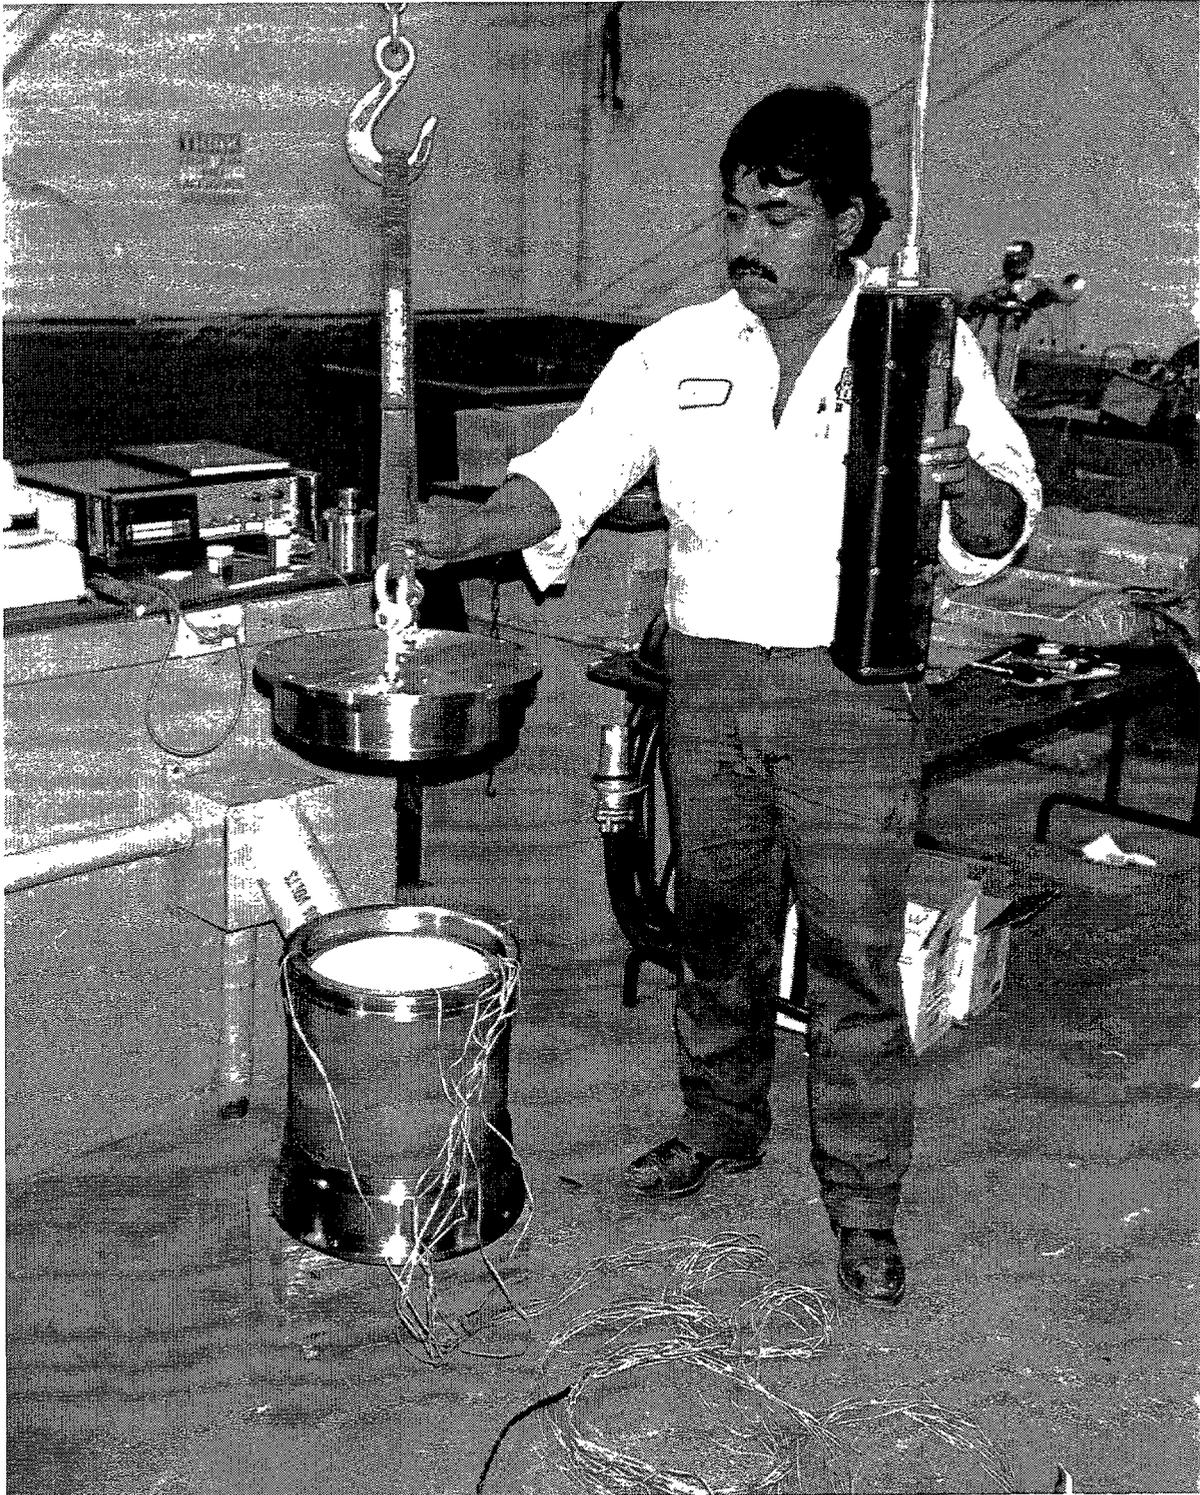
Figure A-3. Placement of steel bulkheads on the ends of the ceramic cylinders.
