TECHNICAL REPORT 1885  
July 2002

# **Monitoring of High-Power Microwave Tube Systems Using the Integrated Condition Assessment System (ICAS)**

North Harris College and  
Prairie View A&M University

SSC San Diego

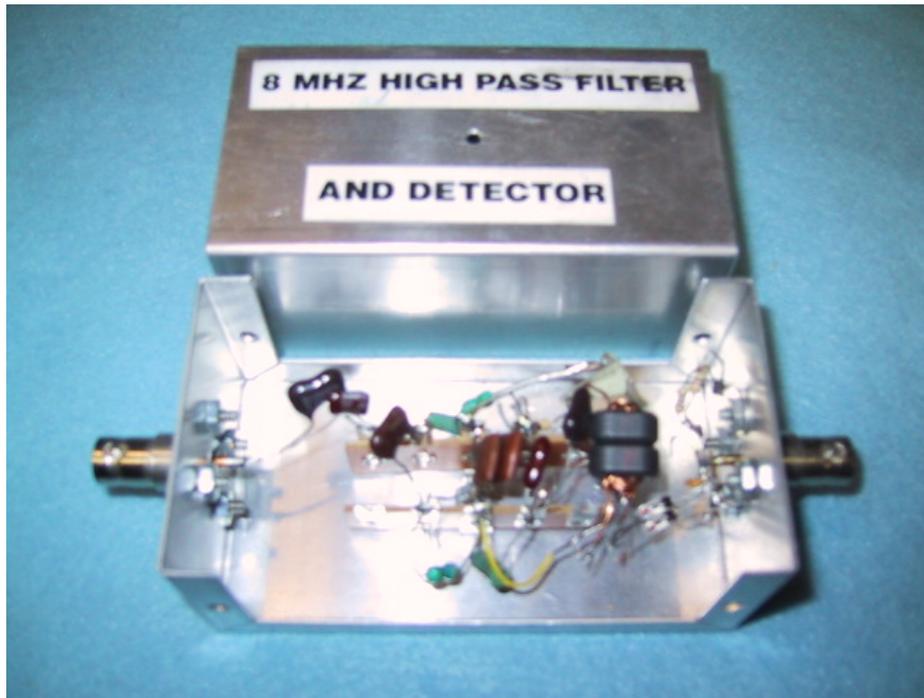
Figure 12. 8 MHz High-Pass Filter and Detector [2C] with photo.

It was found that good cathode current pulses from the magnetron have very little spectral content above about 8 MHz in frequency while bad pulses have much greater content above 8 MHz. Thus, the 8 Mz high pass filter (Figure 12) may produce a much greater output for bad pulses relative to that for good pulses. The signal is then filtered by 15 MHz low pass filter (Figure 13) that cleans up the spectral content of the pulses and smoothes the pulses. As a result, the output of the 15 MHz filter is relatively small for good pulses and much larger for bad pulses. The threshold amplifier has a comparator (Figure 14) with an adjustable threshold that can be set so that it will not respond to good pulses but will generate a 5 volts TTL-compatible output pulse when a bad current pulse occurs.

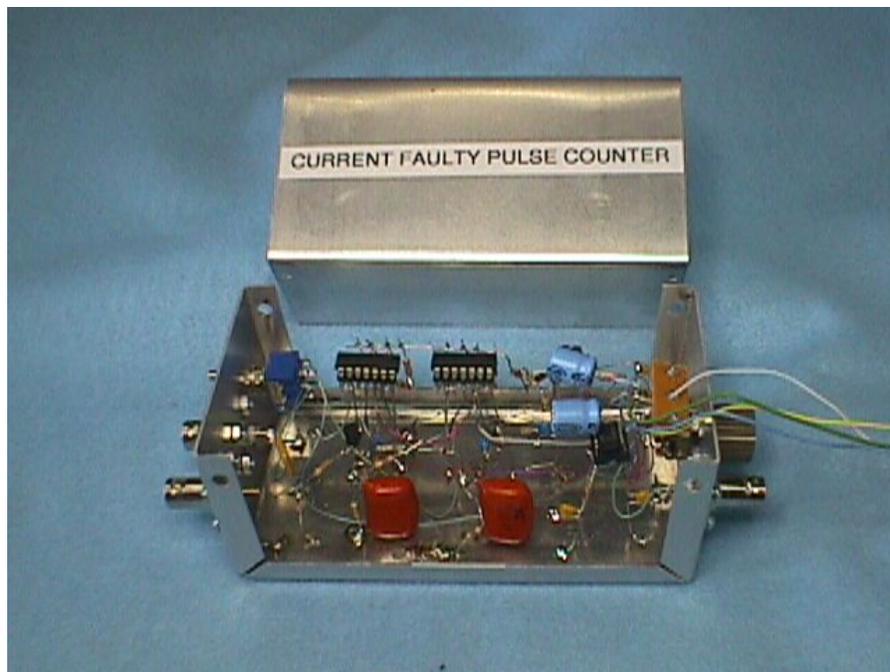
Figure 15. Defective Current Pulse Counter circuit [5C] and photo.

Next, methods were needed to count faulty current pulse signals from the threshold amplifier. Two methods were designed, fabricated, and tested to count faulty pulse signals from the threshold amplifier. A digital method was developed for use when reset pulses were available, and an analog method was developed for use in the absence of reset pulses. These two counting methods are represented in the circuit diagram “Defective Current Pulse Counter,” (Figure 15) with the upper part of the drawing showing the digital section and the lower part of the drawing showing the analog section. The digital method used two TTL count-by-ten circuits, giving the counter the ability to count up to 100 pulses between reset pulses. The output of the TTL counters was fed into a digital-to-

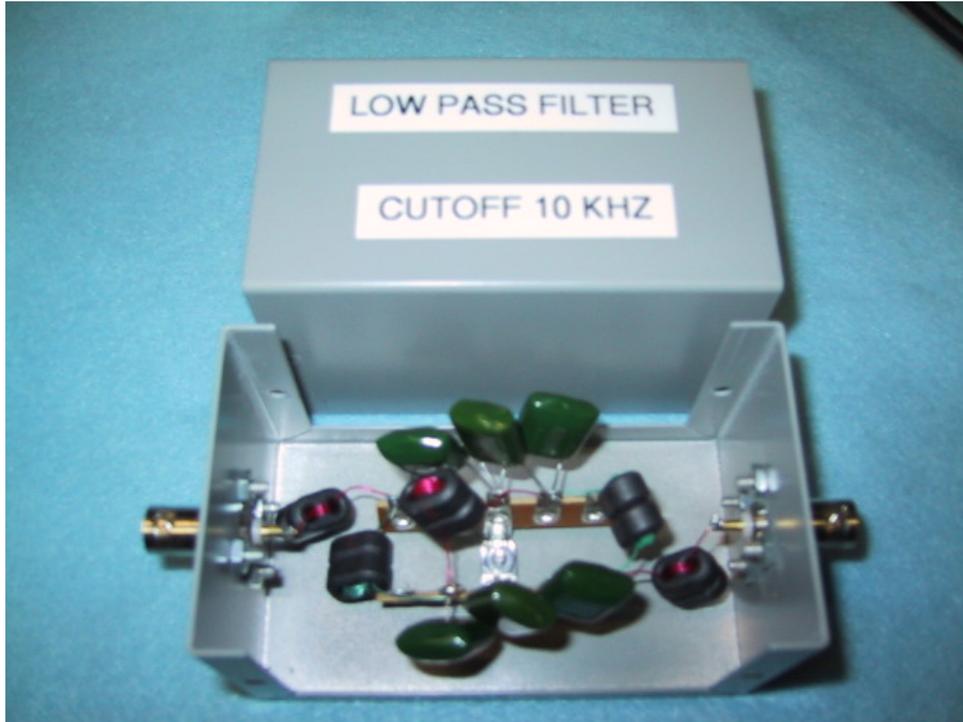
Figure 19. Low-Pass Filter (10 kHz cutoff) circuit [5A] and photo.

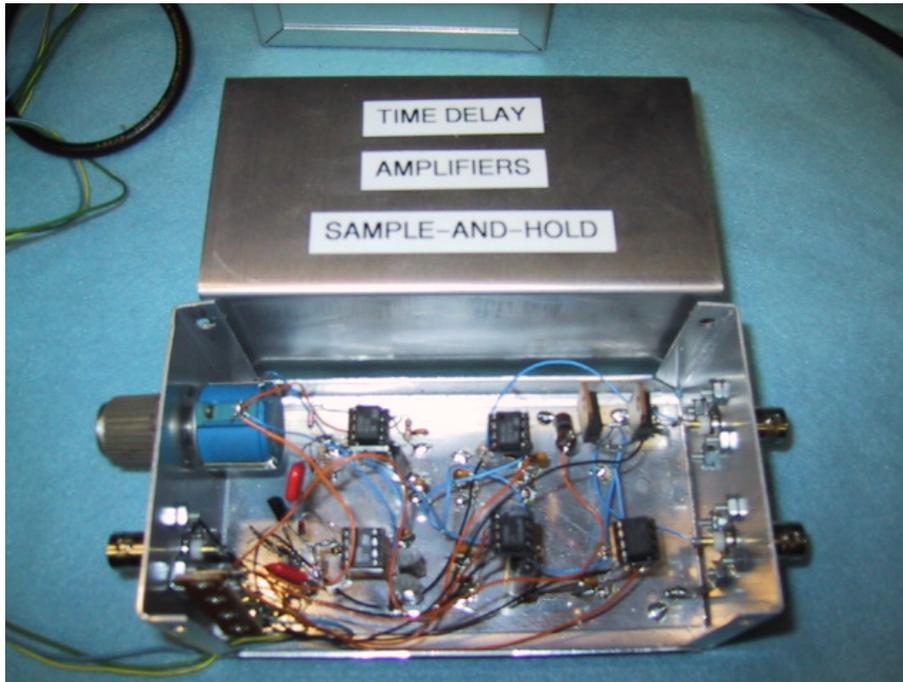
Figure 20. Time Delay, Amplifier, Sample-and-Hold circuit [6A], and photo.

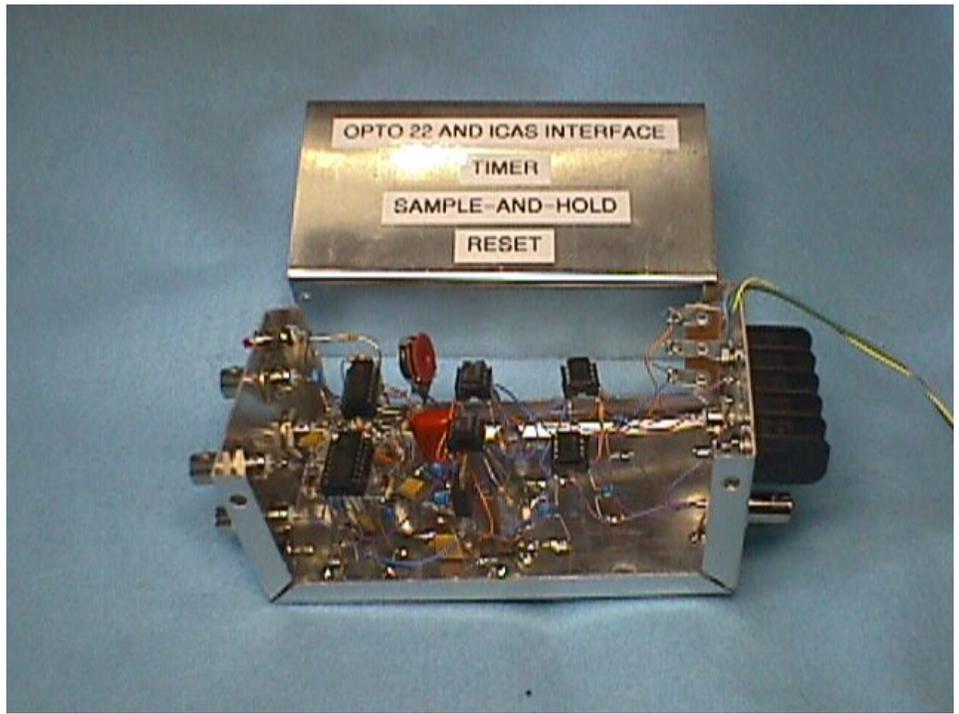
Figure 23. One-Second Data Sample and Reset circuit [9A] and photo.
